**Project Number: P53118-001 LCIP**

**Reporting period: January-June 2025  
N7 Semestral Report**

## **GEORGIA: Livable Cities Investment Project for Balanced Regional Development**

Prepared by the Municipal Development Fund of Georgia of the Ministry of Infrastructure of Georgia for the Asian Development Bank.

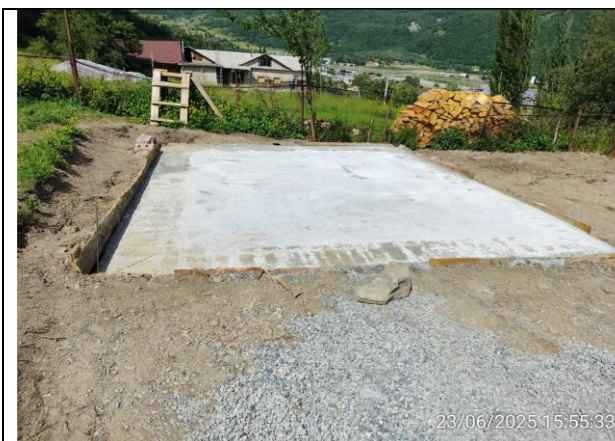
Sector #9 – Building #027 Arrangement of foundation  
Dated 23.06.2025

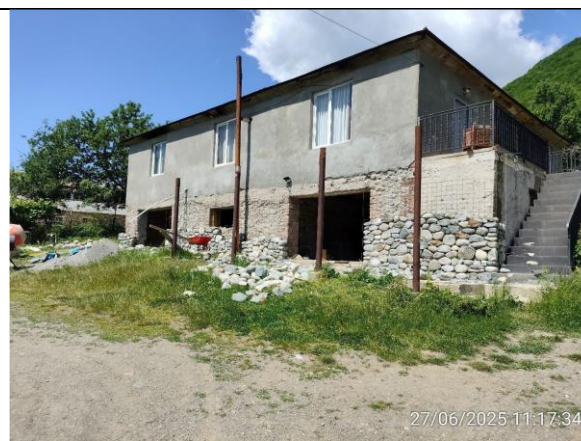
Sector #9 – Building #028 Finishing of the wall in the front façade with stone  
Dated 23.06.2025

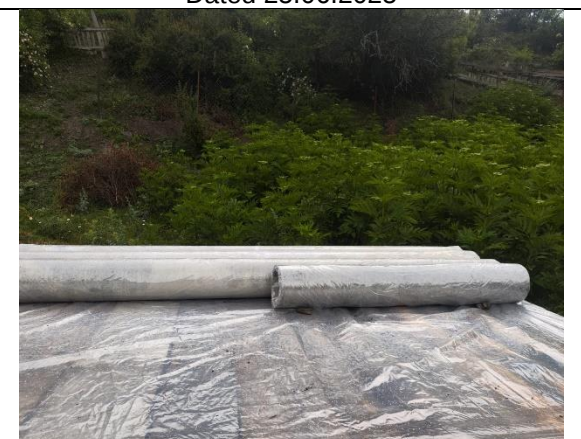
Asbestos-containing pipes securely double-wrapped in plastic sheeting and temporarily stored on a waterproof protective barrier prior to transport to a licensed hazardous waste facility.  
Dated 27.06.2025

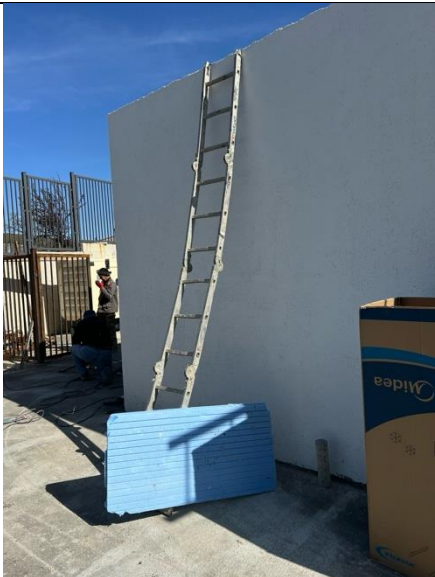
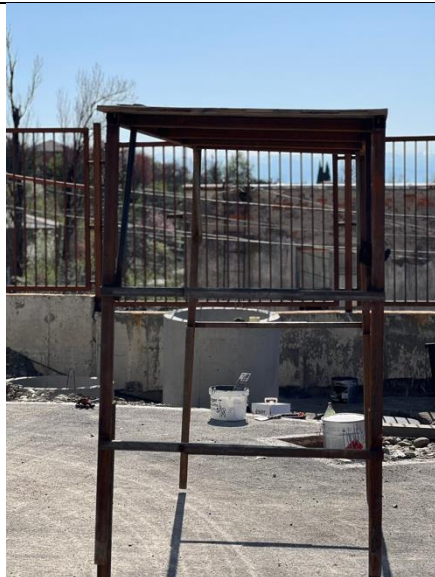
| <p>Use of Self-made ladder on construction site - Non conformity closed when construction activities were completed during the work stage contractor was using self-made ladders and platforms on site</p> | <p>Status: (open, in progress, closed) - Closed</p> |

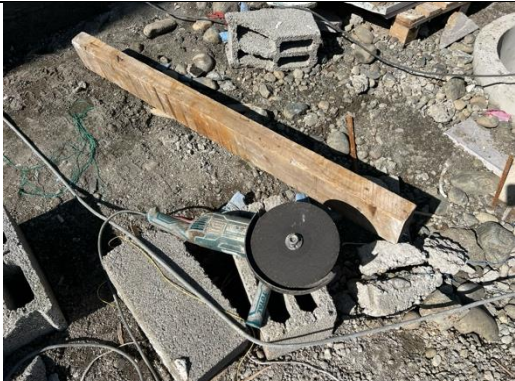
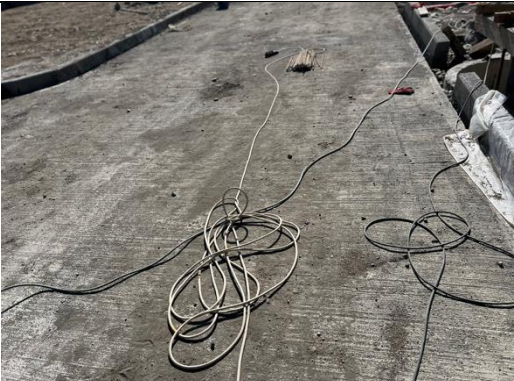
| <p>Unsafe electrical cables and tools - Non conformity closed when construction activities were completed;</p> | <p>Status: (open, in progress, closed) - Closed</p> |

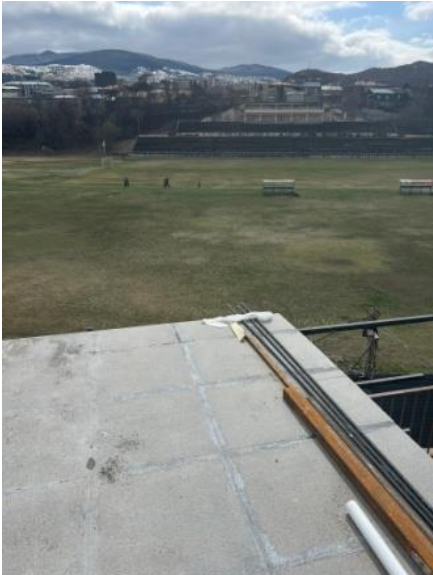
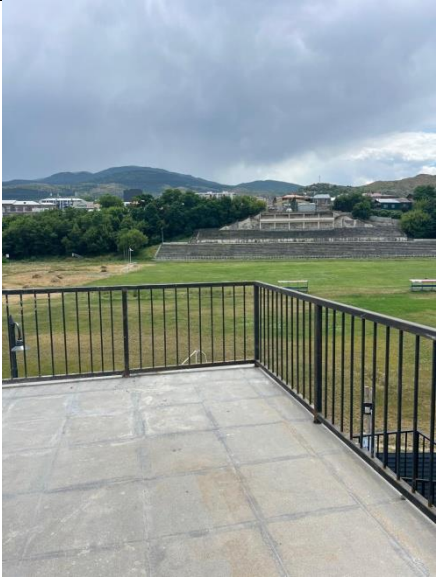
| Detected non conformities | Remedial actions |
|---|---|
| Missing safety barriers, open slab detected | Non conformity is closed as main construction activities are completed;<br><b>Status:</b> (open, in progress, closed) - <b>closed</b> |

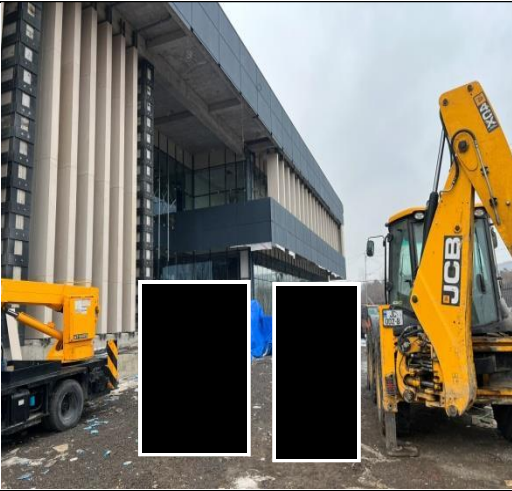
| <p>Lack of PPE -</p> | <p>Non conformity is still remains open <b>Status:</b><br/>(open, in progress, closed) - <b>Open</b></p> |

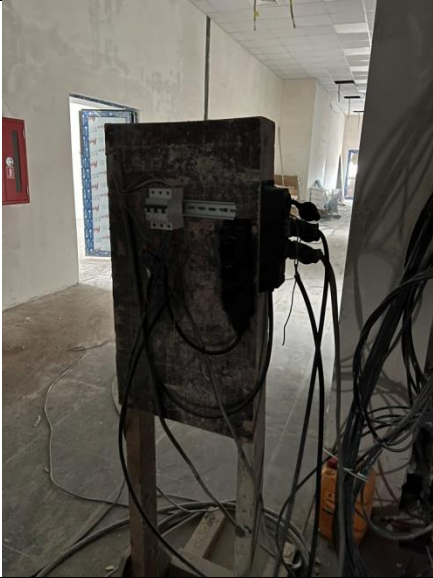
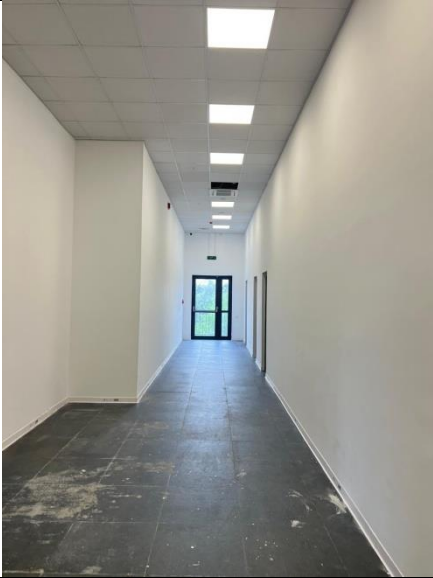
| <p>Unsafe electrical cables and tools</p> | <p>Non conformity Is closed when construction activities were completed<br/><b>Status:</b> (open, in progress, closed) - <b>Closed</b></p> |

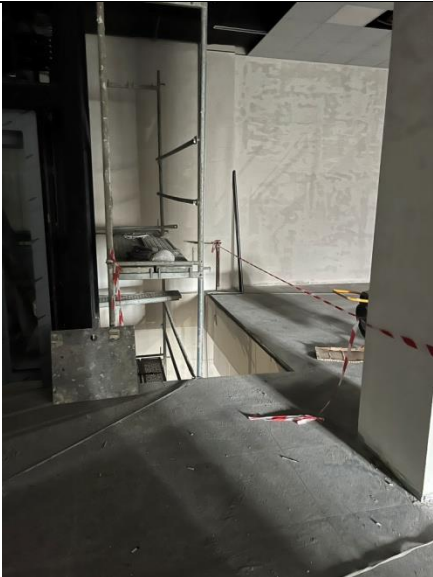
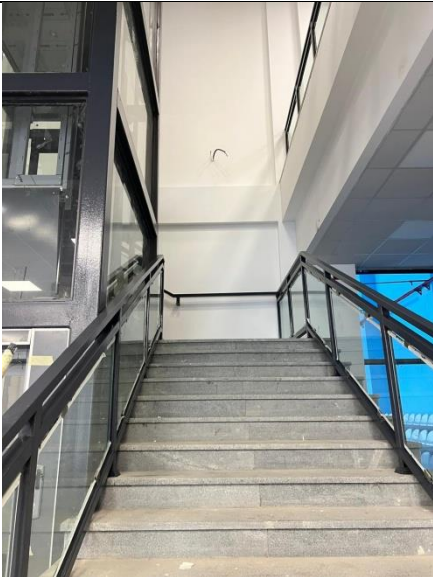
| <p>Missing safety signs for hazardous zone</p> | <p><b>Status:</b> (open, In progress, closed) - <b>Closed</b></p> |

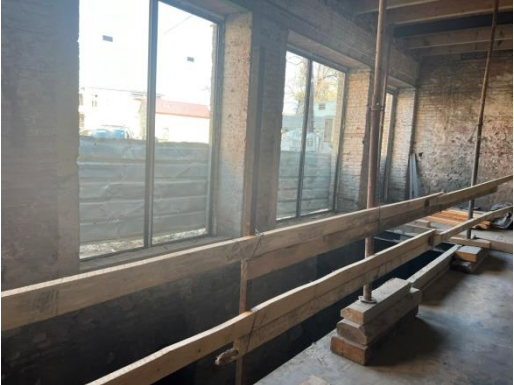
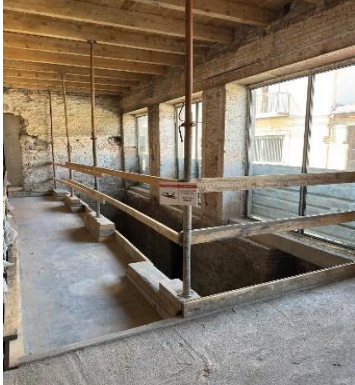
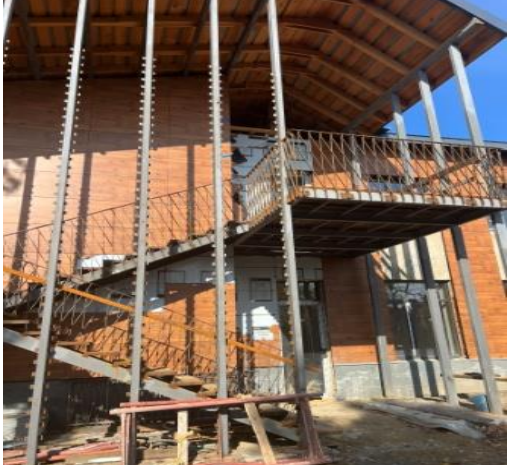
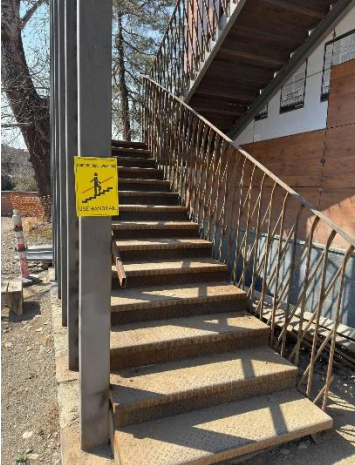
| Detected non conformities | Remedial Actions |
|---|---|
| <p>Risk to fall - self-made platform; (2) not isolated hazardous zones, (3) No safe barriers not according 477 regulations, risk to fall (4) missing relevant signs;</p> | <p><b>Status:</b> (open, in progress, closed) - <b>Closed</b> - on conformity is closed contractor rectified the issues within a in reasonable deadline</p> |

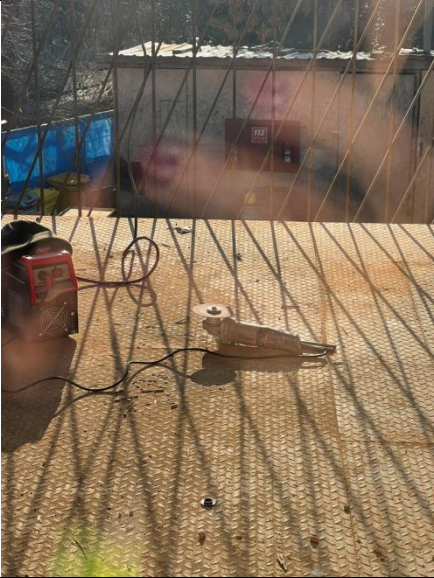
| | | | | | | | | | | | | | | | | | | | | | | | | | | | | | | |
| Description of non-conformity and status: Bad practice of using electrical tools | <b>Status:</b> (open, in progress, closed) - <b>Closed</b> | | | | | | | | | | | | | | | | | | | | | | | | | | | | | | |

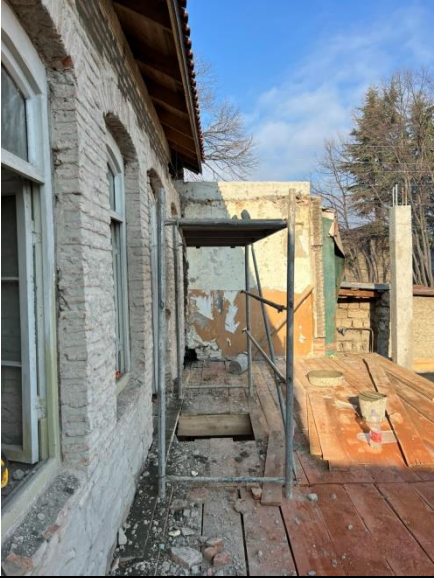
| <p>The scaffold is incomplete due to missing components and is not fully assembled. Additionally, the ladder used is unsafe as it is too short for the specified location — two steps are missing.</p> | <p><b>Status:</b> (open, in progress, closed) - <b>In progress</b></p> |

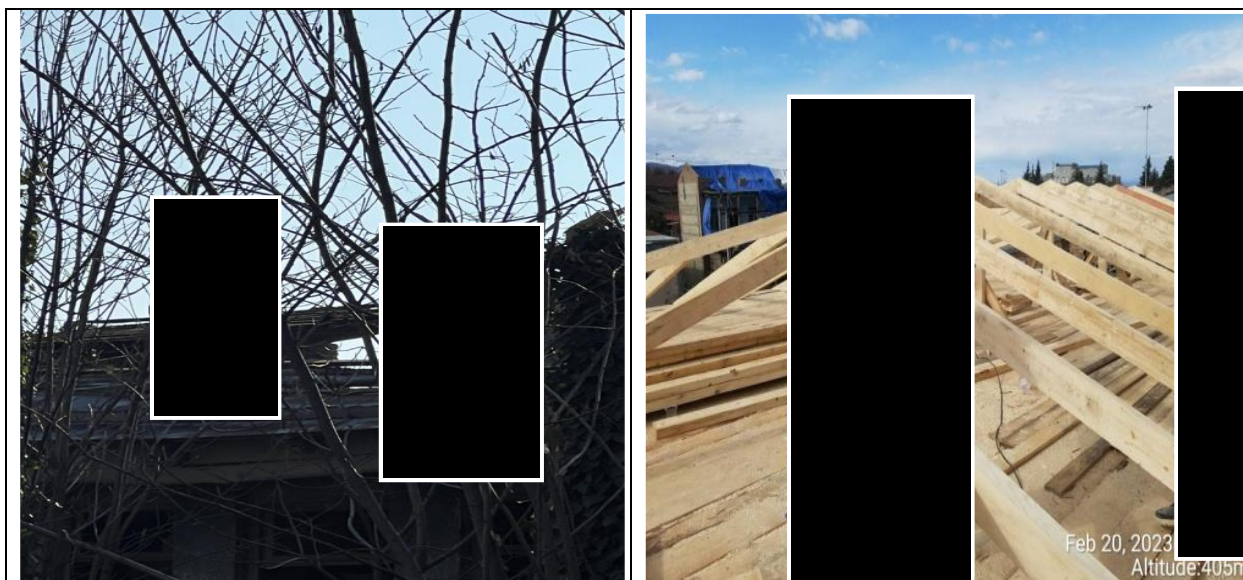
| <p><b>Description of non-conformity and status:</b><br/>Employees are working at height without any form of support. None of them are using safety harnesses, and a lifeline is missing</p> | <p>Non conformity is closed, contractor equip site and personnel with lifeline and safety harness;<br/><b>Status:</b> (open, in progress, closed) - <b>Closed</b></p> |

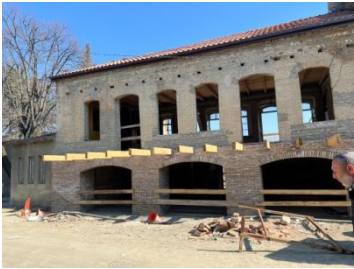
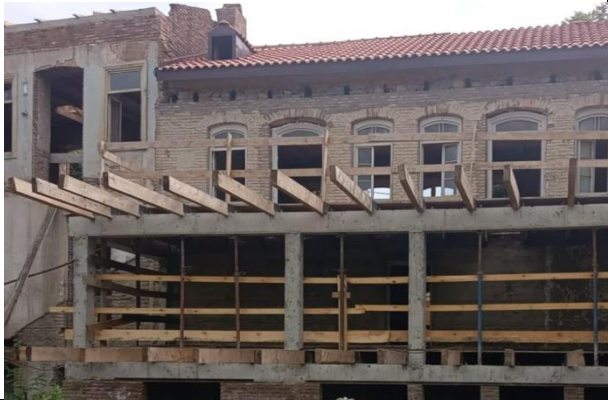
| <p>: Critical practice of working on height - missing barriers according 477 regulation and relevant sings; hazardous zone is not isolated ;</p> | <p><b>Status:</b> (open, in progress, closed) - <b>Closed</b></p> |

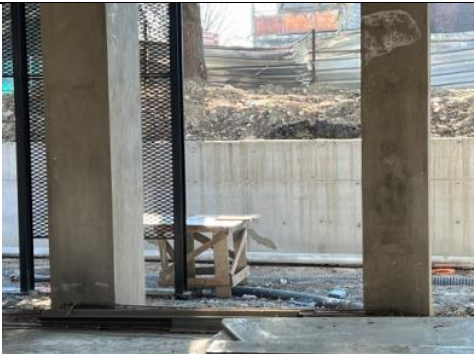
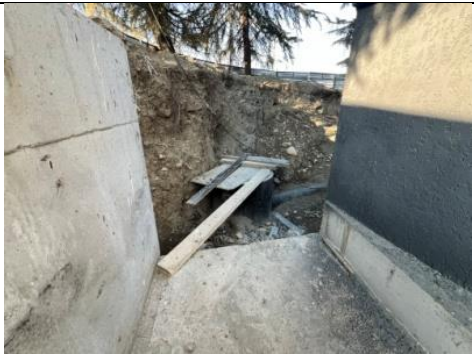
| Detected non conformities | Remedial Actions |
|---|---|
| Self-made “platform” and ladder detected – non conformity Is still remains open; | <b>Status:</b> (open, In progress, closed) - <b>In progress</b> |

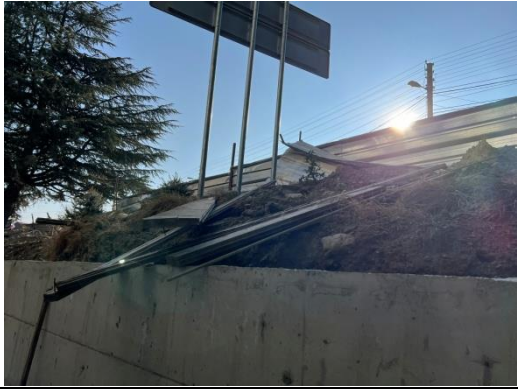
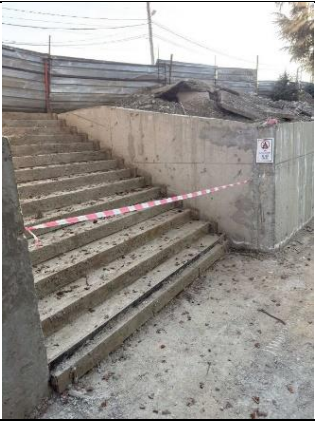
| Detected non conformities | Remedial Actions |
|---|---|
| Material is located at the edge of the slope not safe – risk of fall and body damage on employee<br>Non conformity Is still remains open | <b>Status:</b> (open, In progress, closed) - <b>In progress</b> |

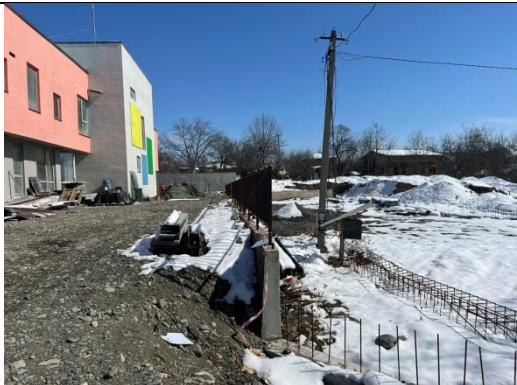
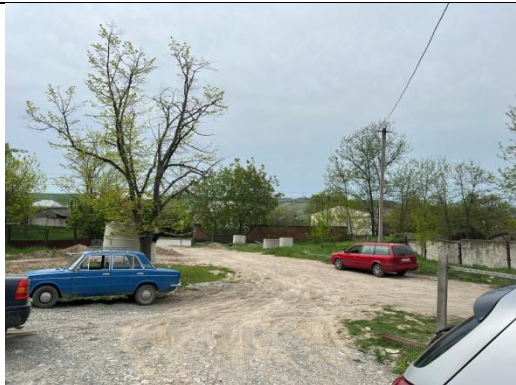
| Non-Conformity | Remedial Actions |
|---|---|
| Third party access missing fencing since beginning of the project | Status: (open, In progress, closed) - <b>open</b> |

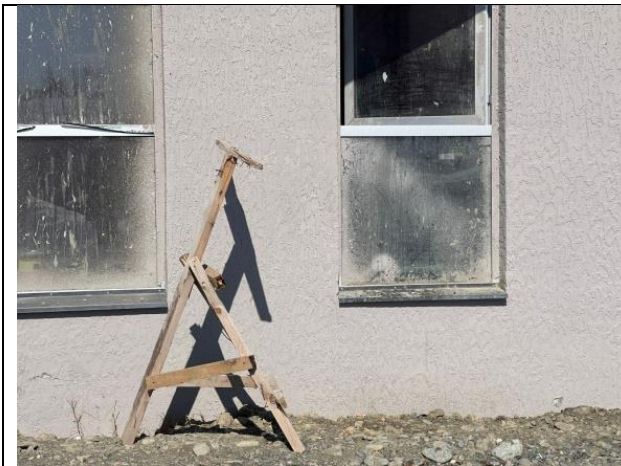
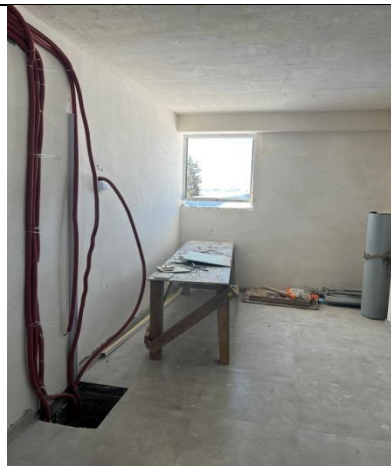
| Non-Conformity | Remedial Actions |
|---|---|
| Self made collective equipment | Status: (open, In progress, closed) - <b>Open</b> |

Not supported slab (2) self made platform in hazardous zone (3) Self made hanging platform - critical inconsistency

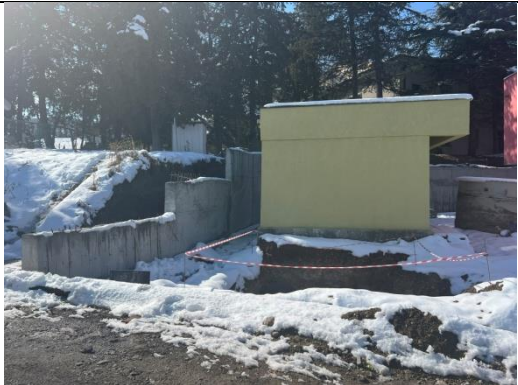
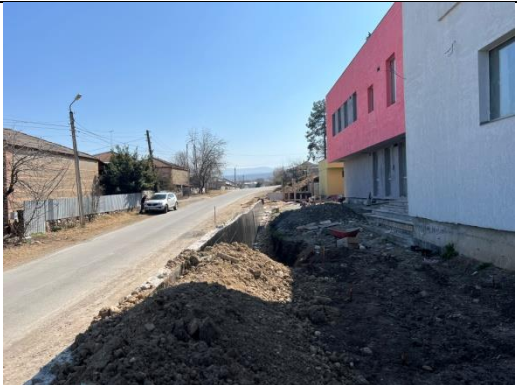
| Non-Conformity | Remedial Actions |
|---|---|
| Third party access and damage, site is not fenced detected open trench, holes, self-made ladders; material stored ; high risk to fall and / or body damage; | <b>Status:</b> (open, In progress, closed) - <b>open</b> |

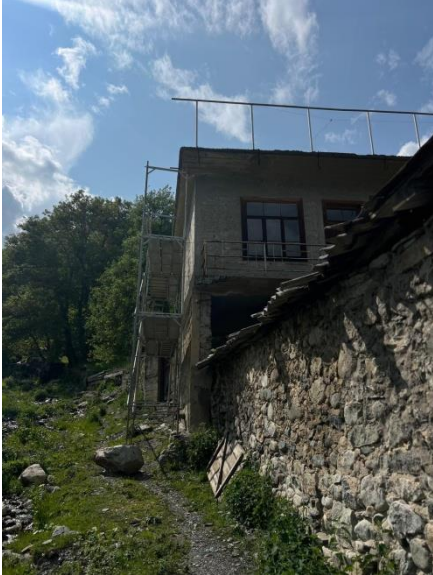
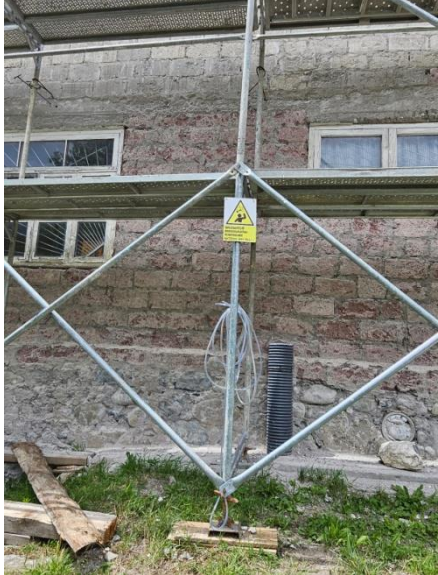
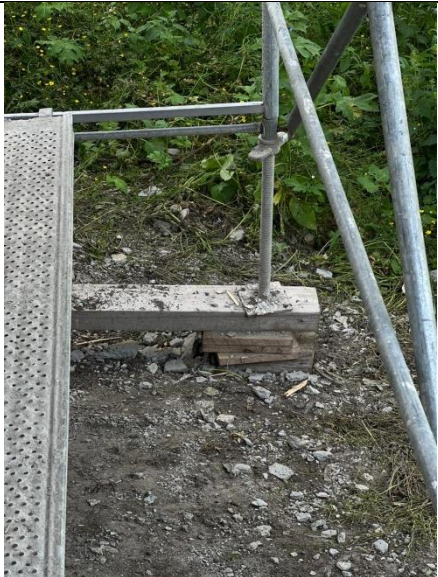
| <p>Scaffolding structures is not full set – missing handrails or boards (top; mid , toe board) ; edges are not protected and not fully secure; (2) ground surface - unlevel surface applier rocks and debris – fall hazard (3) Missing proper fixing (4) hazardous zone is not marked and isolated with signs and employee pathway; (5) not full set of platforms</p> | | <p><b>Status:</b> (open, In progress, closed) - <b>In progress</b> - <b>Missing certificates</b></p> | |

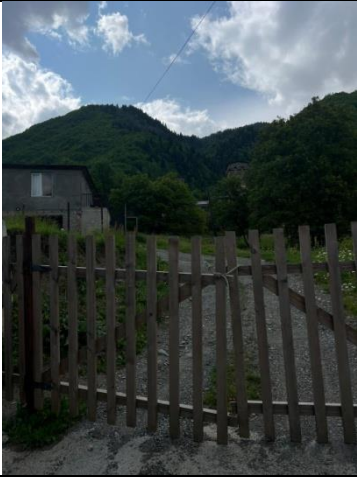
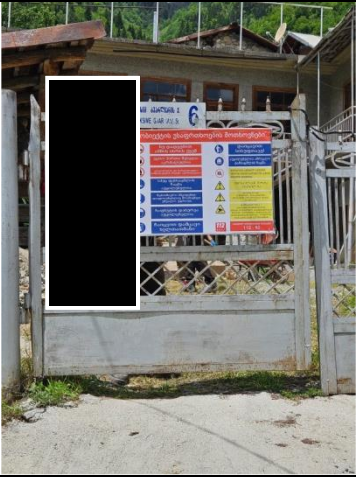
| <p>(1) lack of waste management (2) absence of safety signs, unmanaged access open pathways;<br/> <b>Status:</b> (open, In progress, closed) - <b>Closed</b></p> | |

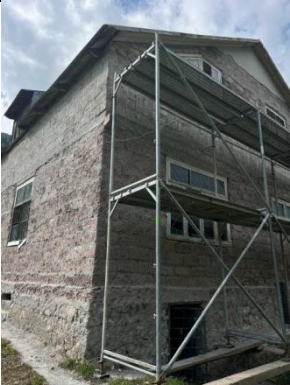
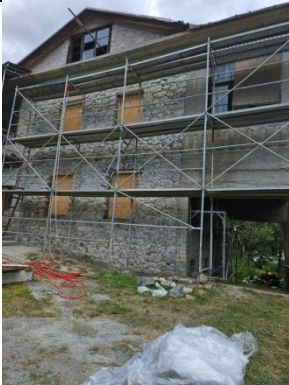
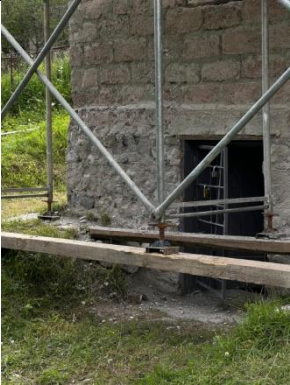
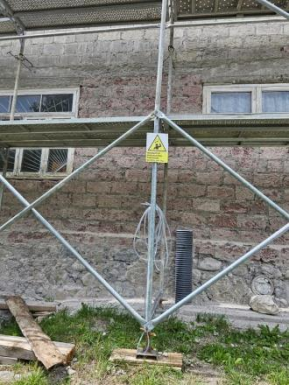
| <p>Scaffolding structures is not full set – missing handrails or boards (top; mid , toe board) ; edges are not protected and not fully secure; (2) ground surface - unlevel surface applier rocks and debris – fall hazard (3) Missing proper fixing (4) hazardous zone is not marked and isolated with signs and employee pathway;<br/> <b>Status:</b> (open, In progress, closed) - <b>In progress</b></p> | |

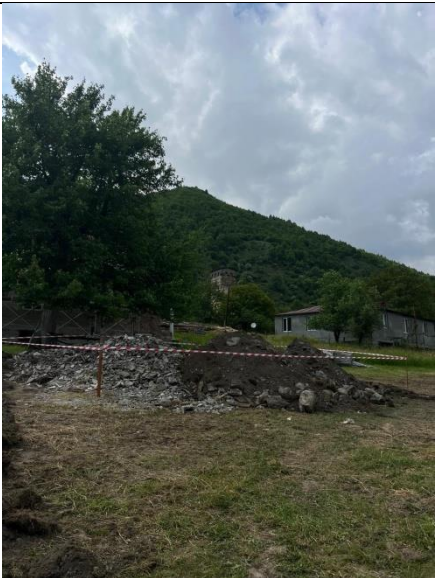
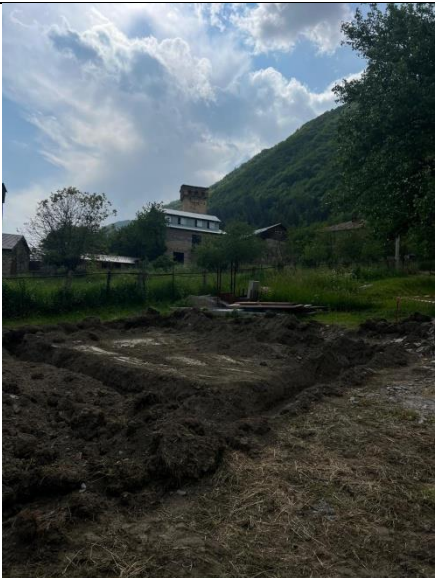
| Lack of safety signs; No hazardous zone marked;<br><b>Status:</b> (open, In progress, closed) - <b>open</b> | |

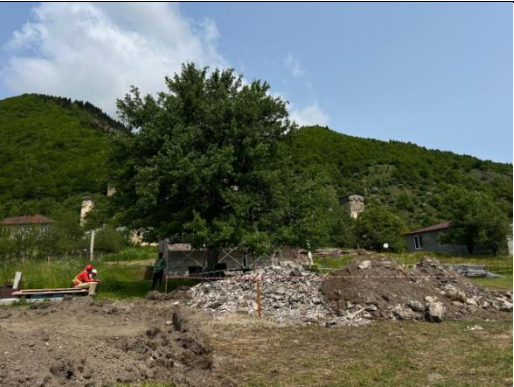
| Hazardous zone is not marked, missing signs, lack of housekeeping<br><b>Status:</b> (open, In progress, closed) - <b>Open</b> | |

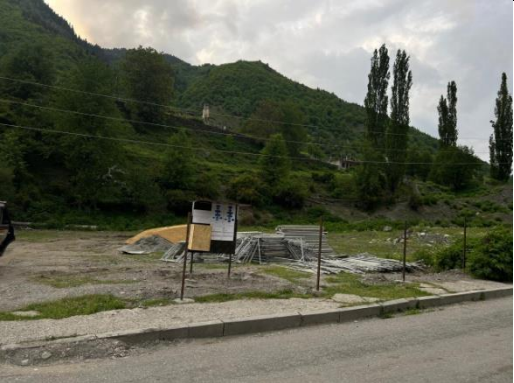
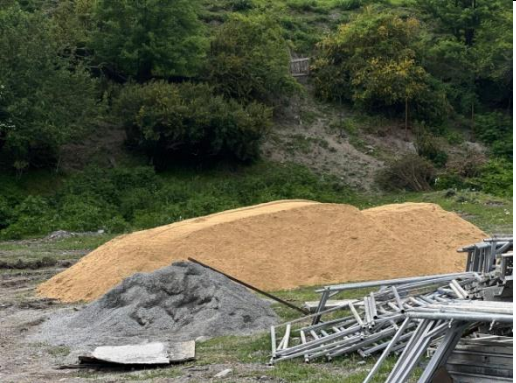
| third party access not controlled site lacks proper fencing ; (2) sand gravel material is not protected or covered (3) Not supported collative equipment (4) lack of mandatory safety signs;<br><b>Status:</b> (open, In progress, closed) - <b>Open</b> | |

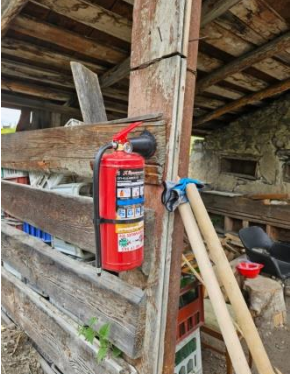
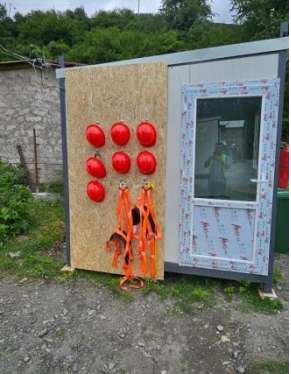
| <p>During the inspection no fire extinguisher and visitors stand found on site<br/> <b>Status:</b> (open, In progress, closed) -Closed</p> | |

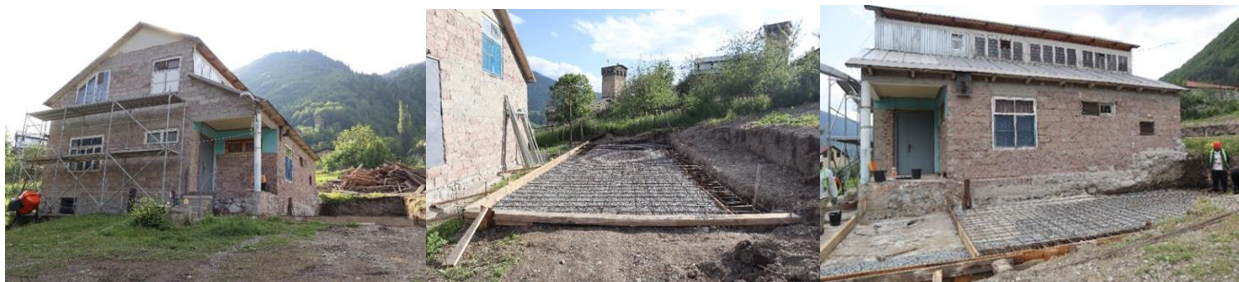
**Figure 45 Photo Material**

194. **Building N27.** During the inspection, the deteriorated building had already been dismantled. Construction of a new building was in progress, with the foundation and concrete platform being installed. A new utility structure is planned to be built: concrete blocks will be used for the first floor, and wooden posts and boarding for the second floor. New wooden doors and windows will be fabricated and installed, along with a new roof structure. The old metal roofing will be replaced with wooden shingles.

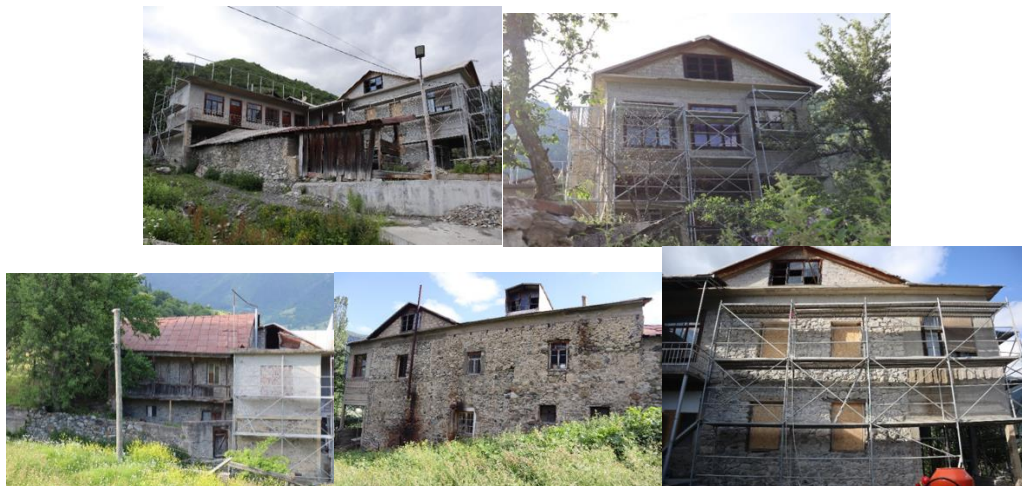
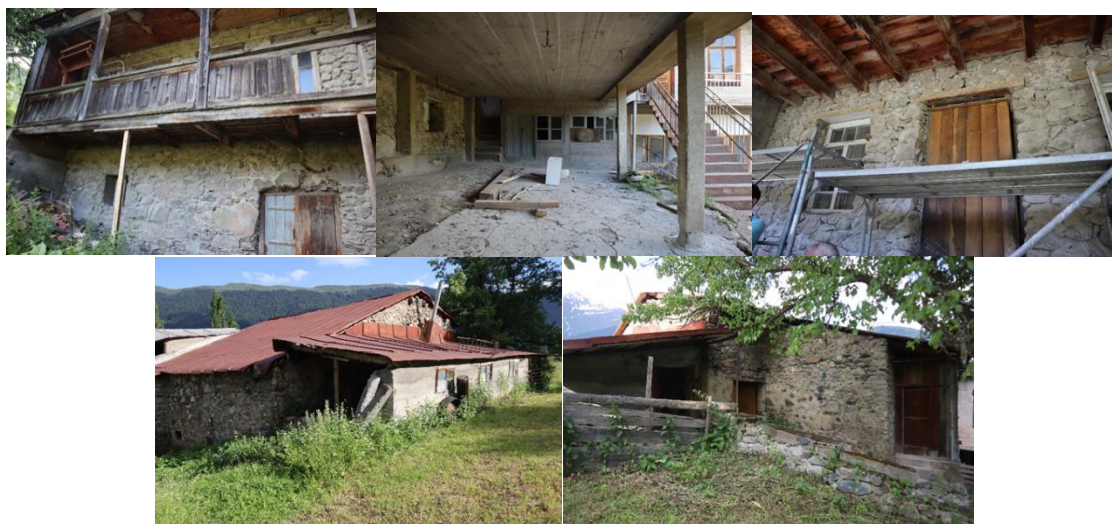
**Figure 48 Photo Material**

199. **Building N30.** This two-story residential building has its first floor constructed with natural stone of various sizes and the second floor with concrete blocks. The intermediate ceiling structure is made of wooden beams. The unplastered façades are broken up by door and window openings. On the west side, a metal staircase and utility structure have been added. Both structures have metal roofing. According to the project, partial boarding of the building and auxiliary structure is planned. The residence, its staircase, and the utility structure will be reroofed using wooden shingles. A storage space will be built beneath the staircase, and part of the façades will be clad in natural stone. At the time of monitoring, construction work was underway in the attached utility room, and plastering of the west façade of the residential building with sand-cement mortar had begun. At this stage, construction work is underway at all sites within the project, although delays from the original schedule are expected.

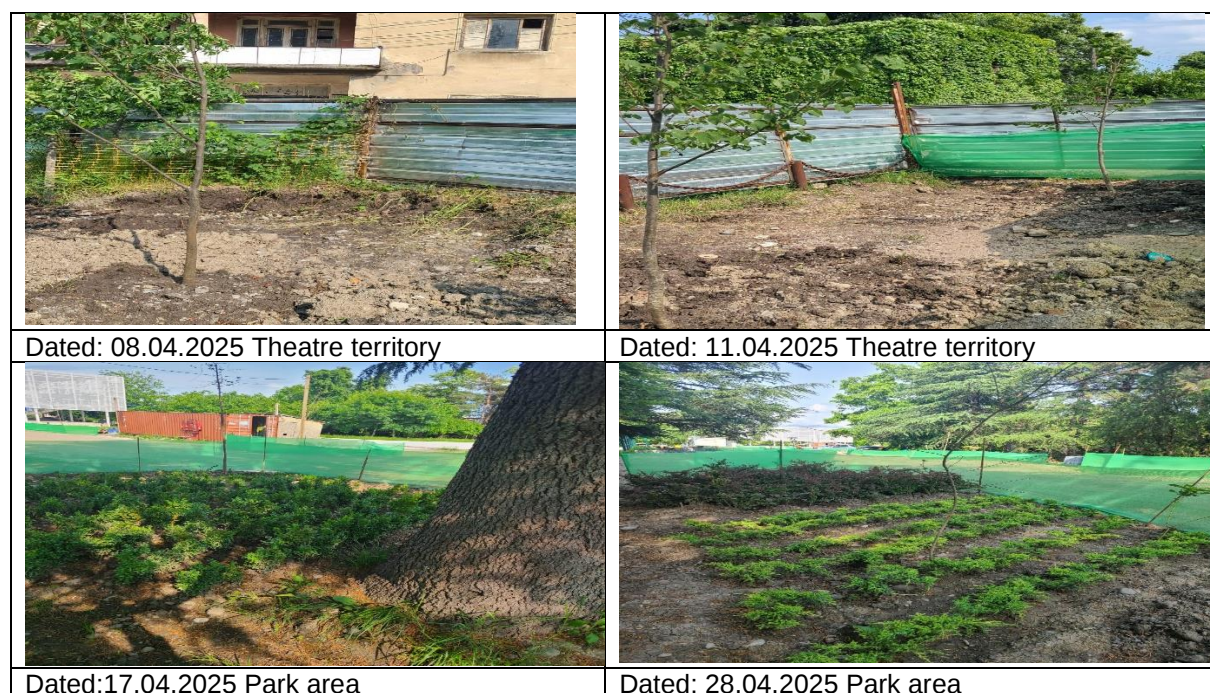
**Figure 50** Photos showing the current condition of the topsoil
