Project Number: P53118-001 LCIP

Reporting period: April - June 2022 N1 Semestral Report

GEORGIA: Livable Cities Investment Project for Balanced Regional Development

Prepared by: Municipal Development Fund (MDF) of Georgia for the Asian Development Bank

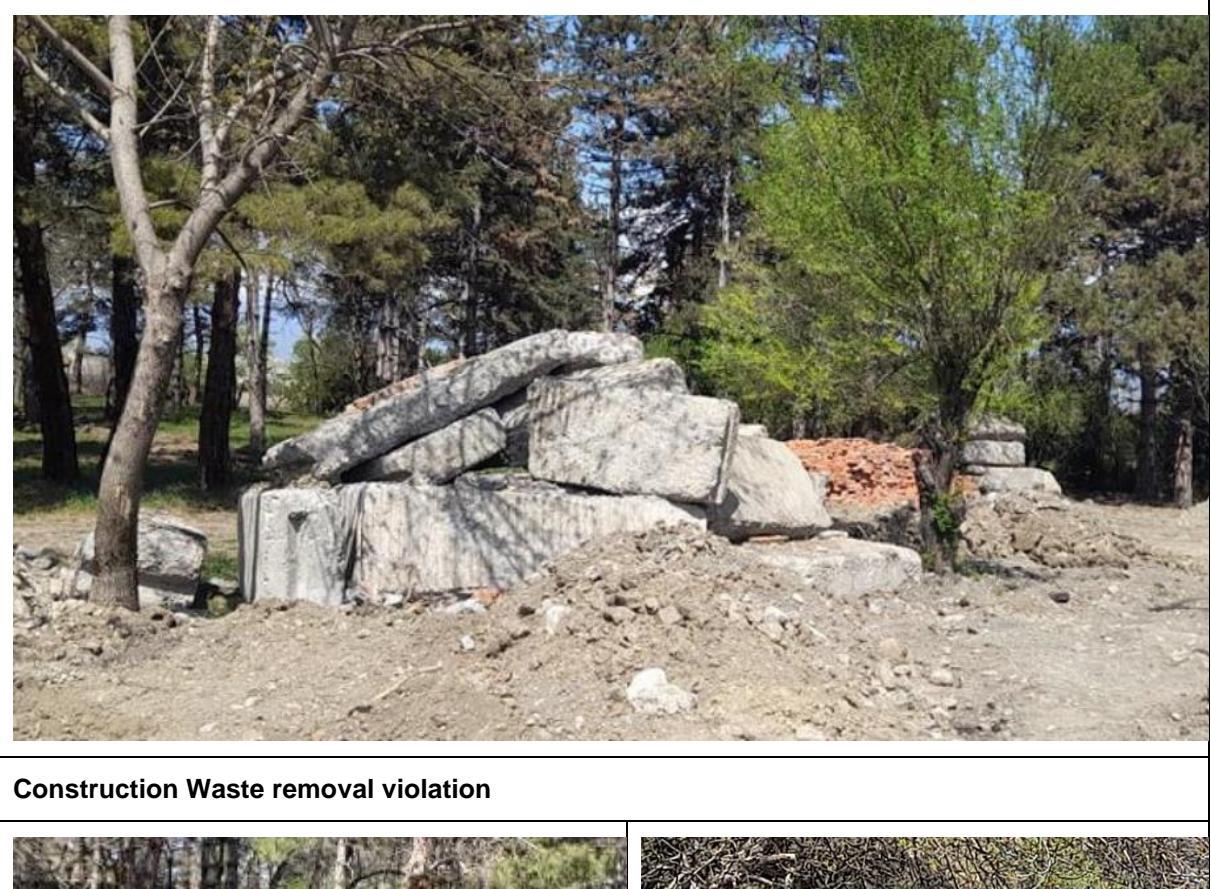
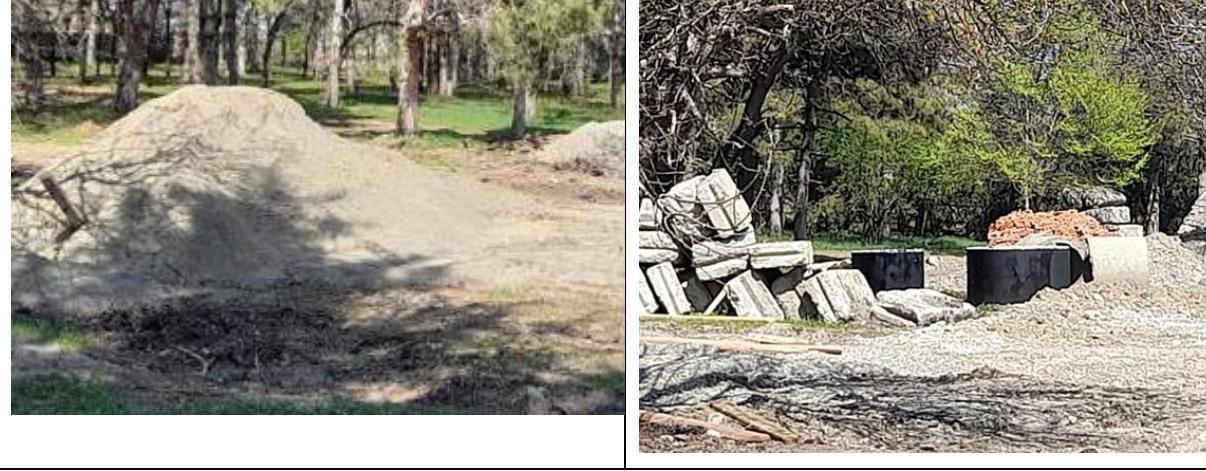
Trees at/nearby construction zone are not protected

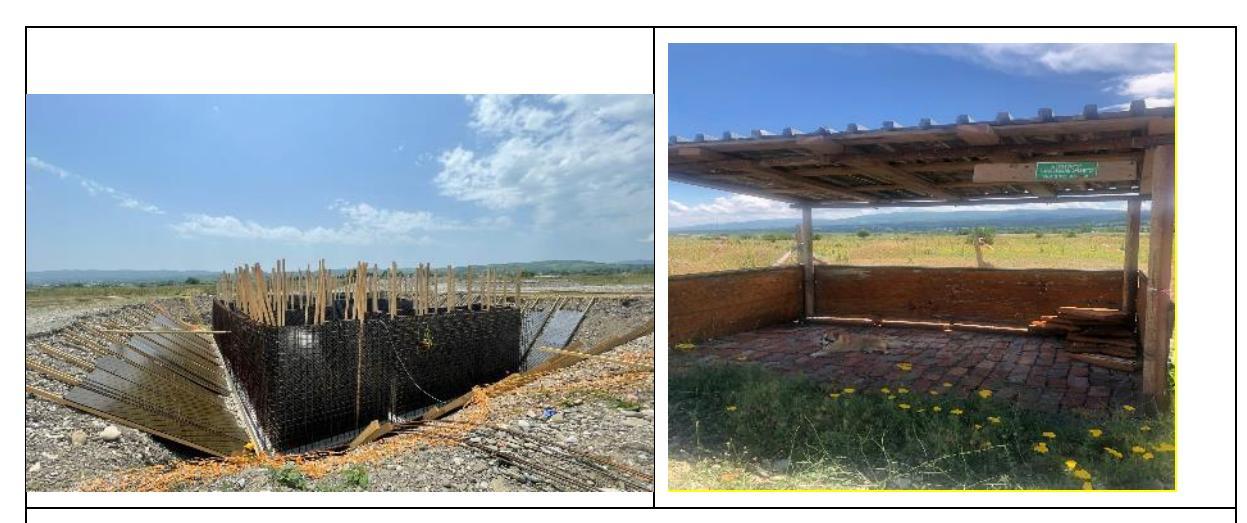
Construction works areas are not arranged properly

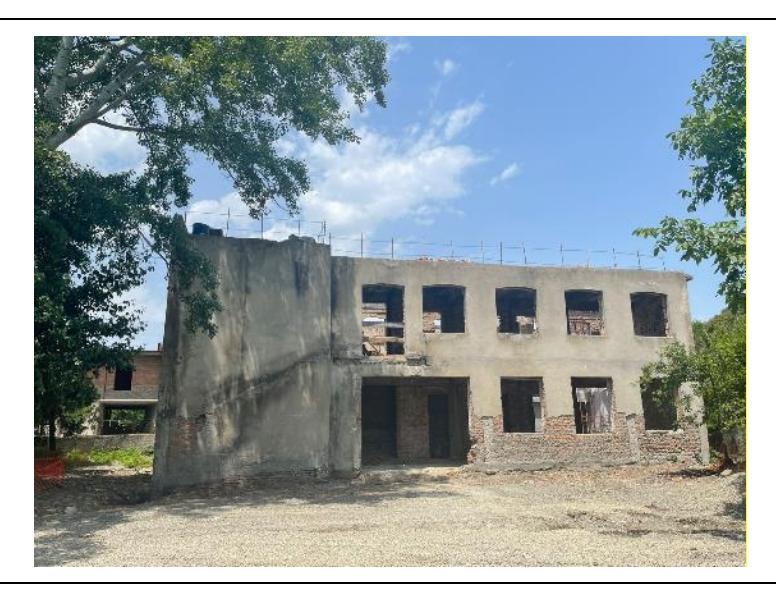
The waste treatment facility territory was not fenced and supervisory consultant together with MDF recommended to fence the territory

No gravel at the entrance of the territory; the medical waste disposal kits were not placed, no waste bins were allocated in the waste treatment facility territory.

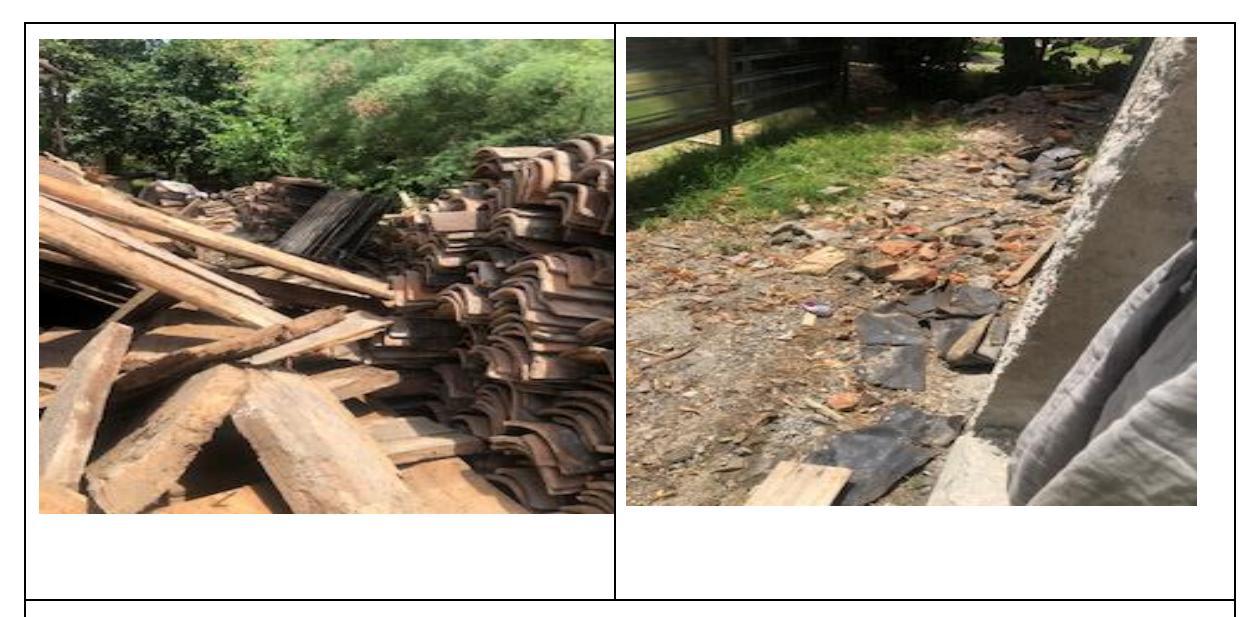
The territory of the building #30 (musical school) requires more signs and housekeeping in some areas, also barriers should be put to separate from the neighbours. Contractor should put safety barriers from the street side once the construction activities are resumed

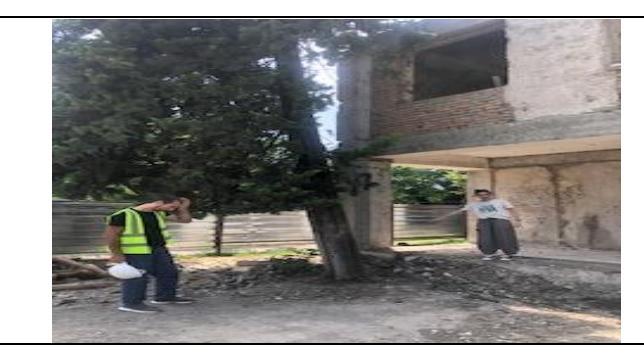
House # 20, 21- needs to be cleaned from construction material and asbestos remains.

Implemented Action: The ACM was removed from the area. The CC Engaged certified and competent asbestos service provider to transport the asbestos materials to the solid waste landfill, managed by the Ltd "Solid Waste Management Company of Georgia" in Telavi.

In order to adopting good practices and minimize the health risks associated with asbestos materials, workers were trained once again about removal, repair, and disposal of ACM and the necessity of using adequate personnel protection while handling asbestos, including respirators and disposable clothing.

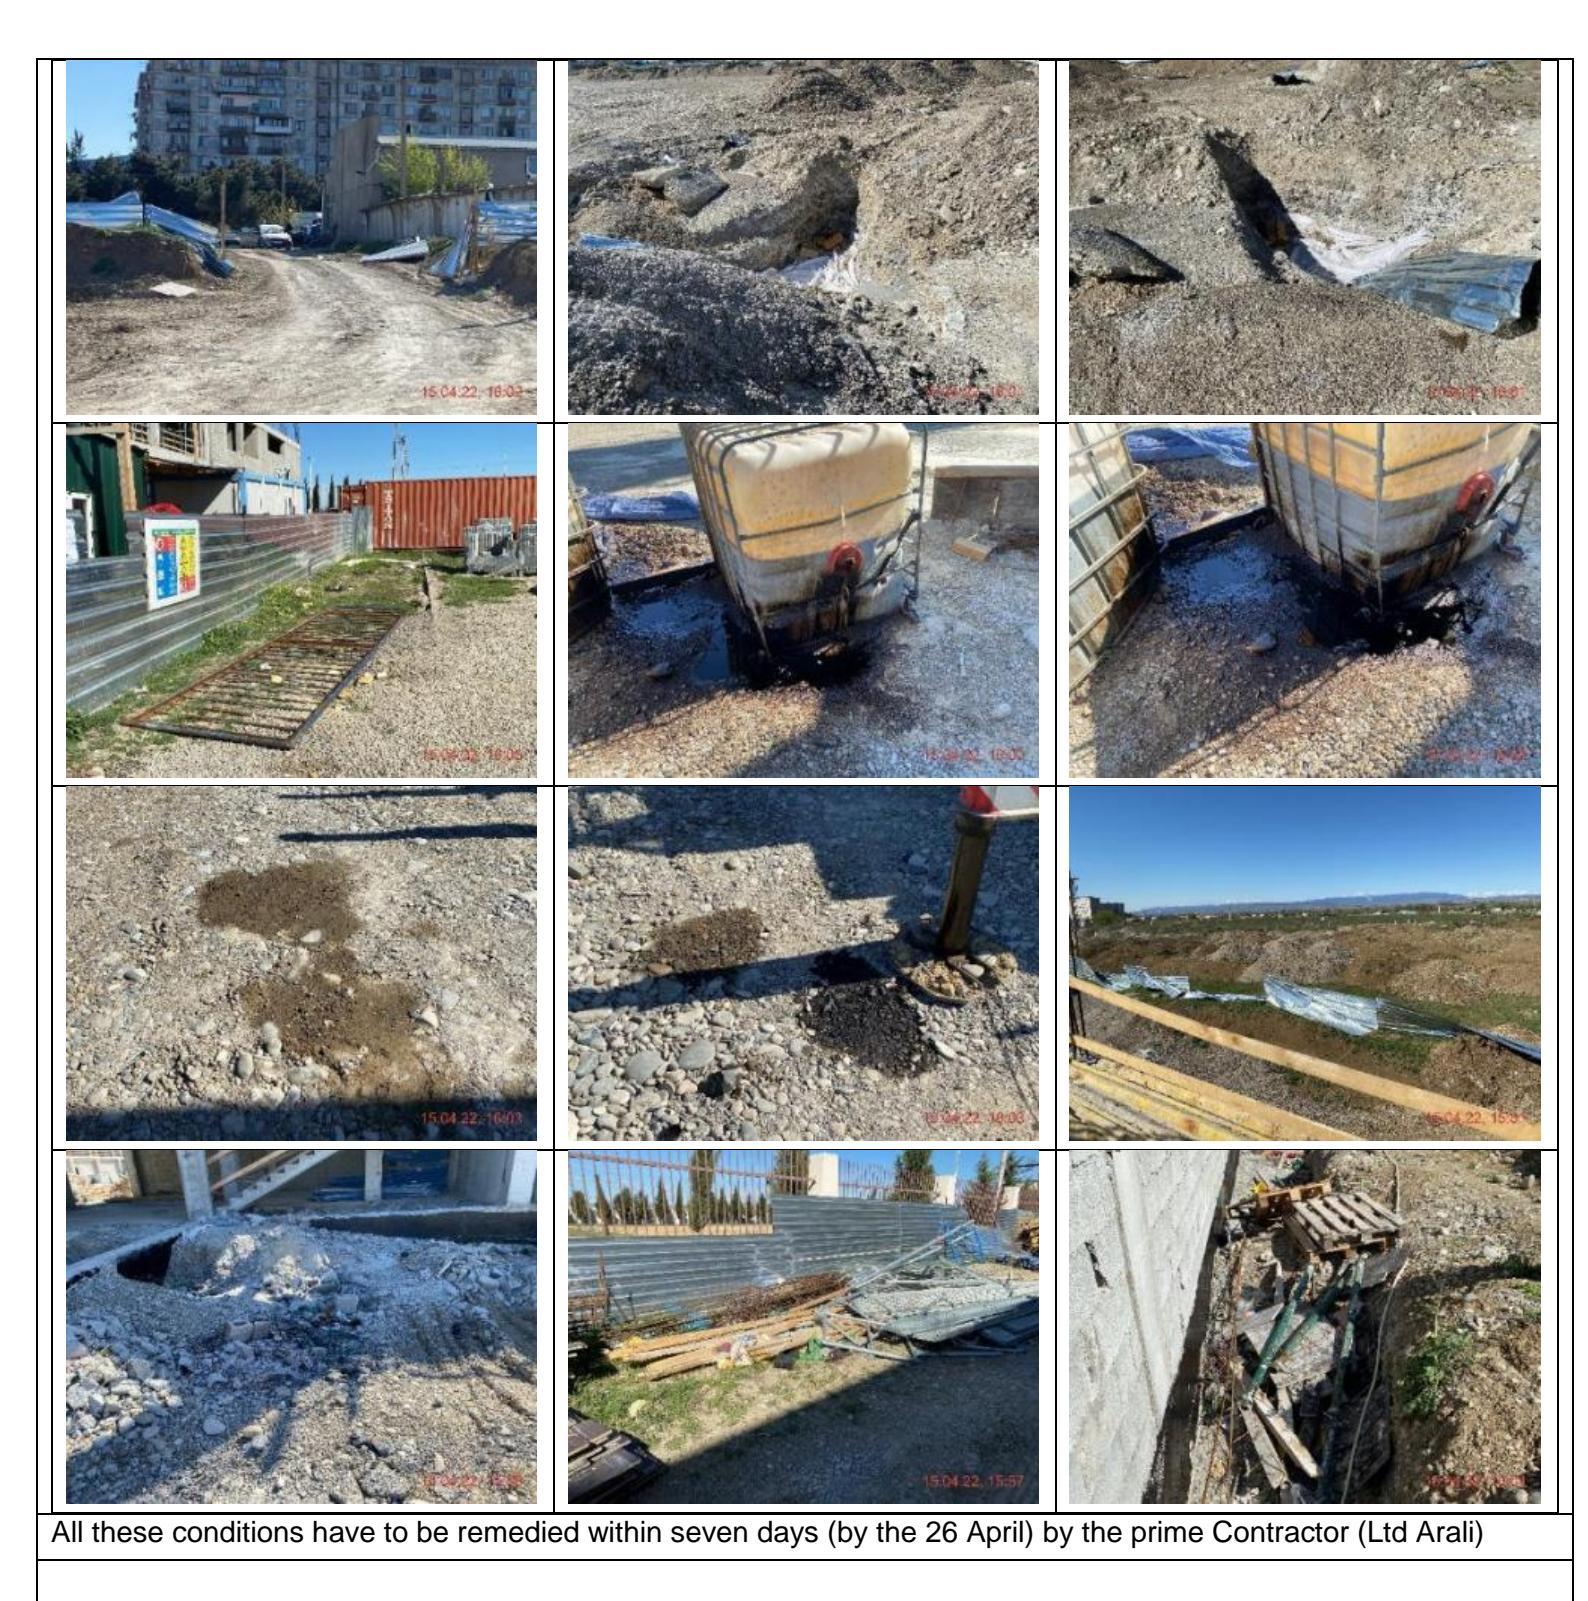
• Scrap at the construction site should be collected separately at on ("Scrap"/"ჯართი")	e location, fenced and signed		
Photos

Date of site visits	15.04.2022
EPTISA – Environmental Specialist	Nika Gogitidze

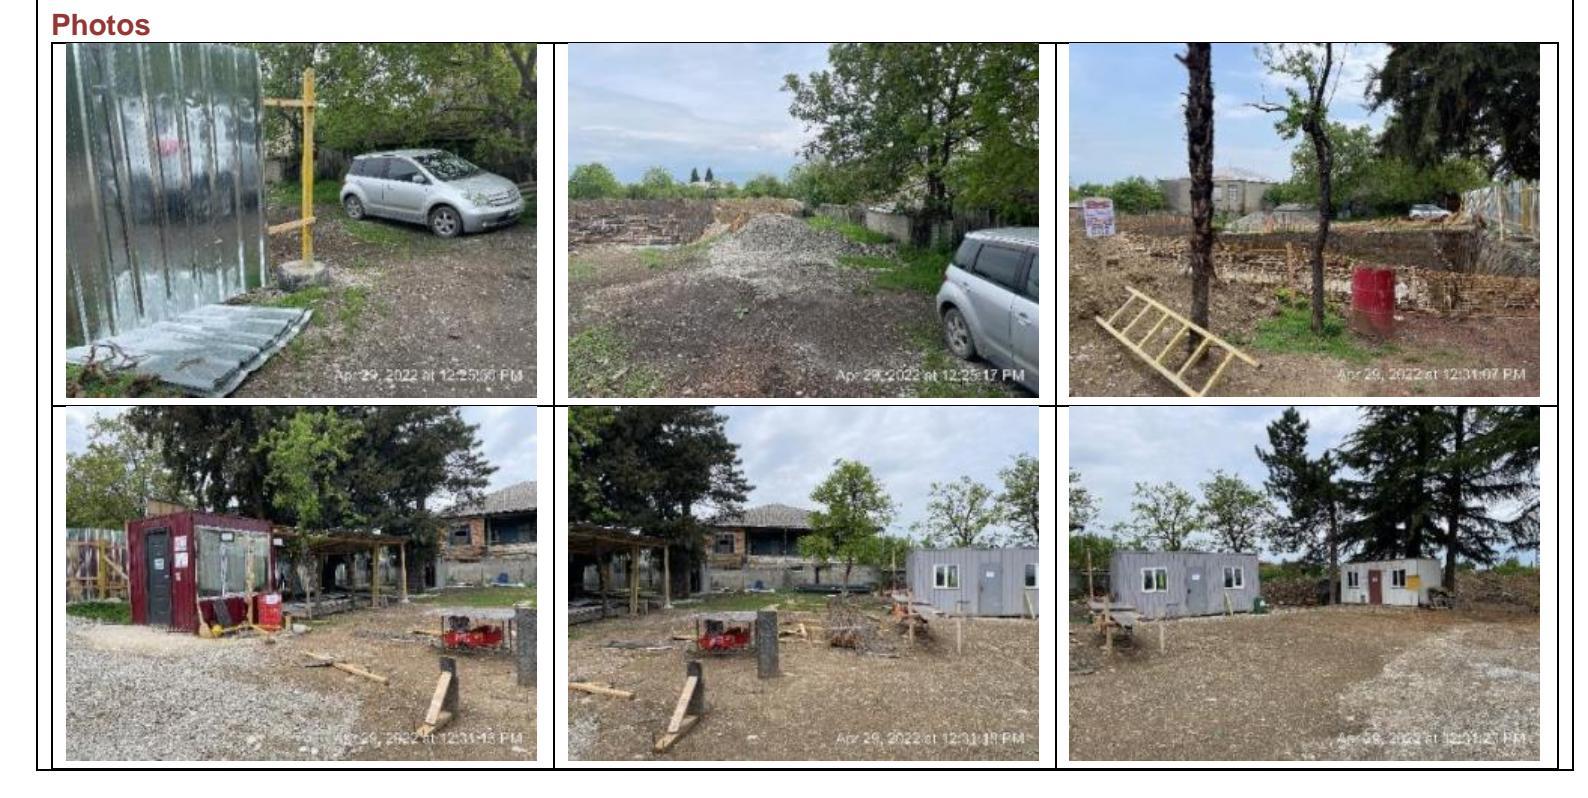
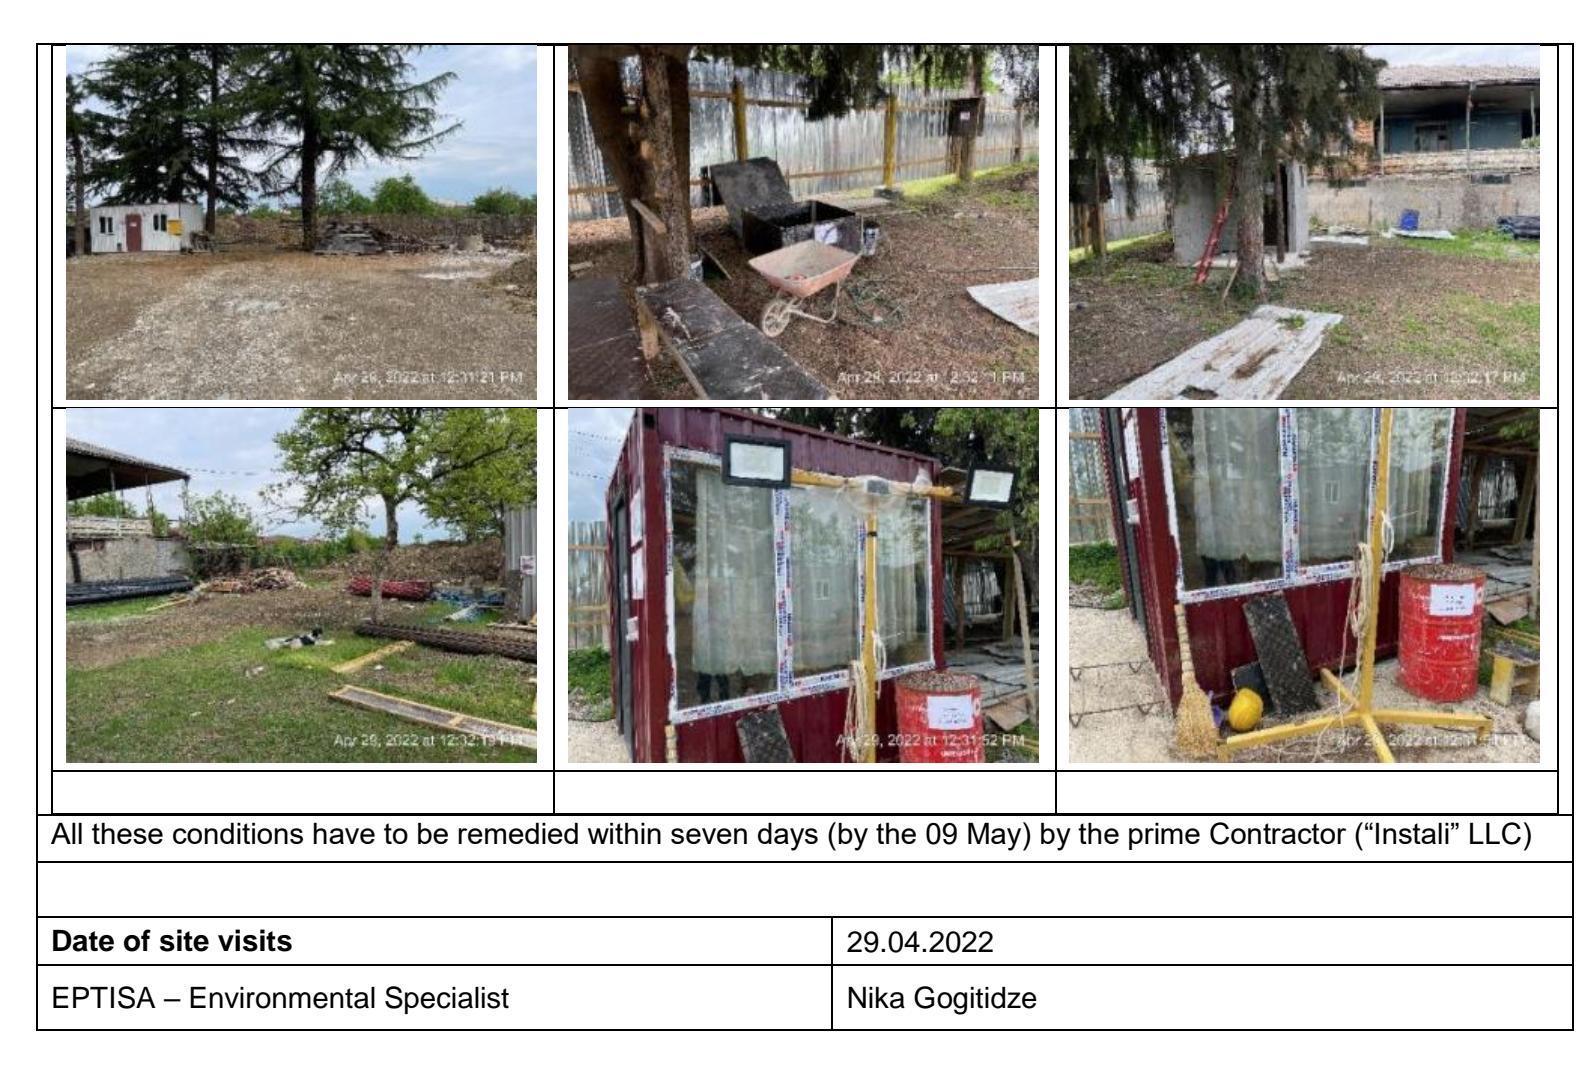
- Construction site is not arranged properly. Site internally should be better arranged, materials should be better segregated/stored and cleaned regularly from household and construction waste

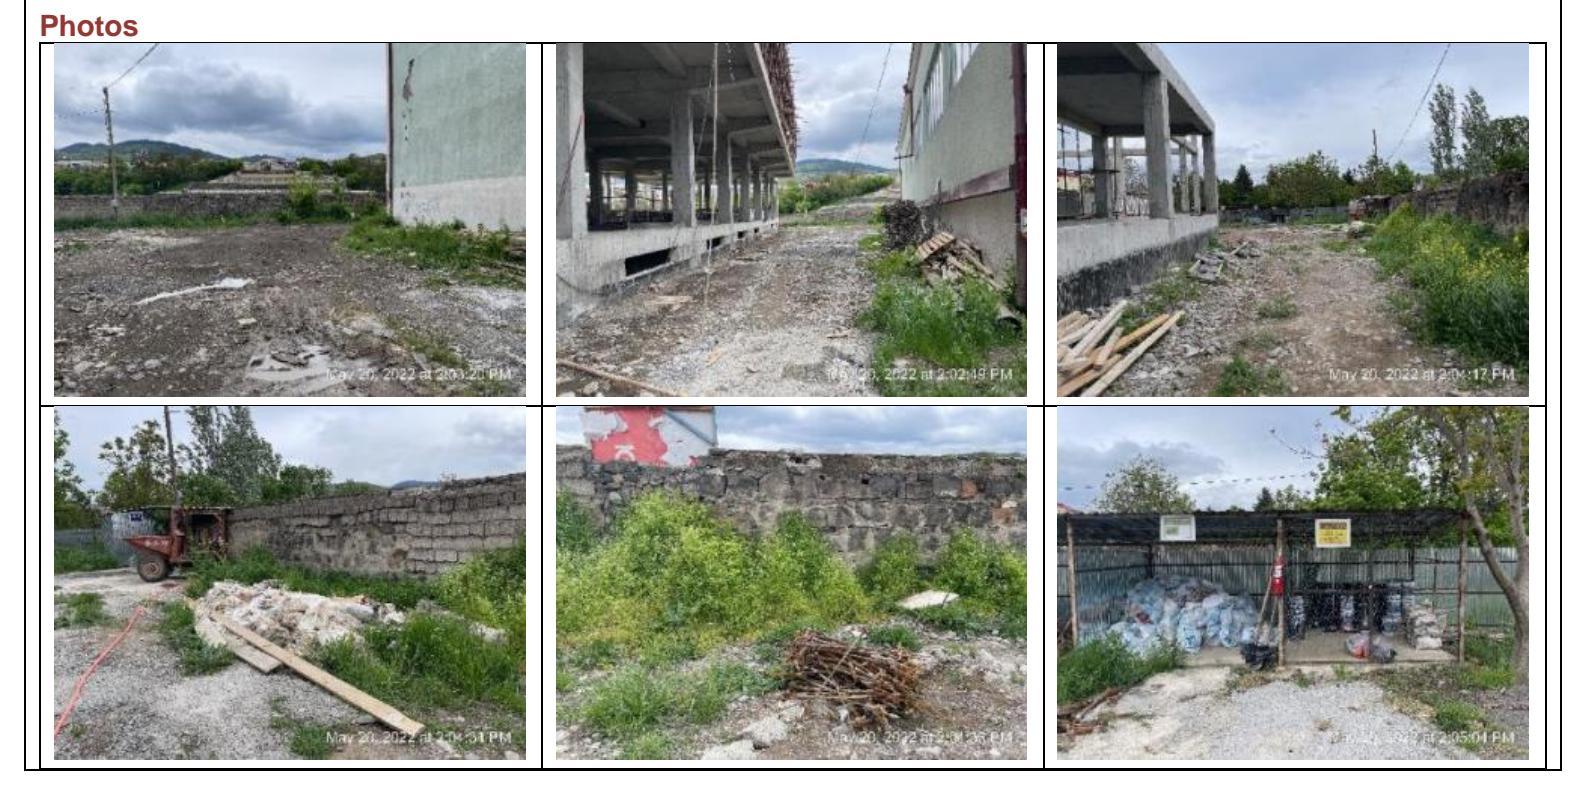
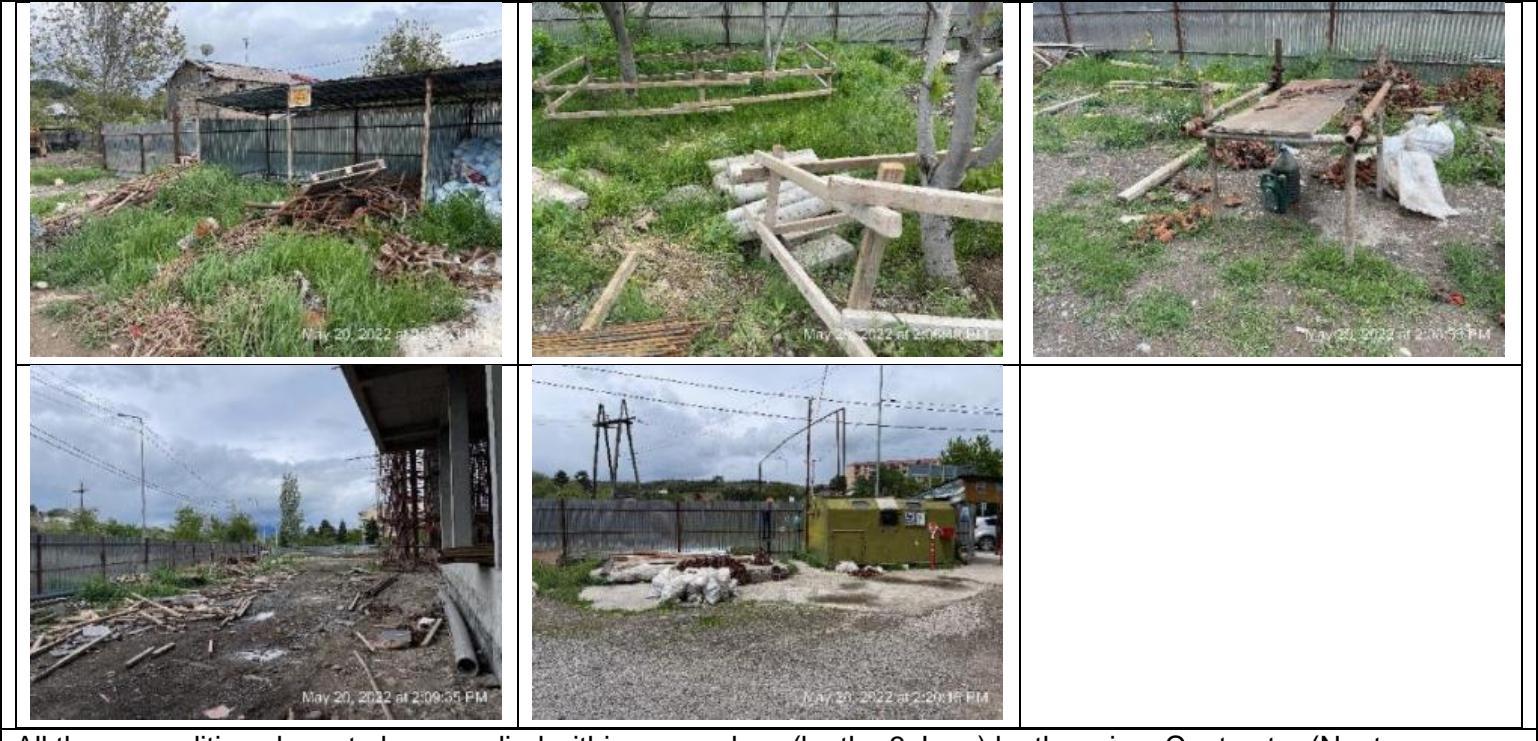
- Asbestos waste should be proper removed by authorized organization according agreement and Act of Acceptance of asbestos waste should be provided.

All these conditions have to be remedied within seven days (by the 3 June) by the prime Contractor (Nantong Sanjian Georgia LLC)
