Biannual Environmental Monitoring Report

Reporting period: **July - December, 2015**

GEORGIA: GEORGIAN SUSTAINABLE URBAN TRANSPORT INVESTMENT PROGRAM, Tranche 2

- **Modernization of Tbilisi-Rustavi Urban Road Link (sections 1 and 3)**

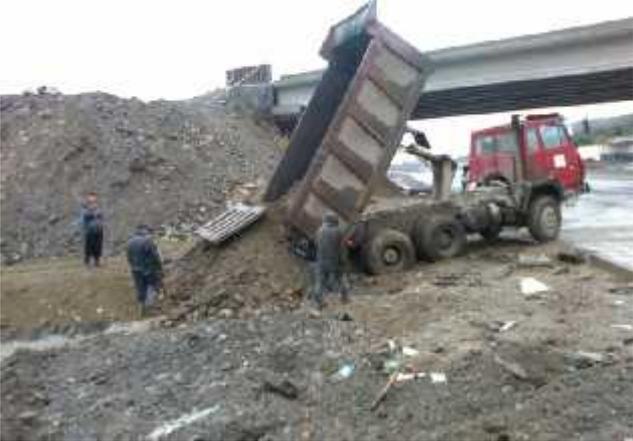
<p>PK21.80 Construction waste is disposing on landfill, assigned for spoil</p>	<p>PK111; Significant oil spill on the access road to the construction camp</p>

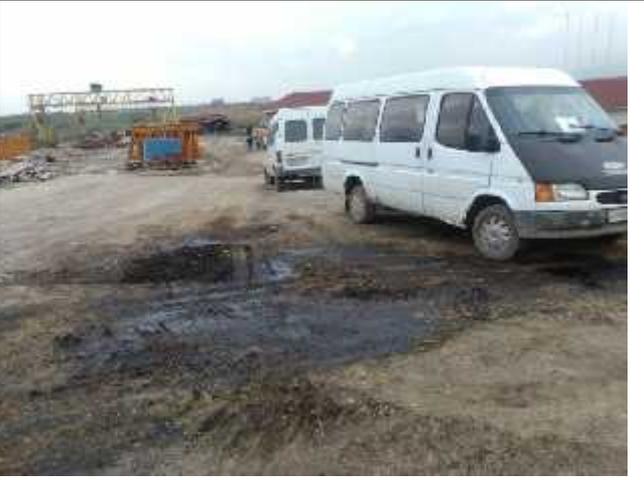
Significant spillages of oil had place on the access road to the construction camp. According to the Engineer`s instruction, the Contactor has immediately removed polluted soil from the hall and temporally stored it in the barrels, according to requirements of pollution prevention management pan.

The Contractor has instructed to submit act of acceptance after delivering of polluted soil to the licensed company.

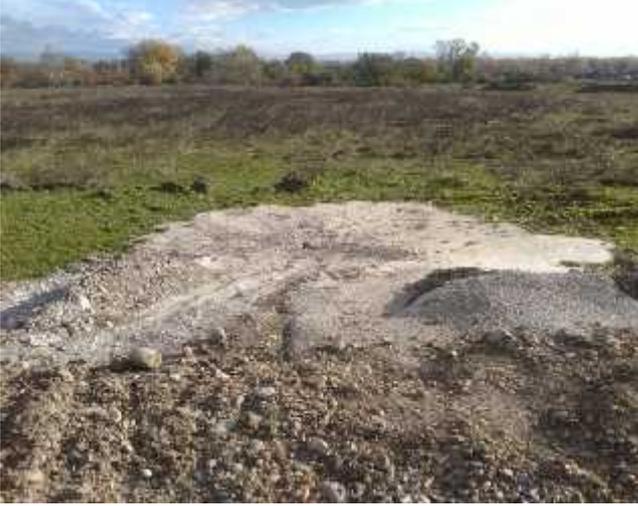
<p>PK128; Water with concrete was discharged outside ROW, directly on topsoil</p>	<p>PK126-128; Construction waste was disposed on the private land plot without agreement with the land owner</p>

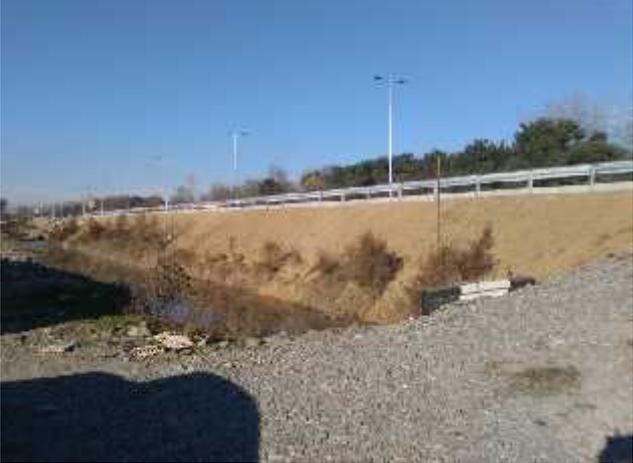
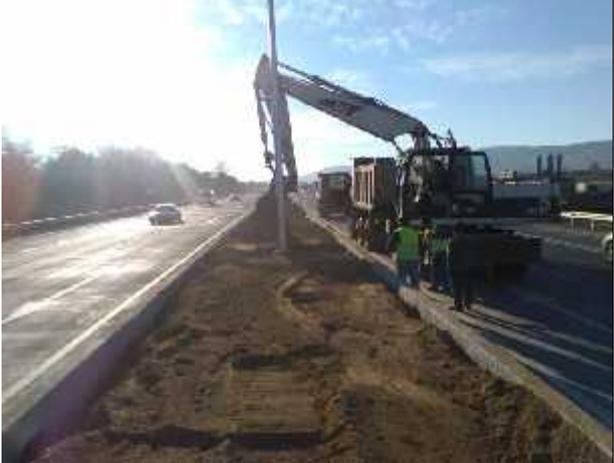
Most part of top soil, removed from the RoW was mixed with subsoil. Currently the Contractor has not enough topsoil for filling of the top of dividing strip and stabilization of slopes of embankment. According IPC the Contractor has removed about 20.000 m³ topsoil from sections 1 and 3. After finishing of construction activities the Contractor was started spreading of borrow material (subsoil and gravel) on the slopes of embankment and disposing it in the dividing strip.

<p>PK105-128; Dividing strip and slopes of embankment are covering by subsoil instead of topsoil</p>

The contractor was instructed to use only material, mentioned in the Contract for reinstatement of slopes and filling of top of median.

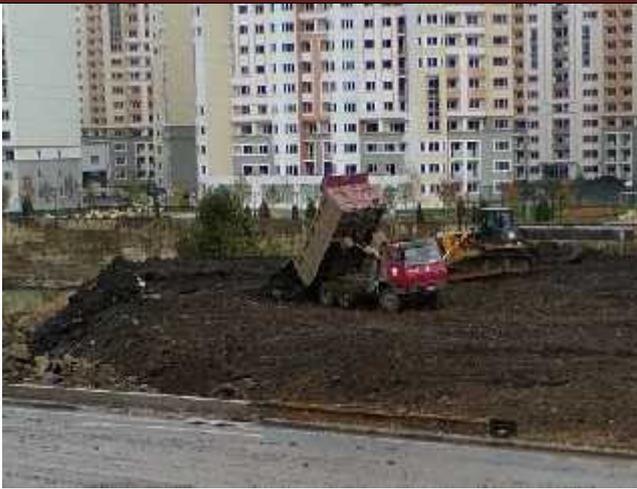
Construction waste is disposing on landfill, assigned for spoil

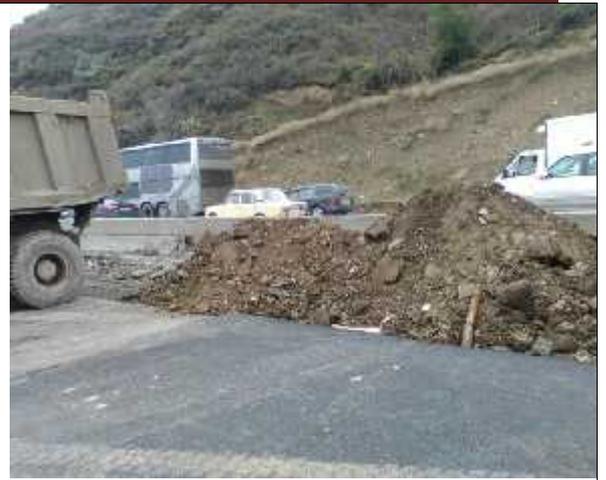
08.10.2015	Disposal of construction waste in dividing strip	PK22-24	Excavate all improper material from dividing strip	Immediately	Improved
12.10.2015	Disposal of construction waste in dividing strips	PK19-22	Excavate all improper material from dividing strip	Immediately	Improved

Construction waste is disposing in dividing strip
