Environmental and Social Impact Assessment Report

for Construction of the Bridge on Khrami River in the vicinity of Pitareti

Monastic Complex

February, 2017

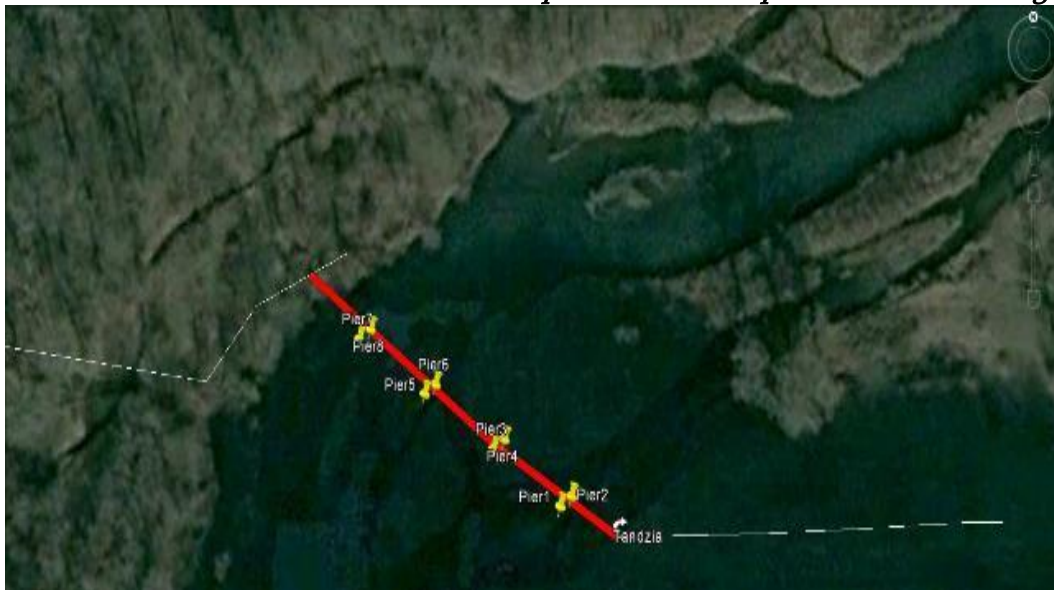
Map 1. Location and parameters of the bridge

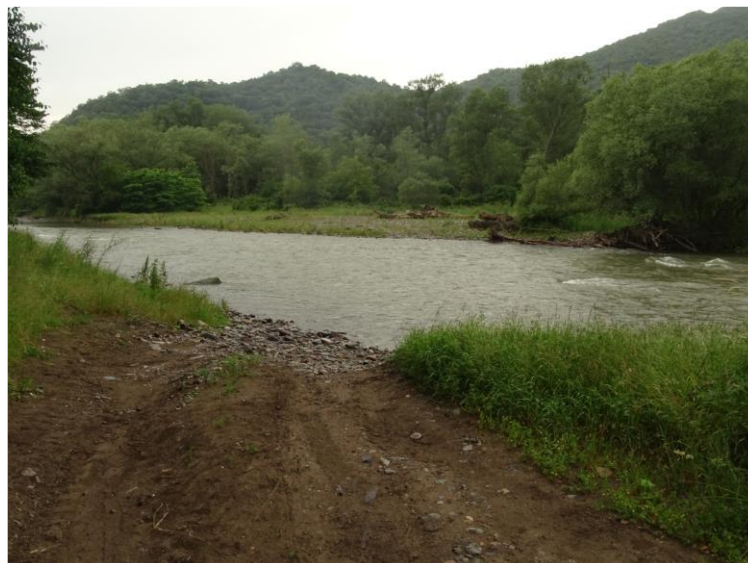
Photo No1. Proposed location of the bridge

In the sub-project area, the river flows through a narrow and deep valley, part of which is represented in the rocky canyons of andesite and basalts. At this location, the river's flood plain width varies within the scopes of 60.0÷200.0 meters, while the river's – within the 25.0÷40.0 meter scopes. The flow depth ranges among 1.0÷1.8 meter. The average slope of the river is 18.4%.

In the bridge area, the floodplain is 250 meters wide and covered with vegetation. The river meanders in the floodplain flows in 25.0÷30.0 m wide bed. The depth of the river flow varies between 0.5÷0.7 meters while the banks are low – up to 1.0 meters. Geologically the two banks of the river are not different from each other and they are mainly represented with the Quaternary sedimentary rocks of a river origin – with up to 10% of sand filling large boulders and rocks.

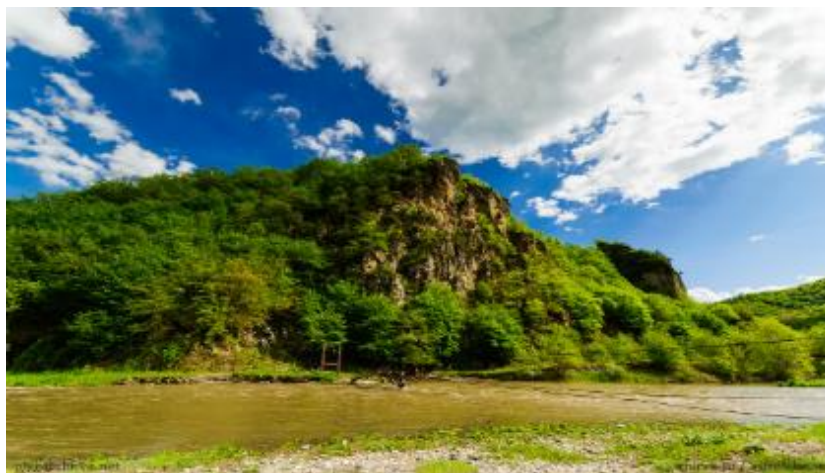
Photo No3. Old, damaged hanging pedestrian bridge

Now in the project area, there is only the old, damaged pedestrian bridge, so vehicles which are moving towards the monastery have to go through a river bed crossing the watercourse. Hence, the impact on biodiversity and the river water quality is significant. If the sub-project is not implemented, there will remain a risk of an injury of the people visiting the Monastery over the river as well as the risk of pollution of the river due to the vehicle which run through the river due to the absence of the bridge.

The study area is located in the floodplain of Khrami River. There is an old, damaged hanging pedestrian bridge footings and metallic ropes stretched between them in this place.
