Post-Construction Environmental Audit Report

Loan Number: 2655-GEO (SF)

July-December, 2017

GEORGIA: GEORGIAN SUSTAINABLE URBAN TRANSPORT INVESTMENT PROGRAM, Tranche 1

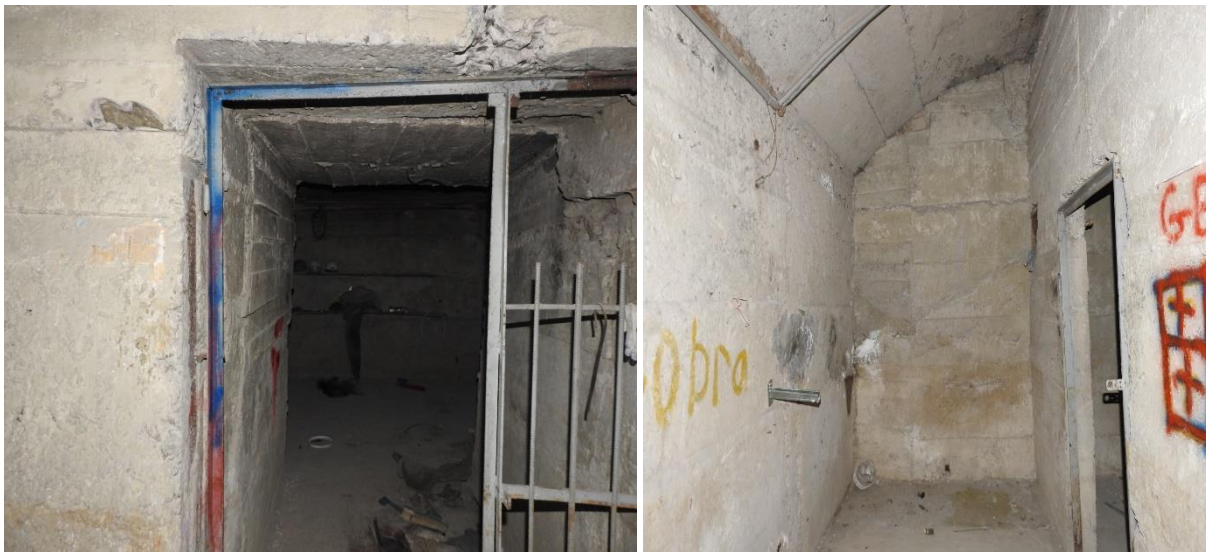
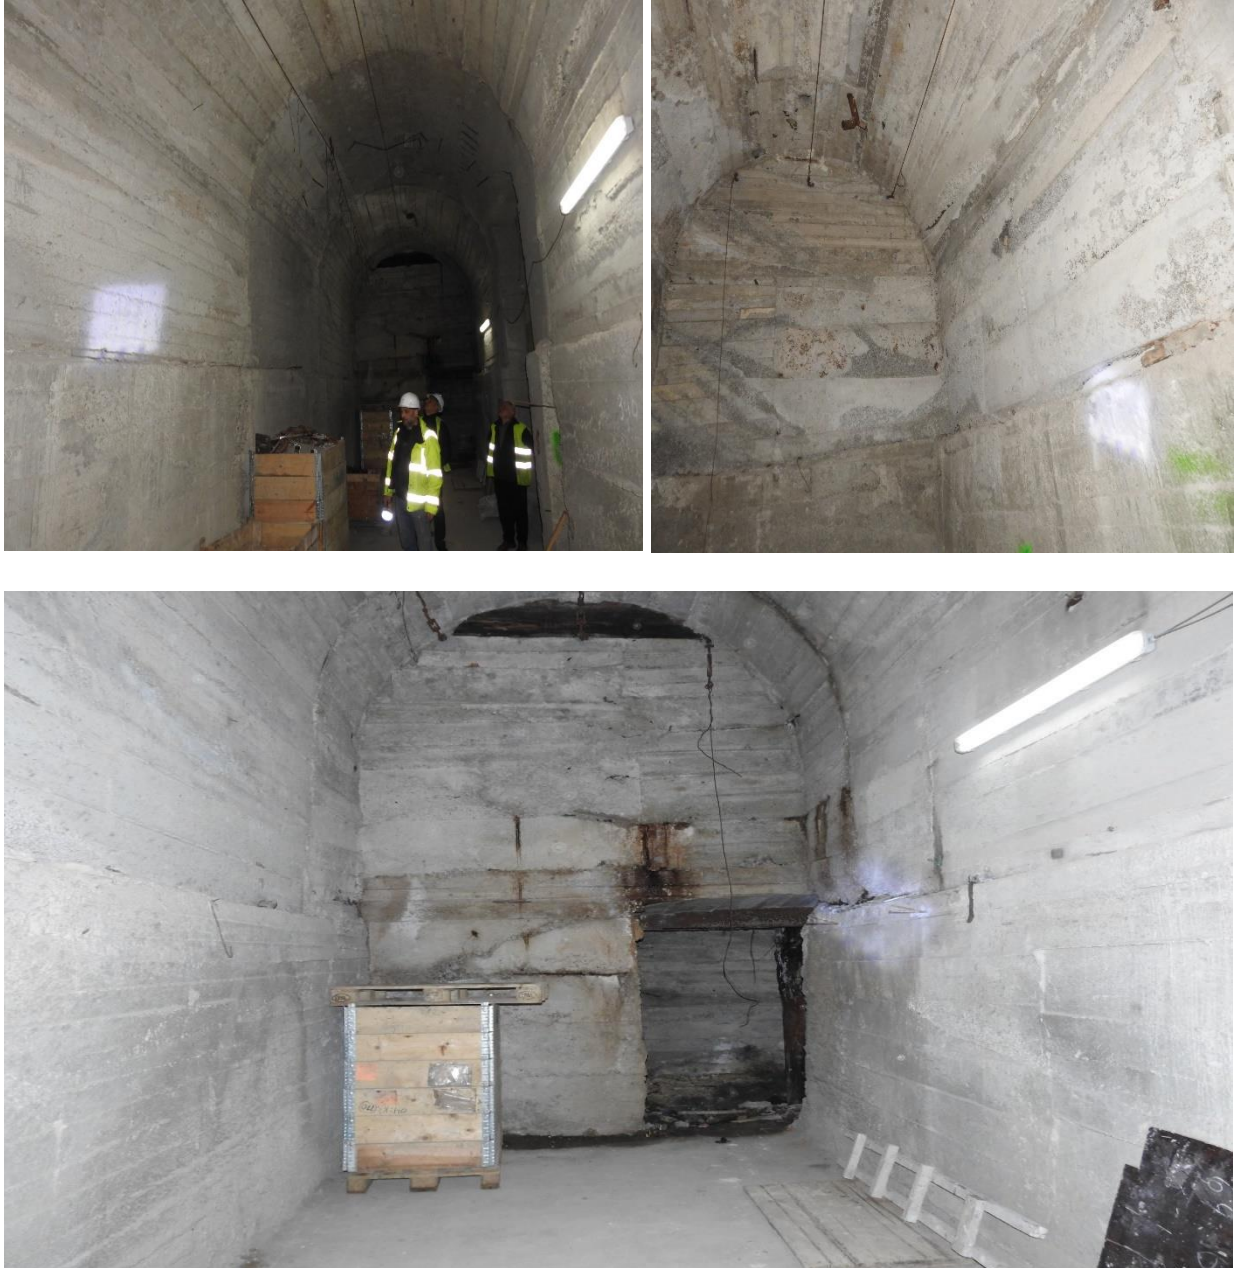
Picture 2: Current situation in tunnels

44. Given the historic presence of bats within the project site a walk over survey was undertaken within the tunnel network by zoologist (bat specialist) on December 7, 2017, to identify if any of the other tunnels are being used as a winter roost for bats.

45. No wintering colony was detected during the survey. Taking into consideration the fact that currently there are no favorable conditions for Horseshoe Bats (*Rhinolophus Ferrumequinum*) colony in the tunnel network – high temperature, noise and vibration caused by operation of metro line – existence of wintering colony in the tunnel is less probable.

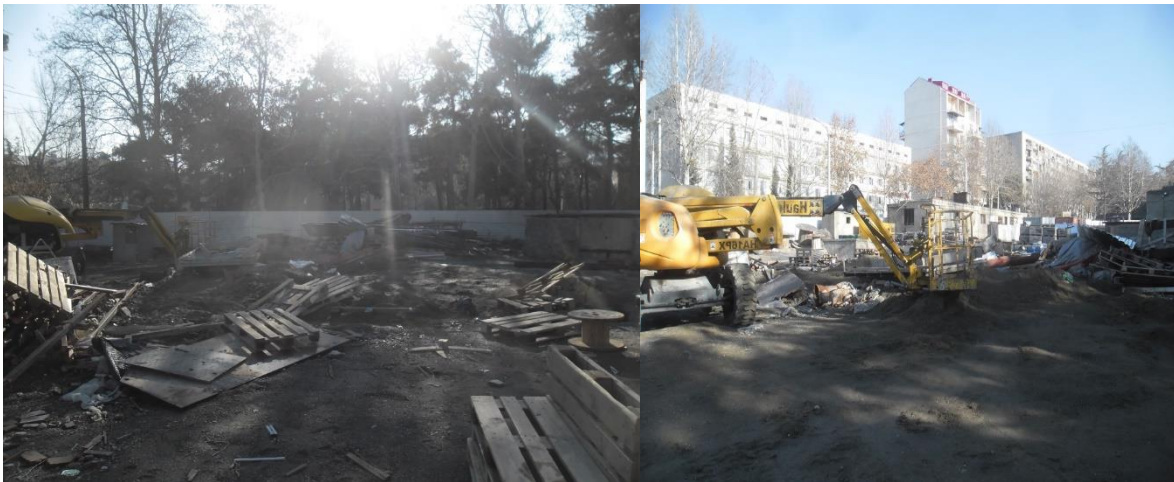
50. All relevant Contracts with mentioned companies were presented in previous EMRs.
51. During inspection some construction related waste was identified at surrounding area of the Camp site.

52. This waste, as it was mentioned above, was removed from the area, after completion of the project.

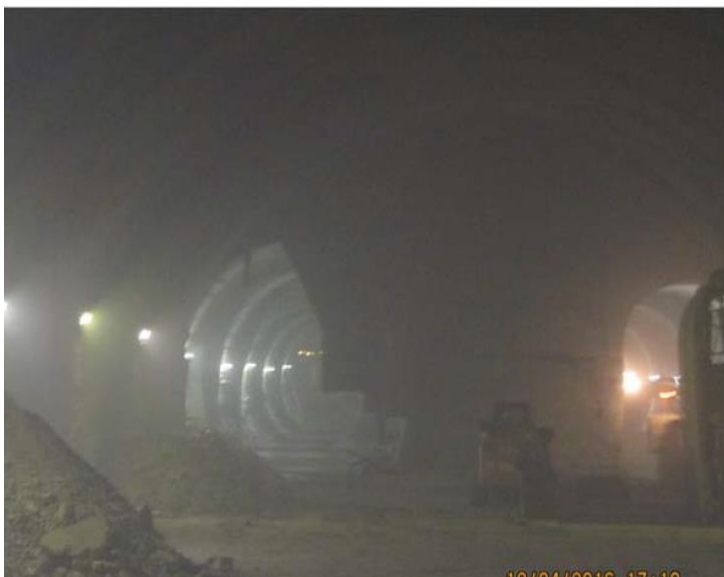
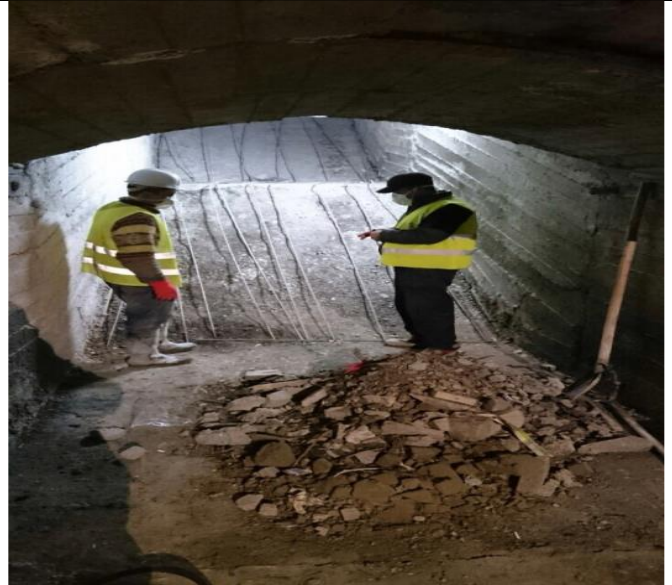
Date of submission	Description of Non-Compliance	Area	Corrective action required	Performance Date of Corrective actions
29.02.2016	There is the plenty of dust in the tunnel. No good ventilation, no working of the existing several fans during construction works.	Site working area	Additional fans to be provided especially in the tunnel and the operating are mandatory all of them all times when construction works are carrying out, PPE Equipment: (respirators, eye goggles).	Closed (The Contractor improved the situation fans are working, No Dust) ; response (S 92.1 Date: 14.04.2016

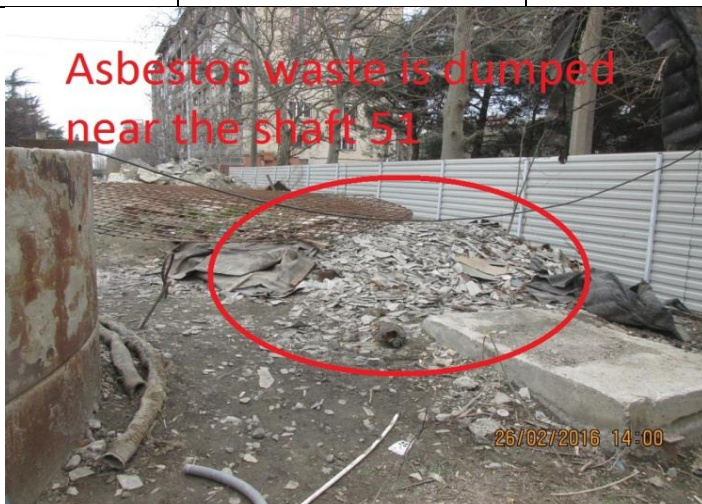
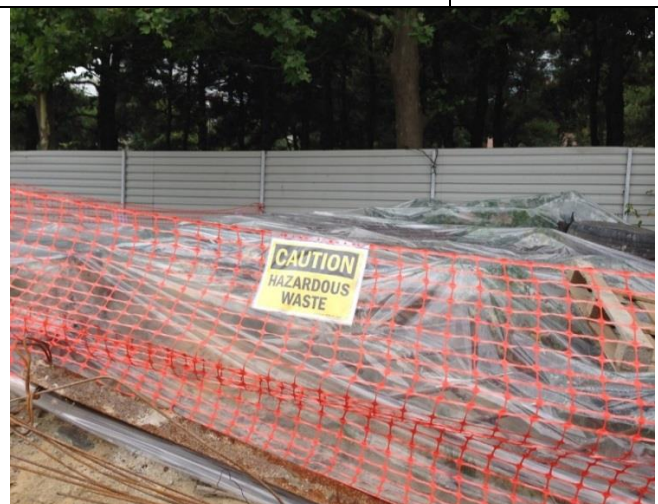
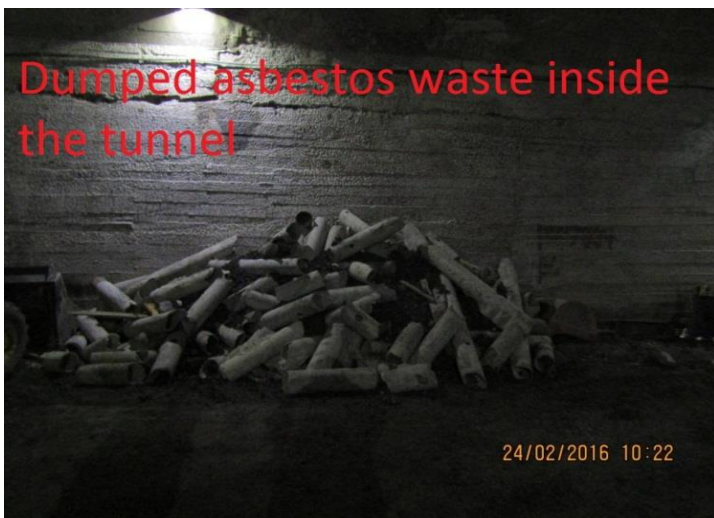
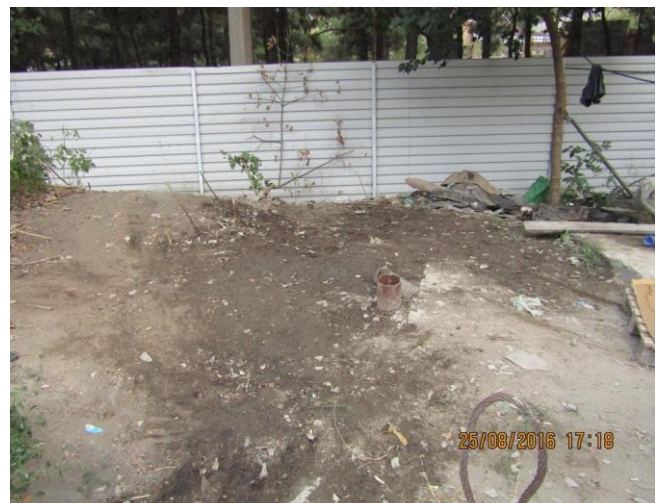
29.02.2016	Asbestos waste is dumped near the shaft 51, It seems the broken roof sheets and inside the tunnel some demolished asbestos pipes as well. No covering, no plastic bags packaging, no temporary designated secure place storage, no sign to identify as hazardous waste and free access for tampering by unauthorized persons.,.	Site working area	Appropriate PPE (Respirators (negative pressure, P100 equivalent particulate filter, half-face or full-face, overalls,), protective gloves, soap, using HEPA Vacuum , air filters, providing of 6-mil plastic bags for putting the asbestos wastes there and human resources (hired some qualified sub-contractor or performing the works by the trained competent people)	Closed (The Contractor removed the asbestos waste from the site as per hazardous wastes removal procedures (dated: 25.08.2016) provided (delivery act, photos). Response (S -162 date: 02.09.2016)

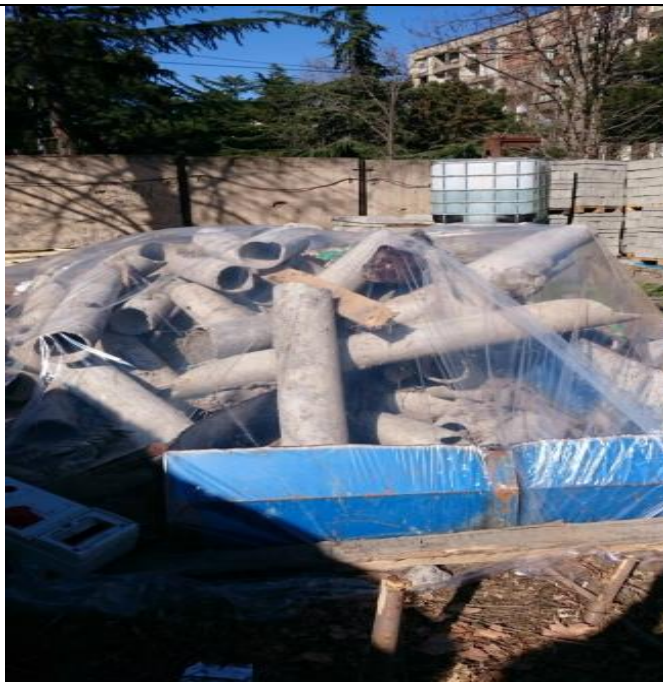
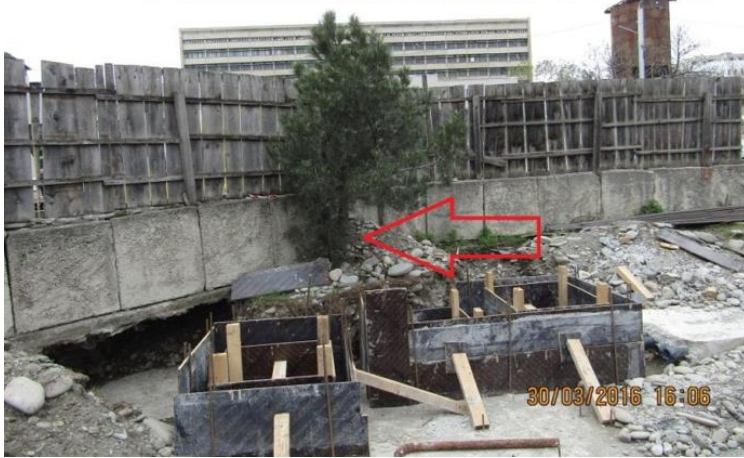
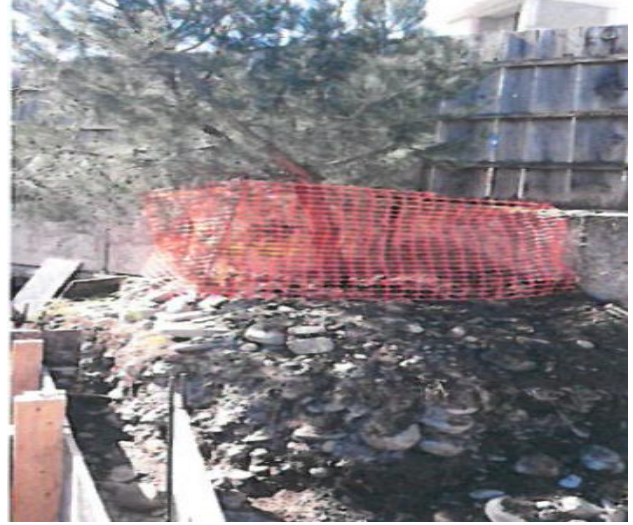
Affected Pine Tree!

30.03.2016	Spoil and stones were dumped on the pine tree located near the shaft 51, No tree protection there.	Near the shaft 51 area	Removing of the spoil and stones from the tree and make the tree proper protection. Contractor should see the Project Supervisor „Euroestudios” Ltd Biannual Environmental Monitoring Report (August-December 2015) Item 2.1.3 Vegetation and soil (recommendation to use tree physical protection).	Closed (The Contractor provided the physical protection method (by wooden planks, metal wires) ; response (S 0083.2 Date: 14.04.2016)

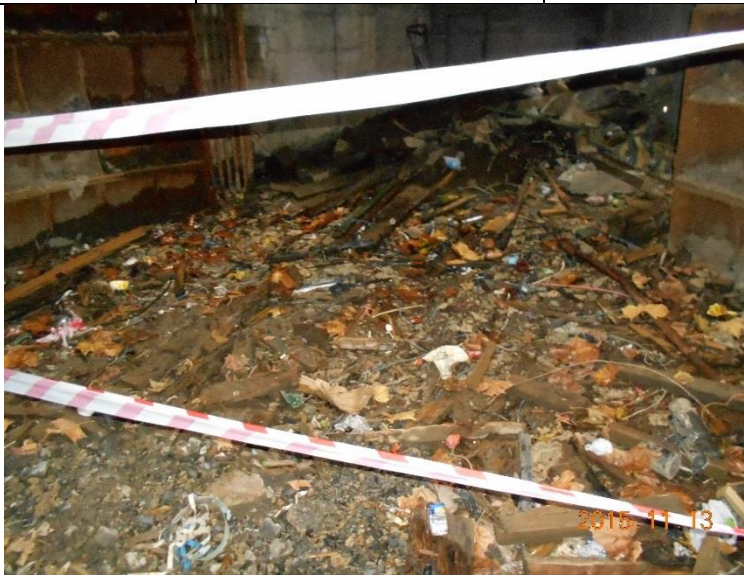
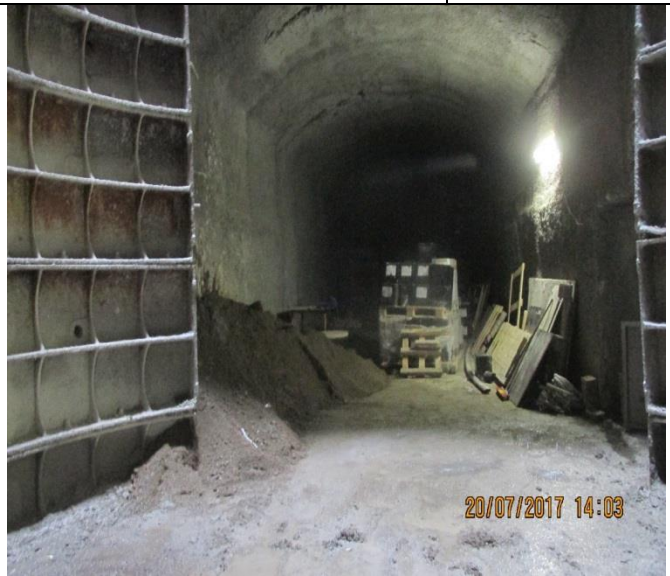
Mixed wastes (Construction, wood, empty cement bags, etc.) and spoil were dumped near the shaft 50 area and inside the tunnel as well. Nowadays they are removed but No any transfer Notes, No evidences to dispose on Gldani Municipality construction wastes landfill ...

Contractor should provide the Wastes Transfer Notes, report with attached the wastes disposing photos.

Closed
(The Contractor provided the transfer notes; response S 0084.1 Date: 05.04.2016)

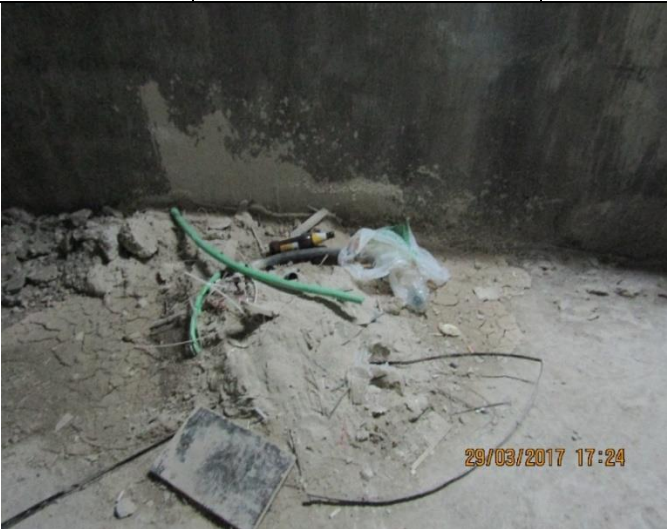
Date of submission	Description of Non-Compliance	Area	Corrective action required	Performance Date of Corrective actions
25.08.2016	Household wastes are scattered in the shaft 51 area, shaft 50 yard, near temporary facility for Contractor JV Cobra Assignia personnel located in 50 shaft yard.	Shaft 51 area, shaft 50 yard, near temporary facility for Contractor JV Cobra Assignia personnel located in 50 shaft yard.	Using of appropriate PPE: (respirators, Overalls, Protective gloves) Collecting, sorting, and putting into the waste containers for temporary disposal, providing of the housekeeping on the site. It is recommended to take one waste container from the site office territory and put near the temporary facility located in shaft 50 yard.	<u>CLOSED</u>
