Rehabilitation of Ten Community Stadiums in Gori (Gori Municipality) Sub-Project

Environmental and Social Screening and Environmental Management Plan

**WORLD BANK FINANCED
SECOND REGIONAL AND MUNICIPAL INFRASTRUCTURE DEVELOPMENT PROJECT**

November 2016

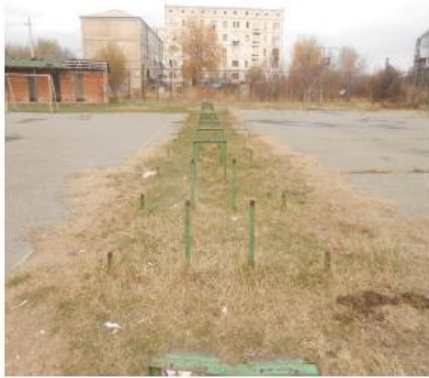
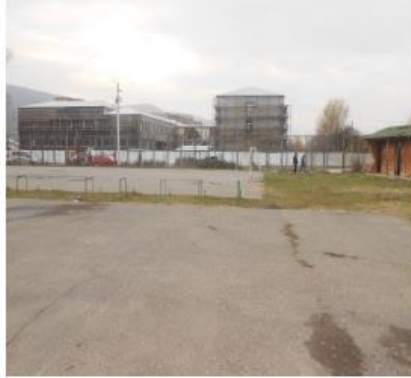
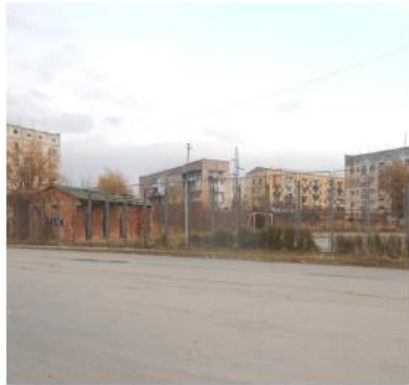
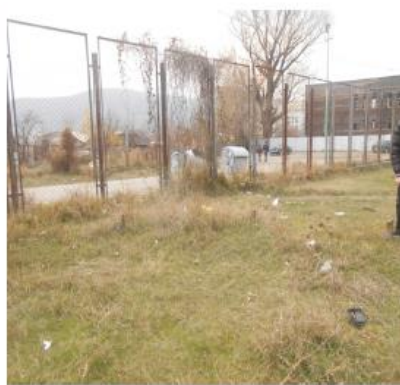
1. Stadium at Elioizishvili Street

The stadium situated at Elioizhvili Street is currently functioning and consists of one-storied brick administrative building as well as football, basketball and volleyball playgrounds with asphalt cover. The area is fenced with wire grid, which is inserted in angle on the steel pipes. Stadium electricity is connected to the town network. The land is in the municipal ownership (annex 1). The total area consists of 3185 m².

The administrative building of the stadium has three rooms and four sanitary units connected to the local municipal network. Although the building is constructively resistant, the roof made of tin, is partially damaged and the inner part of the building as well (ceiling, floor, walls, bathrooms, doors and windows) is in a poor condition and requires rehabilitation.

Furthermore, the asphalt cover of the playgrounds is deformed; there are neither football doors, nor volleyball nets or basketball backboards; besides, outdoor lighting is not functioning and the power supply line is damaged.

- Rehabilitation of the administrative building including: partial rehabilitation of the roof, arrangement of suspended ceiling, thermos insulation, installation of plastic doors and windows;
- Rehabilitation of WCs and bathrooms;
- Restoration of indoor lighting network;
- Dismantling of asphalt cover and disposing at the local landfill;
- Arrangement of artificial grass cover on the football and volleyball playgrounds;
- Arrangement of the ground sand crushed stones for the basketball playground;
- Arrangement of the outdoor lightning;
- Dismantling of the existing metal poles and wire net;
- Installation of the playground fence.

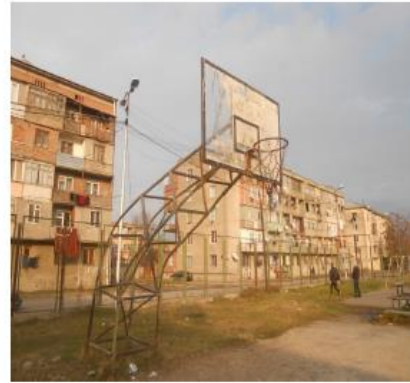
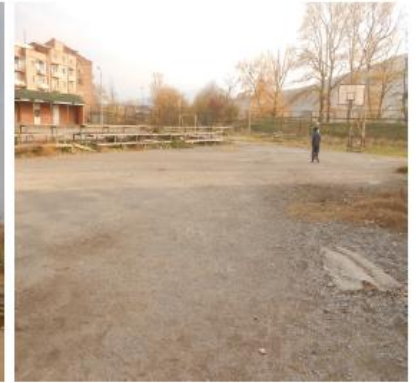
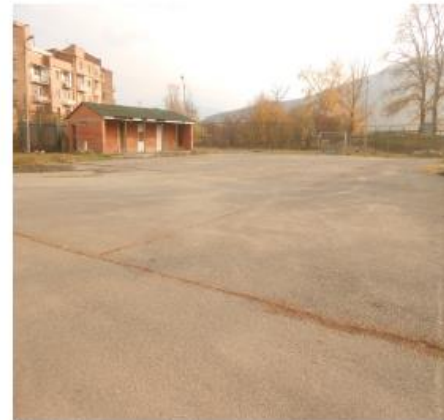
2. Stadium nearby Gorki Street

The stadium situated nearby Gorki Street is currently functioning and consists of one-storied brick administrative building as well as football and basketball playgrounds with asphalt cover. The area is fenced with wire grid, which is inserted in angle on the steel pipes. Stadium electricity is connected to the town network. The land is in the municipal ownership (annex 2). The total area consists of 1,310 m². The SP envisages rehabilitation works for the stadium and its administrative building as well.

The administrative building of the stadium has three rooms and four sanitary units connected to the local municipal network. Although the building is constructively resistant, roof, which is made of tin, is totally damaged as well as the suspended ceiling and weatherization and the inner part of the building as well (ceiling, floor, walls, bathrooms, doors and windows) is in a poor condition and requires rehabilitation.

Furthermore, the asphalt cover of the playgrounds is deformed; there are neither football doors, nor basketball backboards; besides, electricity power supply line is damaged and outdoor lighting is not functioning.

- Rehabilitation of the administrative building including: partial rehabilitation of the roof, arrangement of suspended ceiling, thermos insulation, installation of plastic doors and windows;
- Rehabilitation of WCs and bathrooms;
- Replacement of the sewage piping up to the well located near the building (6 meters long);
- Restoration of indoor lighting network;
- Dismantling of asphalt cover and placing at the local landfill;
- Arrangement of artificial grass cover on the football and volleyball stadium;
- Arrangement of the ground Sand crushed stones for the basketball stadium;
- Arrangement of the outdoor lightning;
- Dismantle of the existing metal poles and wire net;
- Installation of the stadium fence.

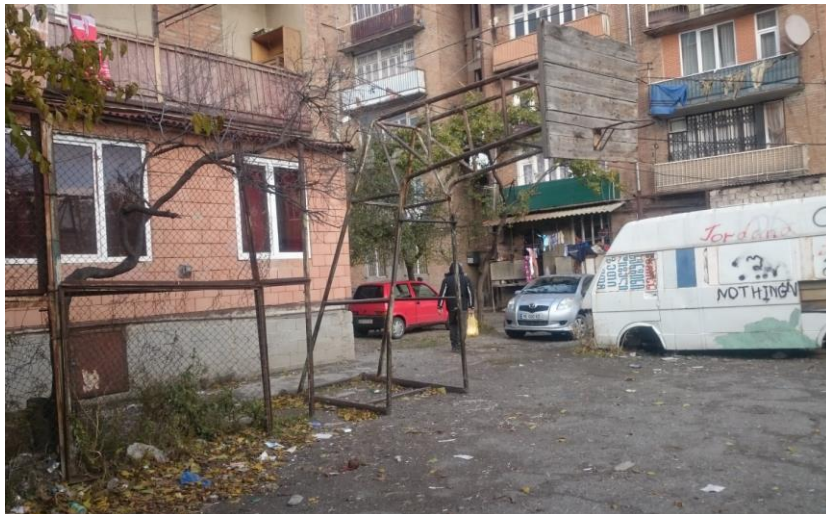
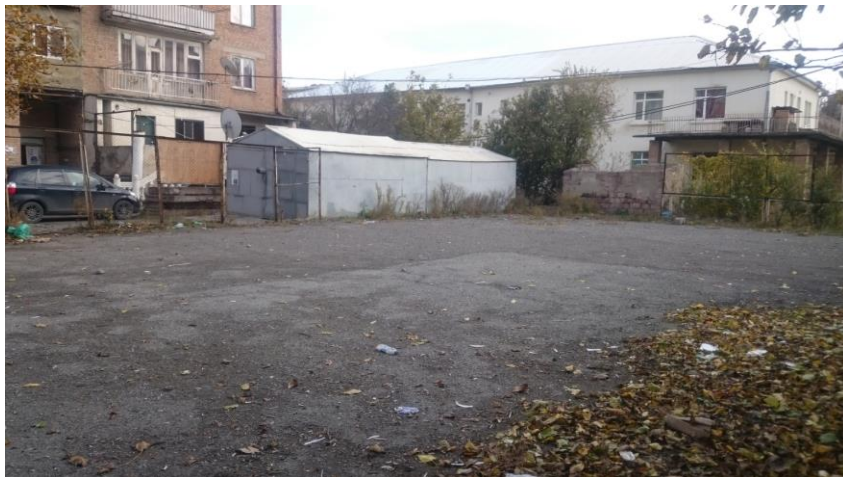
3. Stadium near 56 Kipiani Street

The SP envisages rehabilitation works for the basketball stadium located near 56 Kipiani Street. The stadium is currently functioning, although its asphalt cover and the basketball backboards are damaged. The area is fenced with wire grid, which is inserted in angle on the steel pipes. Playground has neither electricity nor outdoor lighting. The land is in the municipal property (annex 1) and the total area consists of 465 m².

- Dismantling of asphalt cover and disposing at the local landfill;
- Arrangement of the ground sand crushed stones for the playground;
- Arrangement of the outdoor lightning;
- Dismantling of the existing metal poles and wire net;
- Fencing the playground with plastic-coated wire.

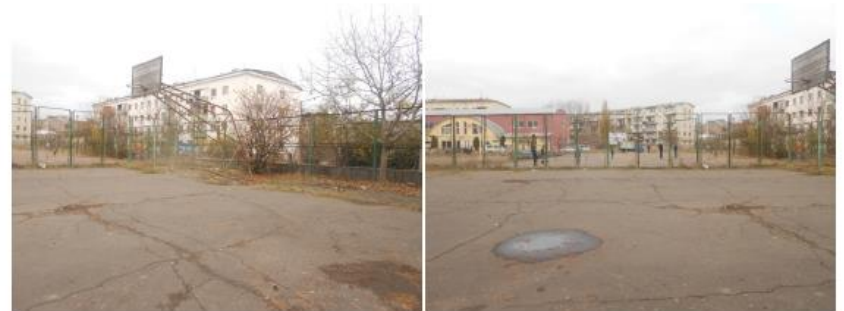
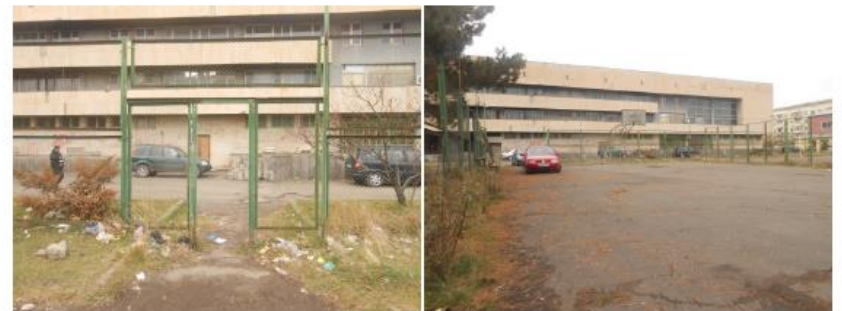
4. Stadium near Besiki Street

The stadium situated nearby Besiki Street is currently functioning and consists of football, basketball and volleyball play areas. The first two has asphalt cover and the volleyball stadium is pure ground. The area is fenced with wire grid, which is inserted in angle on the steel pipes. Stadium is connected to the municipal power supply network. The land is in the municipal property (annex 2). The total area consists of 2713 m².

The asphalt cover of the playgrounds is deformed; there are neither football doors, nor basketball backboards or volleyball net; besides, electricity power supply line is damaged and outdoor lighting is not functioning. Tribunes of the stadium are damaged as well.

- Dismantling of asphalt cover and disposing at the local landfill;
- Arrangement of artificial grass cover on the football and volleyball stadium;
- Arrangement of the ground sand crushed stones for the basketball stadium;
- Arrangement of the outdoor lightning;
- Dismantling of the existing metal poles and wire net;
- Installation of the playground fence.

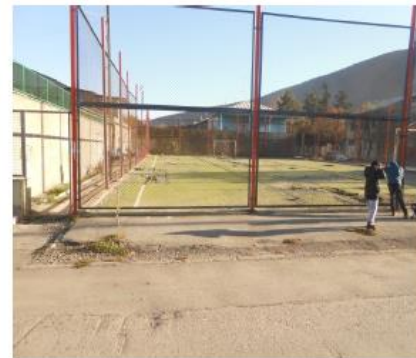
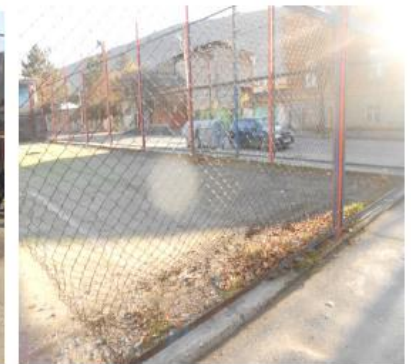
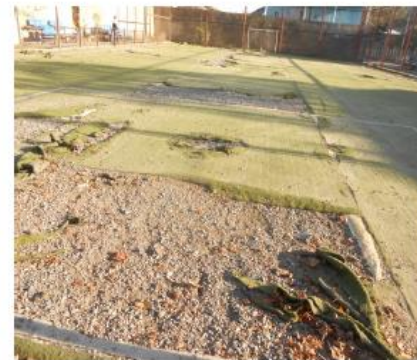
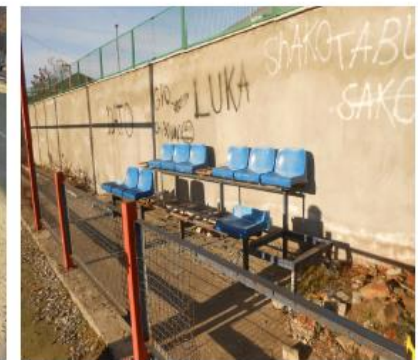
6. Stadium near 42 Uplistsikhe Street

The SP envisages rehabilitation works for the football stadium located near 42 Uplistsikhe Street. The playground is currently functioning, although its asphalt cover and the basketball backboards are damaged. The area is fenced with wire grid, which is inserted in angle on the steel pipes. Stadium is connected to the municipal power supply network. The land is in the municipal property (annex 1) and the total area consists of 836 m².

- Dismantling of asphalt cover and disposing at the local landfill;
- Dismantling of the existing artificial grass cover and disposing at the local landfill;
- Arrangement of the ground sand crushed stones for the stadium;
- Arrangement of the artificial grass field;
- Arrangement of the outdoor lightning;
- Dismantle of the existing metal poles and wire net;
- Fencing the playground with plastic-coated wire.

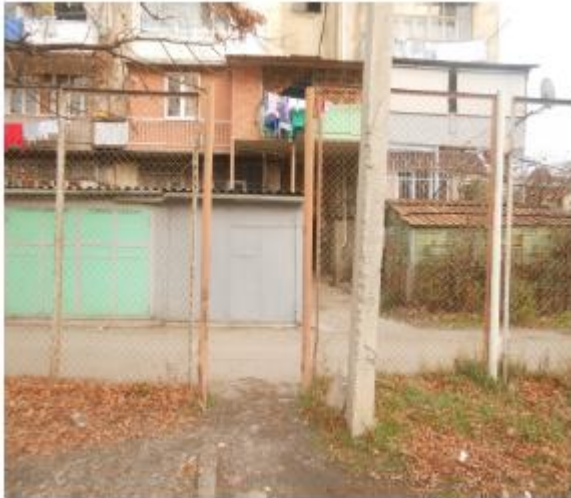
7. Stadium near 3 Shindisi Highway

The SP envisages rehabilitation works for the football stadium located near 3 Shindisi Highway. The stadium is currently functioning, although its asphalt cover as well as the football doors are damaged. The area is fenced with wire grid, which is inserted in angle on the steel pipes. The Stadium is not connected to the municipal electricity network. The land is in the municipal property (annex 1) and the total area consists of 1,218 m².

- Dismantling of asphalt cover and disposing at the local landfill;
- Arrangement of the ground sand crushed stones for the stadium;
- Arrangement of the artificial grass field;
- Arrangement of the outdoor lightning and connecting the stadium power supply to the nearest transformer substation (length 8 meters)
- Dismantling of the existing metal poles and wire net;
- Fencing the playground with plastic-coated wire.

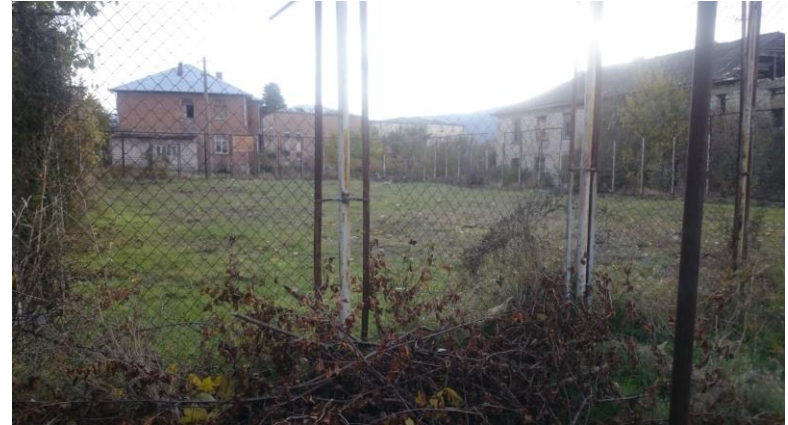
8. Stadium near 57 Sukhishvili Street

The SP envisages rehabilitation works for the football stadium located near 57 Sukhishvili Street. The playground is currently functioning, although its asphalt cover as well as the football doors are damaged. The area is fenced with wire grid, which is inserted in angle on the steel pipes. The land is in the municipal property (annex 1) and the total area consists of 767 m².

- Dismantling of asphalt cover and disposing at the local landfill;
- Arrangement of the ground sand crushed stones for the stadium;
- Arrangement of the artificial grass field;
- Arrangement of the outdoor lightning;
- Dismantling of the existing metal poles and wire net;
- Fencing the playground with plastic-coated wire.

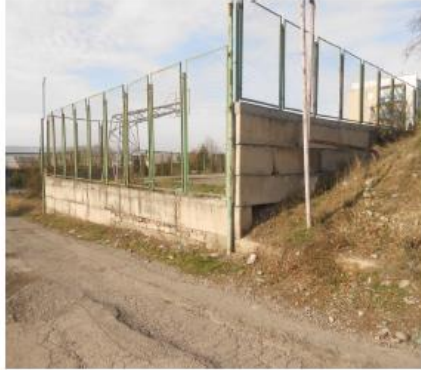
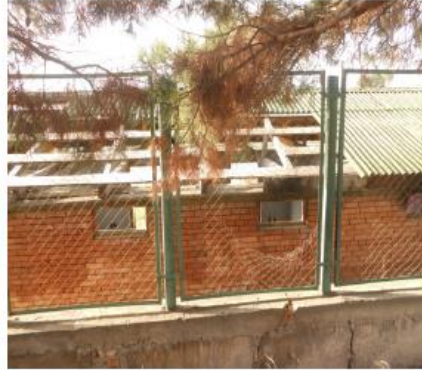
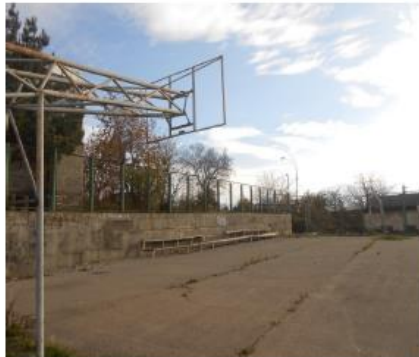
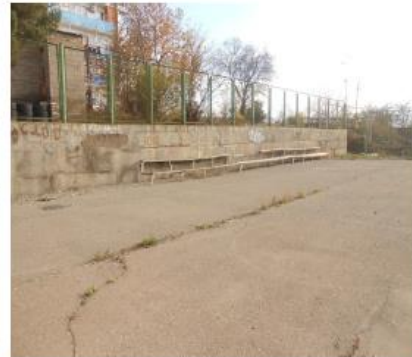
9. Stadium near 9 Sukhishvili Street

The stadium situated near 9 Sukhishvili Street is currently functioning and consists of one-storied brick administrative building as well as football and basketball playgrounds with asphalt cover. The area is fenced with wire grid, which is inserted in angle on the steel pipes. Stadium electricity is connected to the town network. The land is in the municipal ownership (annex 2). The total area consists of 1,966 m². The SP envisages rehabilitation works for the stadium and its administrative building as well.

The administrative building of the stadium has three rooms and four sanitary units connected to the local municipal network. Although the building is constructively resistant, the roof, which is made of tin, is totally damaged as well as the suspended ceiling, weatherization and the inner part of the building (floor, walls, bathrooms, doors and windows) are in a poor condition and require rehabilitation.

Furthermore, the asphalt cover of the playgrounds is deformed; there are neither football doors, nor basketball backboards or volleyball net; besides, electricity power supply line is damaged and outdoor lighting is not functioning.

- Rehabilitation of the administrative building including: partial rehabilitation of the roof, arrangement of suspended ceiling, thermos insulation, installation of plastic doors and windows;
- Rehabilitation of WCs and bathrooms;

- Replacement of the sewage line up to the well located near the building (6 meters long);
- Restoration of indoor lighting network;
- Dismantling of asphalt cover and disposing at the local landfill;
- Arrangement of artificial grass cover on the football and volleyball stadium;
- Arrangement of the ground Sand crushed stones for the basketball stadium;
- Arrangement of the outdoor lightning;
- Dismantling of the existing metal poles and wire net;
- Installation of the playground Fence.

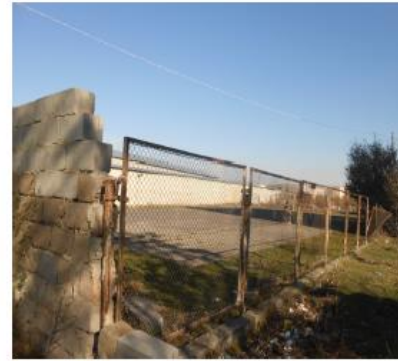
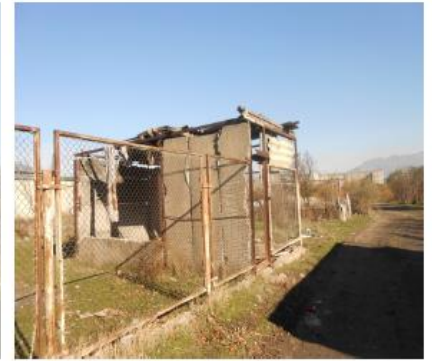
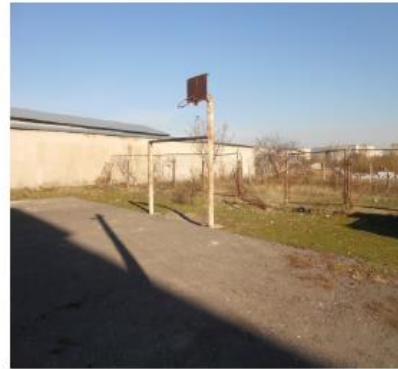
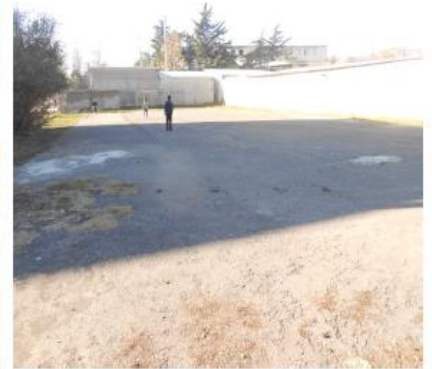
10. Stadium near 32 Shindisi Highway

The stadium is currently functioning, although its asphalt cover as well as the football doors are damaged. The area is fenced with wire grid, which is inserted in angle on the steel pipes. There is no electricity connected to the stadium. The land is in the municipal property (annex 1) and the total area consists of 1,041 m².

- Dismantling of asphalt cover and disposing at the local landfill;
- Arrangement of the ground sand crushed stones for the stadium;
- Arrangement of the artificial grass cover;
- Arrangement of the outdoor lightning;
- Dismantling of the existing metal poles and wire net;
- Installation of the playground fence.
