Biannual Environmental Monitoring Report

Loan Number: 3273-GEO (SF)

Reporting period: July-December, 2017

GEORGIA: GEORGIAN SUSTAINABLE URBAN TRANSPORT INVESTMENT PROGRAM - Tranche 4

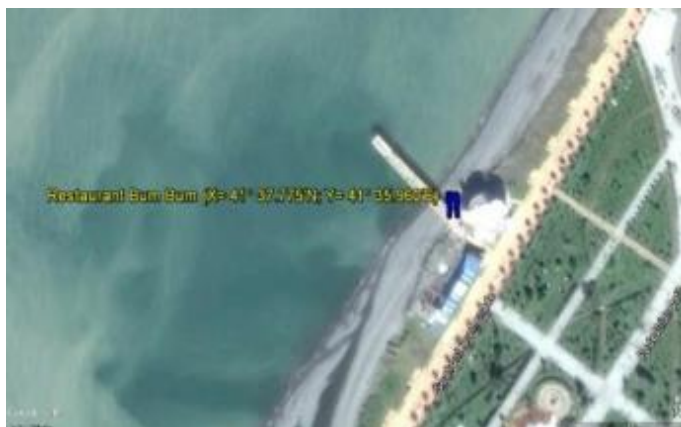
70. Noise level results, acquired on the 23.02.2017, were in the range from 76.4 dBA at Alphabet tower to 86.3 dBA at restaurant BUM BUM sampling point (map and coordinates are provided below). No meteorological data were acquired. Without meteorological data it was impossible to understand the reason of the exceedance of the threshold limit (wind and waves could account for that values but meteo data need to be acquired simultaneously).

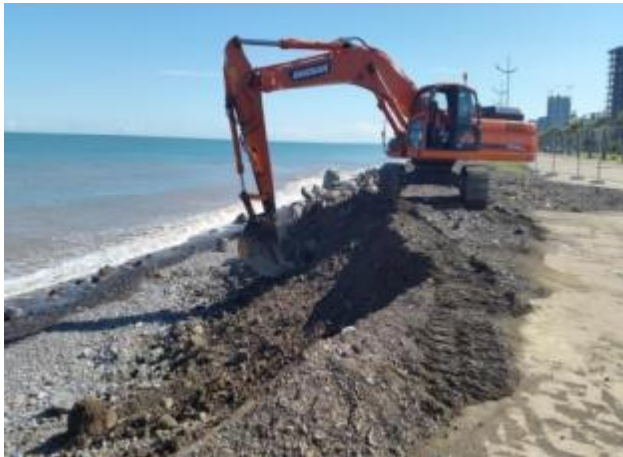
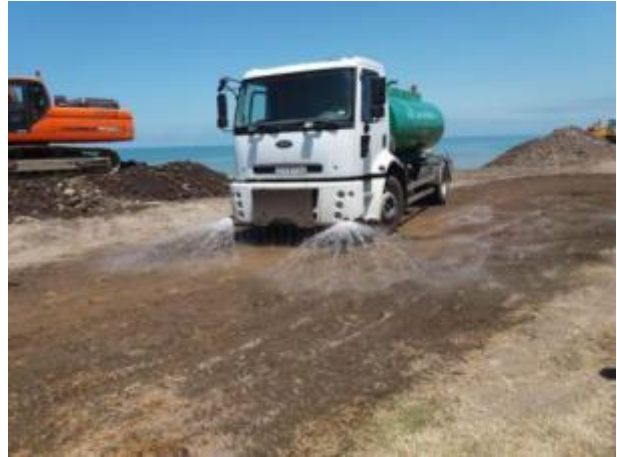
Working area for extra works and filling with materials coming by quarry
And watering the site by water truck

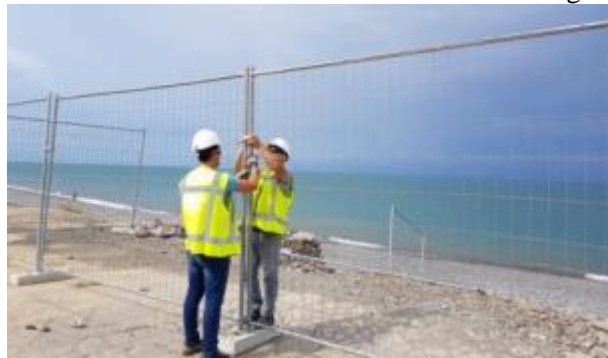
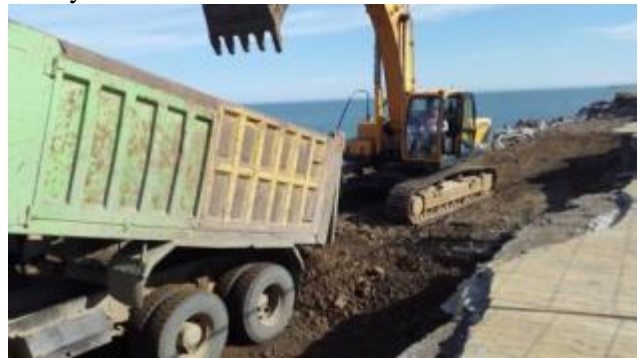
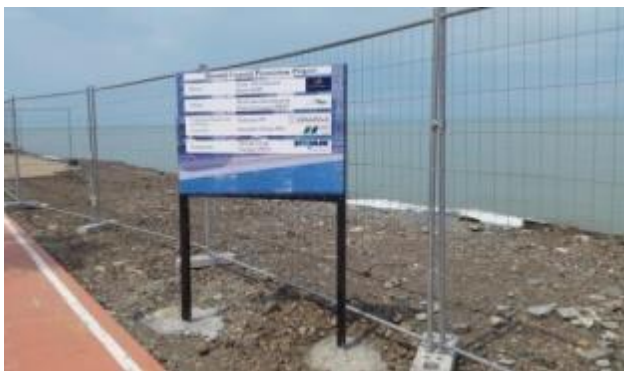
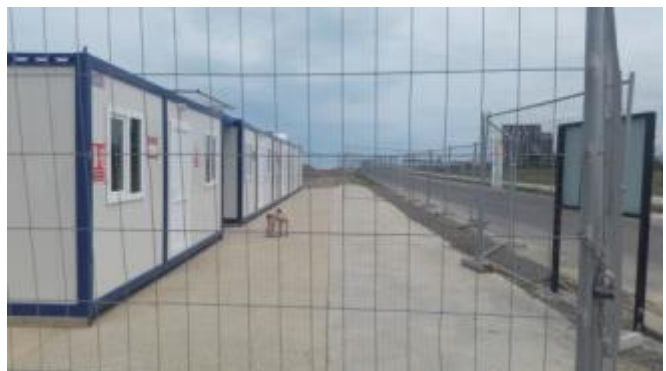
Extra works- restoration of eroded bualvar area; Insalation of site main banners (three); Cleaned camp site territory

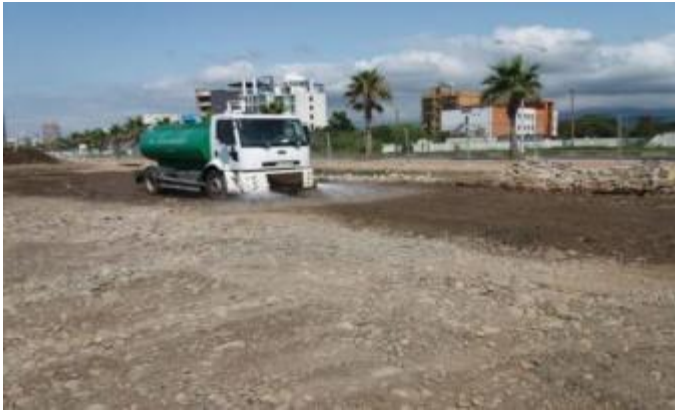
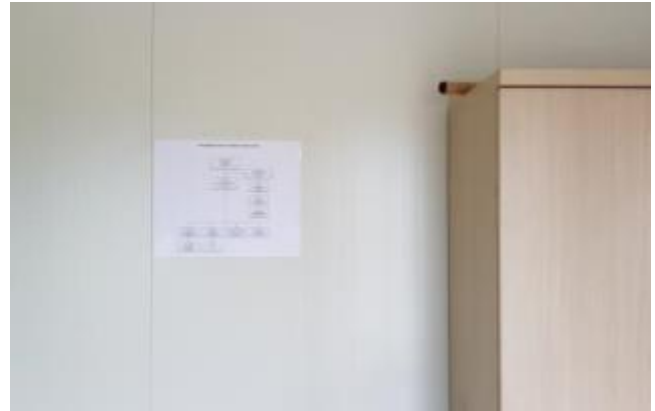
Watering the site and organization chart

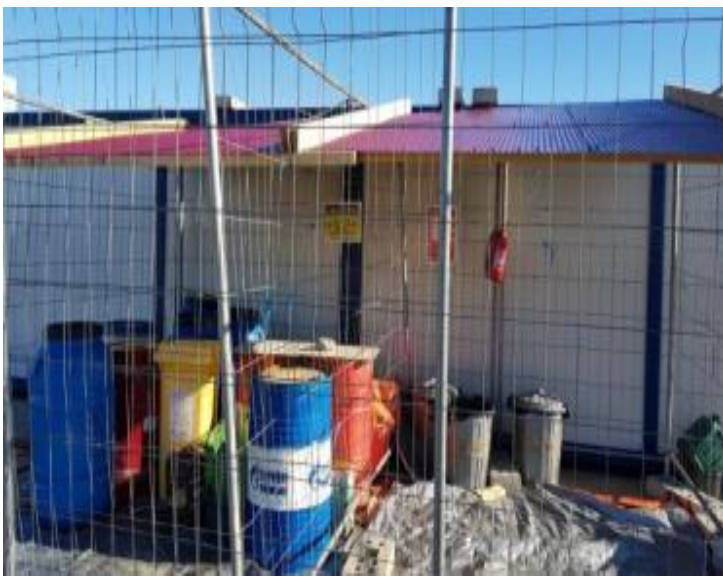
Site camp area and singinig

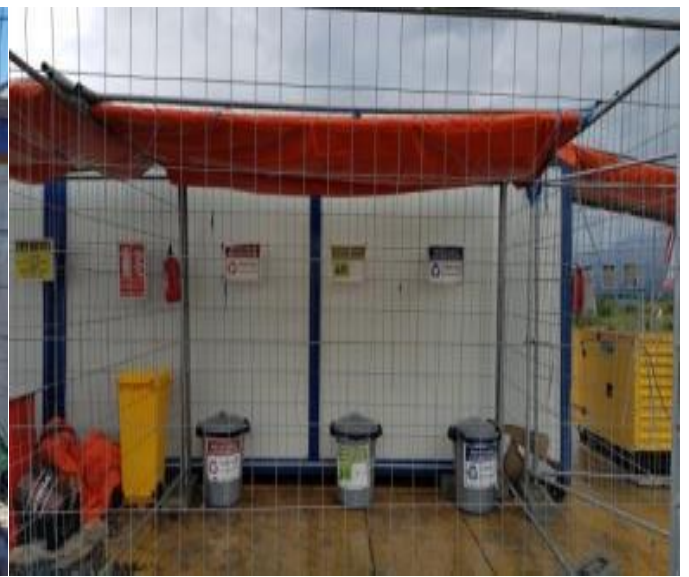
Hazardous waste storing area

82. Waste Management Plan was approved by “Saunders Group” Ltd, MDF (Municipal Development Fund) and director of construction contractor “Struijk Group Georgia LLC”. There were installed three different waste bins in the temporary waste area. Proper signs are Installed: Hazardous waste, General waste, paper waste, plastic waste, smoking area, temporary hazardous waste area, grievance box, do not burn, WC, keep area clean and etc. Temporary hazardous waste area has been arranged with two layers of Polyethylene. Area is fenced with metal fence and locked.

83. The Construction Company collects hazardous waste at the temporary storage sites and pass it to the licensed operator Sanitary LTD having environmental permit on operation of the hazardous wastes. The contract with “Sanitary” Ltd was signed on 07 April, 2017.

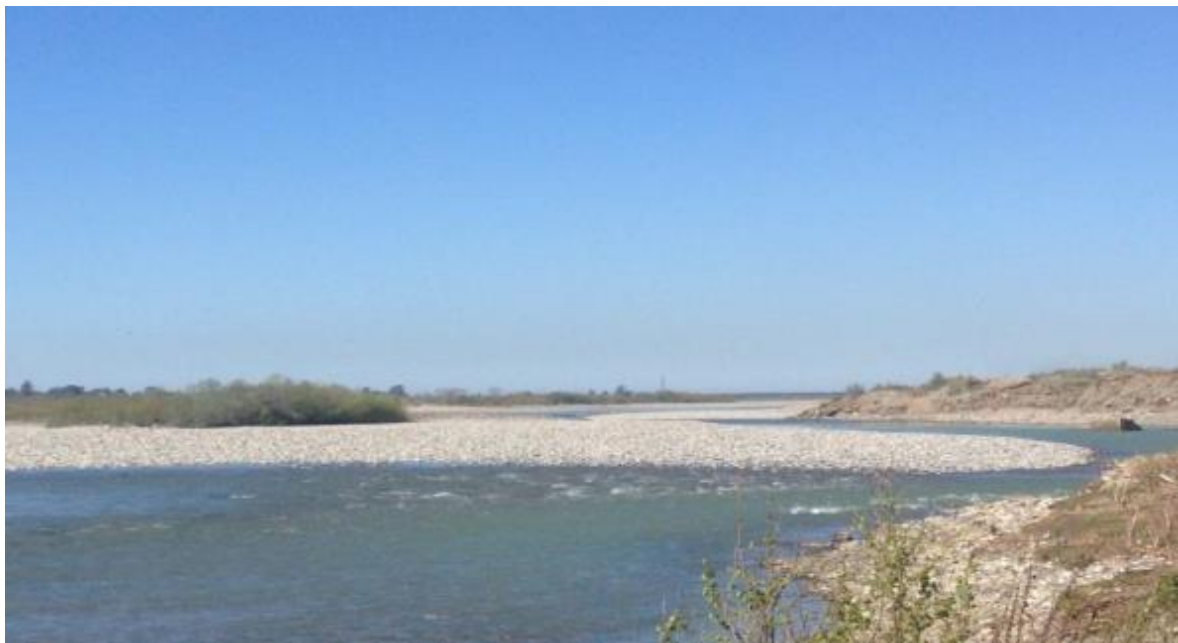
Delta of the Choroki River

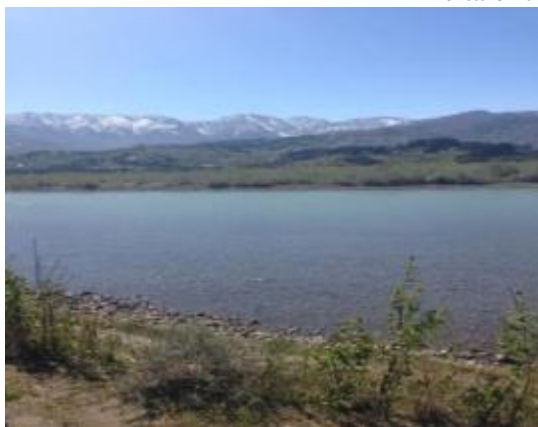
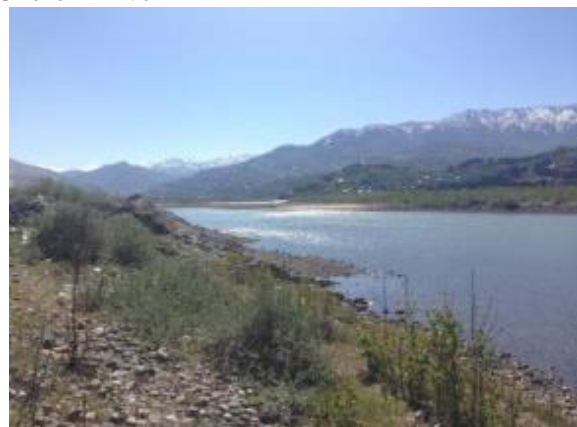
Chorochi River from the delta toward the first dike

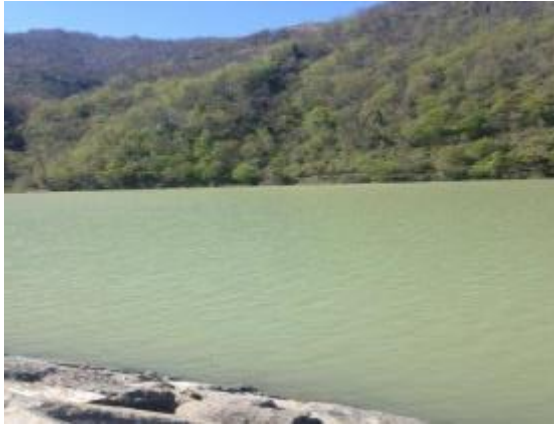
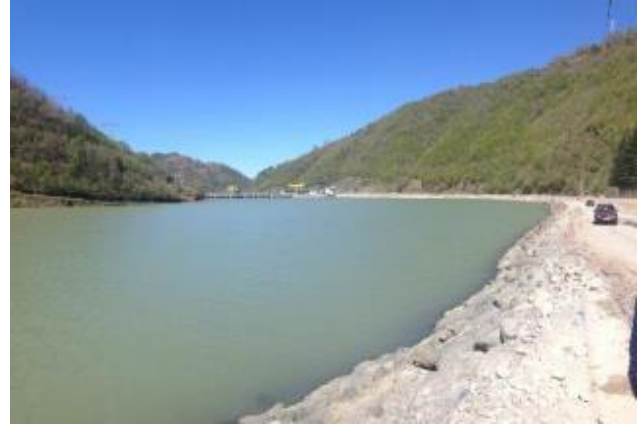
Choroki River immediately up of the first dike

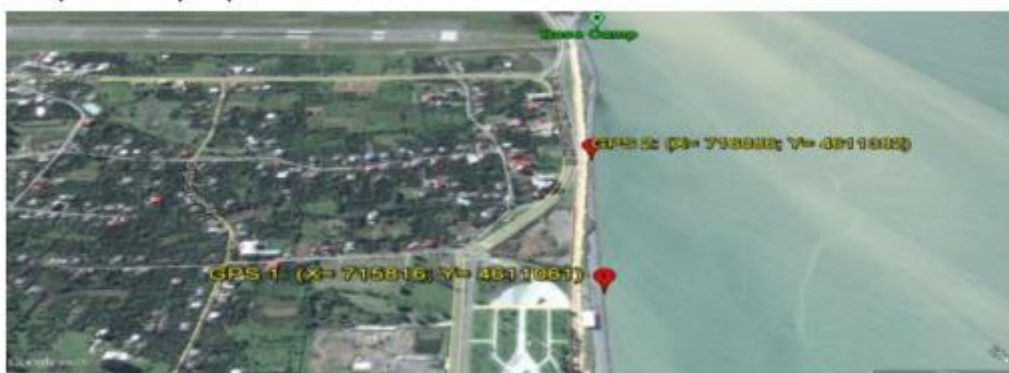
Map with samples points:

N1	Location	Measured Parameters	Unit	Results	Method
1	GPS 1: {X= 715816; Y= 4611061}	Suspended Solids	mg/L	23	Photometric

N1	Location	Measured Parameters	Unit	Results	Method
2	GPS 2: {X= 716086; Y= 4611382}	Suspended Solids	mg/L	19	Photometric

Based on the results of the tests conducted in two places {GPS 1: (X= 715816; Y= 4611061); and GPS 2: (X= 716086; Y= 4611382)}, Monitoring water turbidity level are under the norm of UKTAG standard.

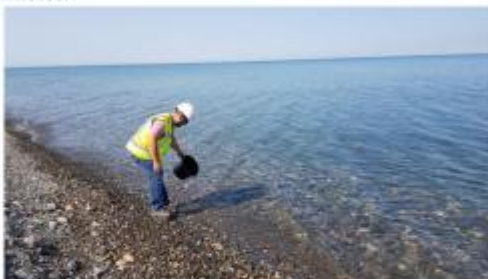
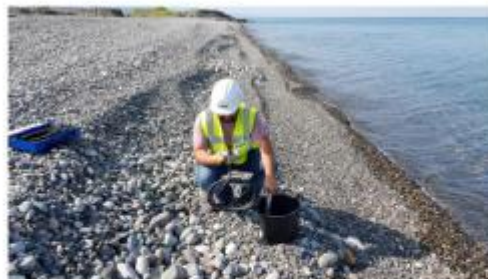
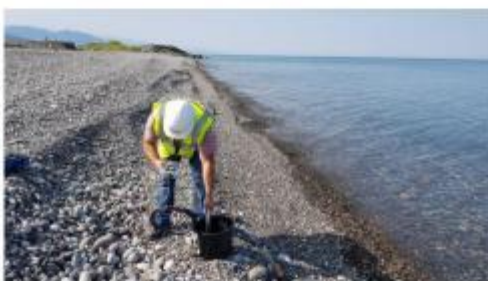
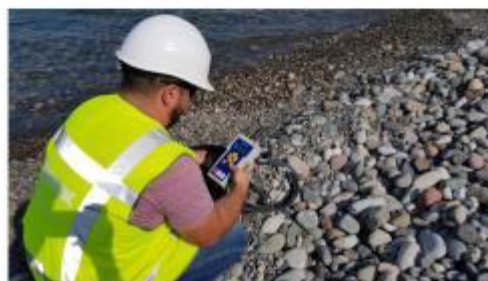
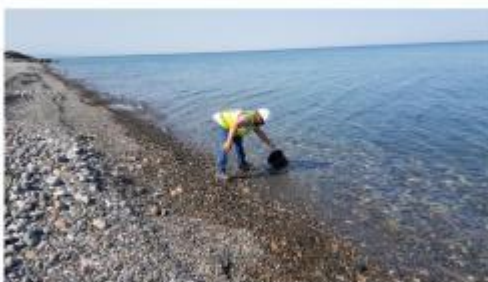
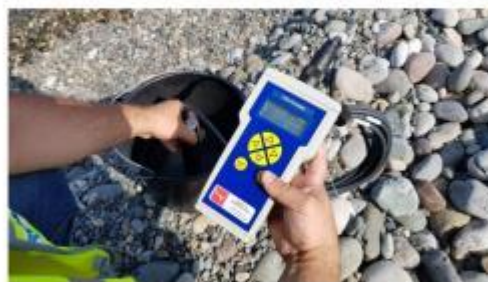
Photos:

Based on the results of the tests conducted in two places {GPS 1: (X= 715623; Y= 4610841); and GPS 2: (X= 715580; Y= 4610778)}, Monitoring water turbidity level are under the norm of UKTAG standard.

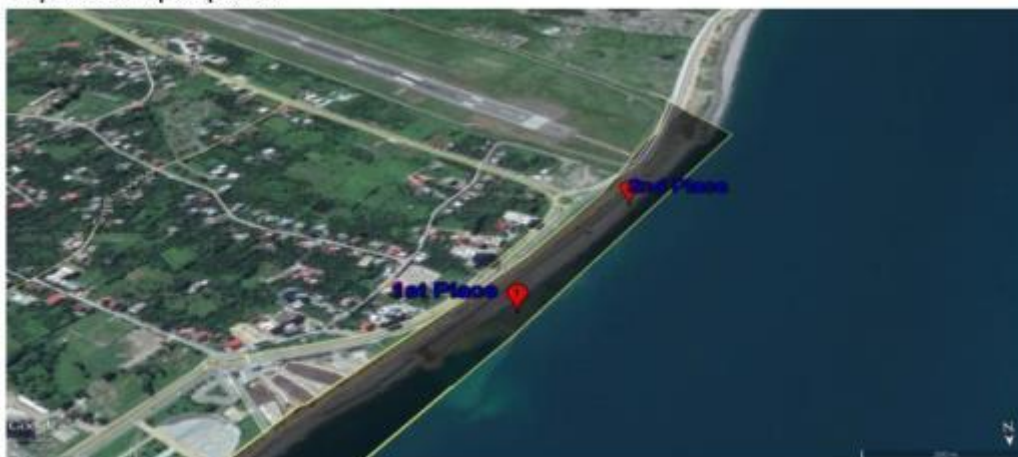
Map with samples points:

N1	Location	Measured Parameters	Unit	Results	Method
1	GPS 1: (X= 715771; Y= 4611059)	Suspended Solids	mg/L	18.03	Photometric
N1	Location	Measured Parameters	Unit	Results	Method
2	GPS 2: (X= 715580; Y= 4610778)	Suspended Solids	mg/L	24.35	Photometric

Based on the results of the tests conducted in two places {GPS 1: (X= 715771; Y= 4611059); and GPS 2: (X= 715580; Y= 4610778)}, Monitoring water turbidity level are under the norm of UKTAG standard.

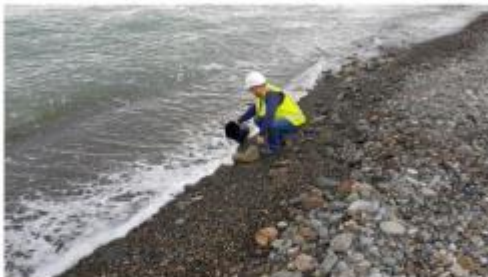
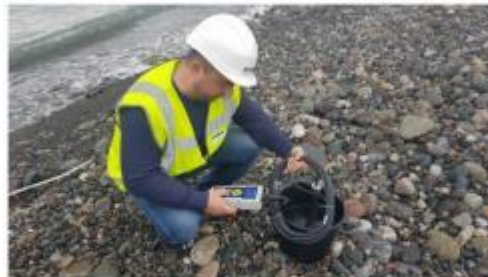
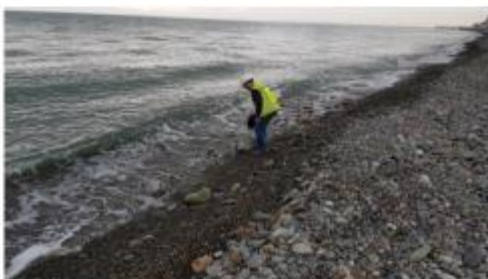
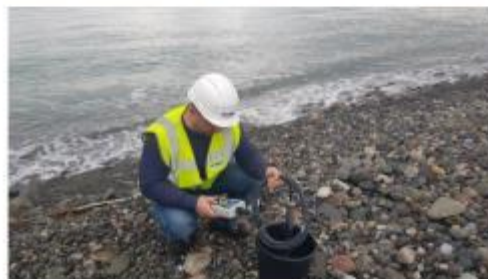
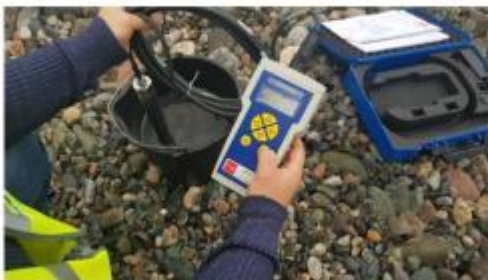
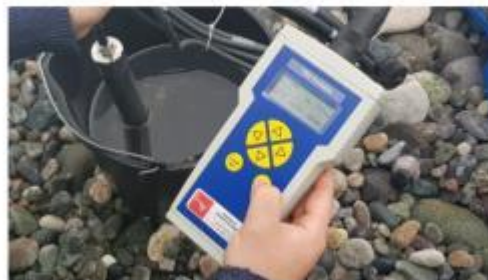
Photos:

Based on the results of the tests conducted in two places {GPS 1: (X= 715671; Y= 4610929); and GPS 2: (X= 715516; Y= 4610717)}, Monitoring water turbidity level are under the norm of UKTAG standard.

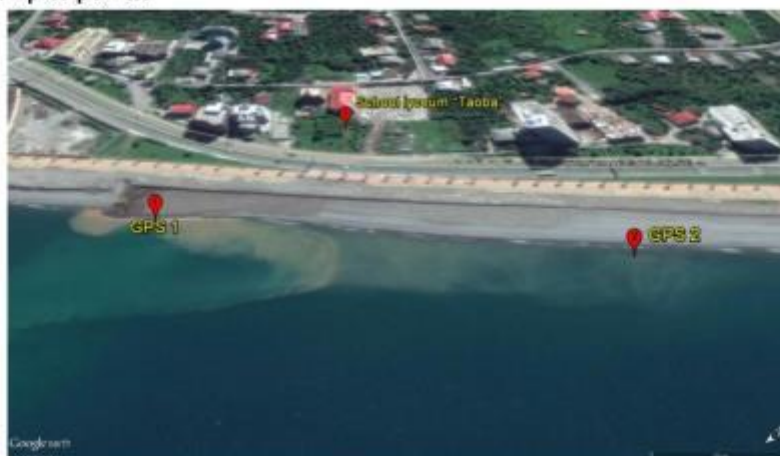
Map with samples points:

N1	Location	Measured Parameters	Unit	Results	Method
1	GPS 1: (X= 715866; Y= 4611143)	Suspended Solids	mg/L	31.70	Photometric
N1	Location	Measured Parameters	Unit	Results	Method
2	GPS 2: (X= 715637; Y= 4610888)	Suspended Solids	mg/L	44.60	Photometric

Based on the results of the tests conducted in two places {GPS 1: (X= 715866; Y= 4611143); and GPS 2: (X= 715637; Y= 4610888)}, Monitoring water turbidity level are under the norm of UKTAG standard.

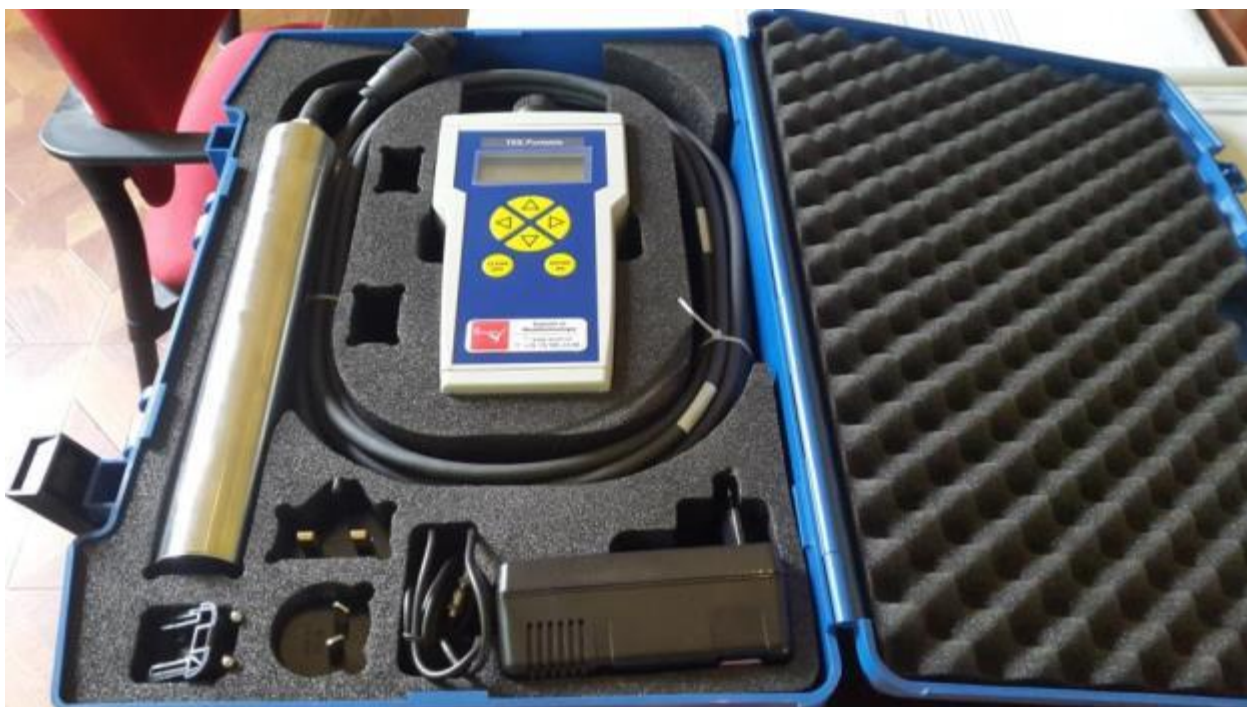
2.5 Probe

The probe contains sensitive optical and electronic components. Care must therefore be taken to ensure that it is not subjected to any hard mechanical impacts. The inside of the probe, and of the display unit, does not contain any components that can be serviced by the user.
