# Semi-annual Environmental Monitoring Report

**Project Number:** Sustainable Urban Transport Investment Program - Tranche 4  
LOAN NUMBER 3273-GEO

**Reporting period:** July – December 2018

## **GEORGIA: GEORGIAN SUSTAINABLE URBAN TRANSPORT INVESTMENT PROGRAM - Tranche 4**

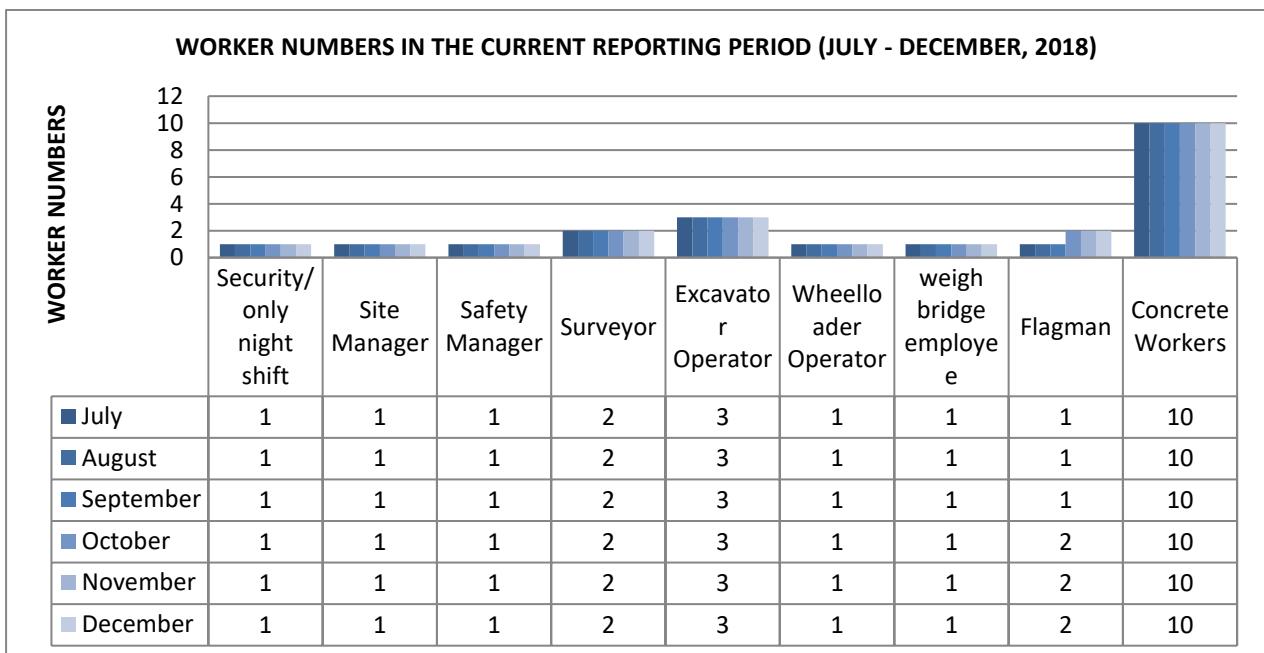
34. Details of worker numbers (maximum, minimum) during current reporting period is outlined by the chart provided below:

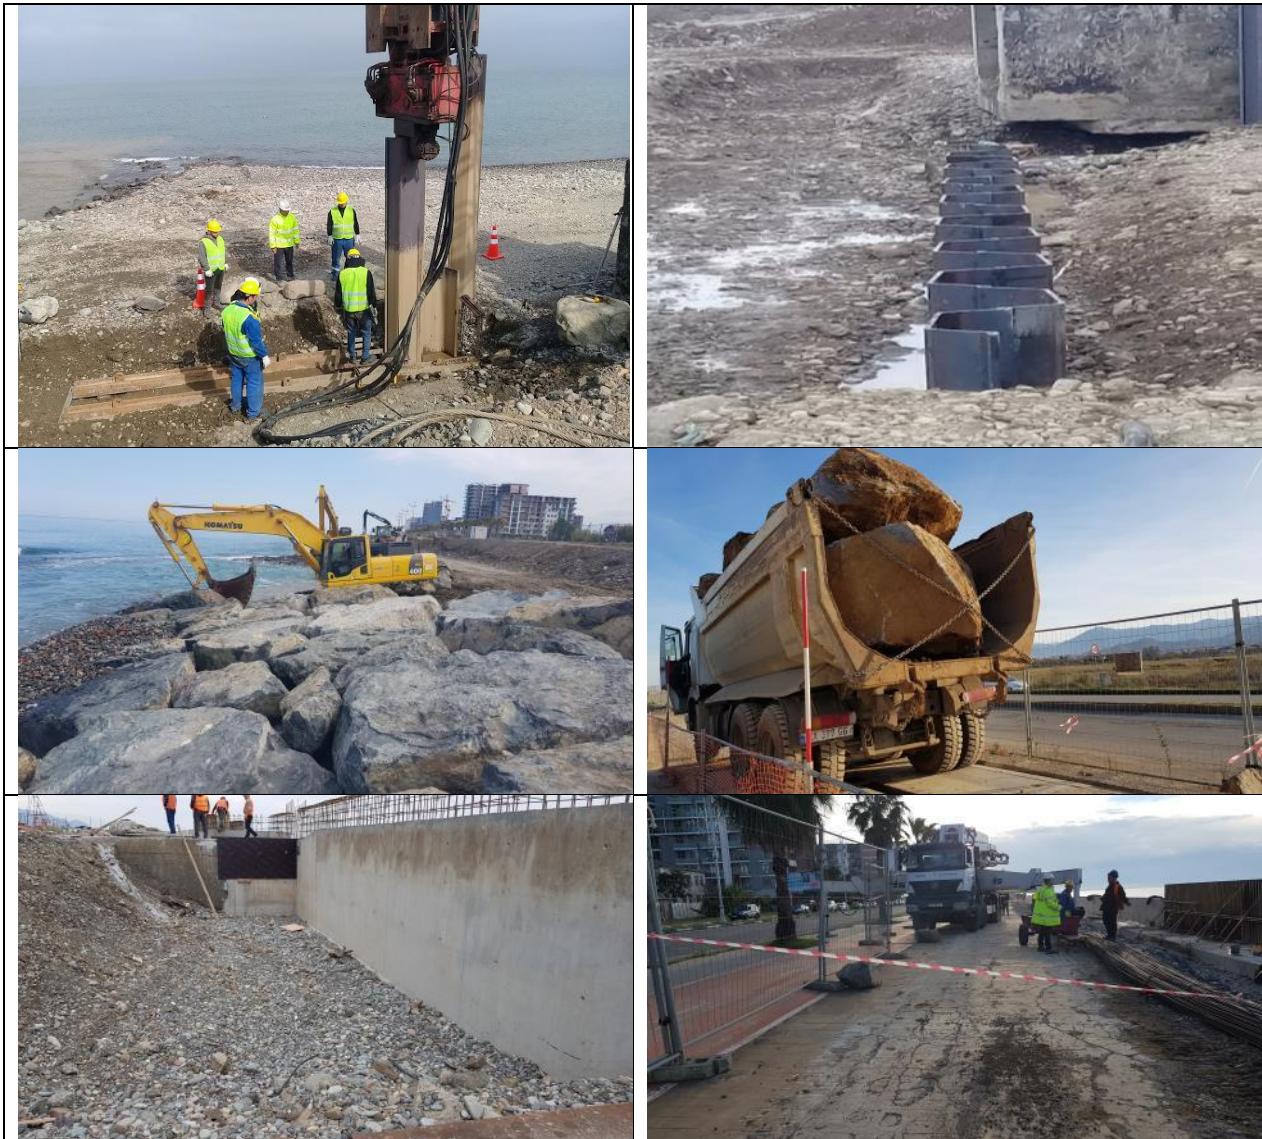
36. Where the revetment and crown wall are interrupted for building these accesses, stability of the shoreline against both - wave and earth loadings are to be supported by a proper retaining structure consisting in a 4 m reinforced concrete wall founded on steel sheet-piles, placed along the crown wall line.

38. Construction of 10 beach accesses along the shoreline with interruption of the revetment. In these cases, the stability is assured by a proper retaining structure consisting in an approx. 4 m reinforced concrete wall founded on steel sheet-piles, placed along the crown wall line.

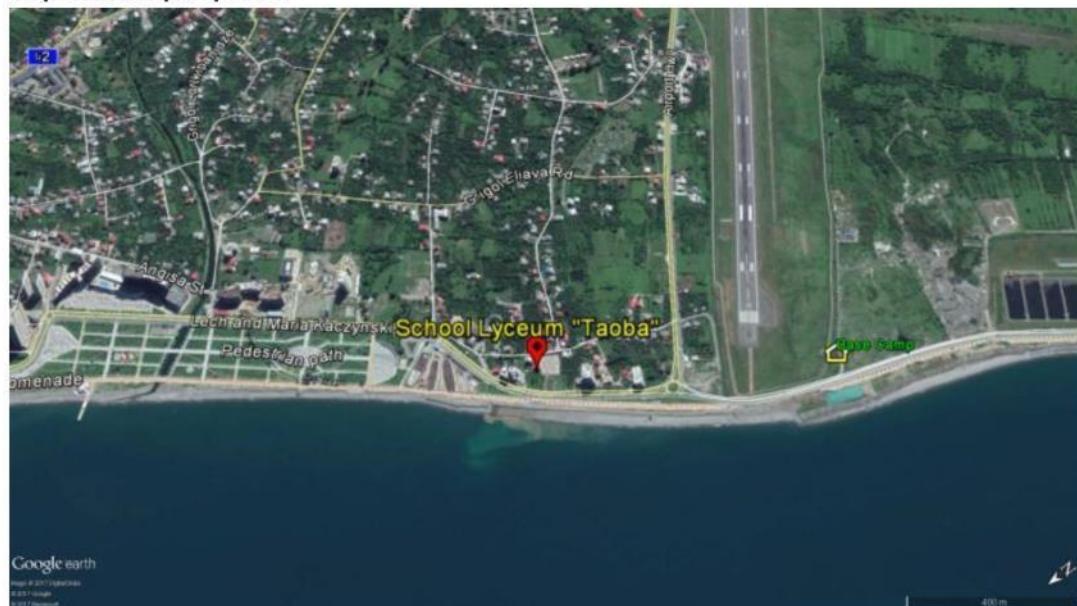
**Map with samples points:**

**Note:** The threshold #I3 and highlighted in the table (yellow) is thresholds, which are considered.

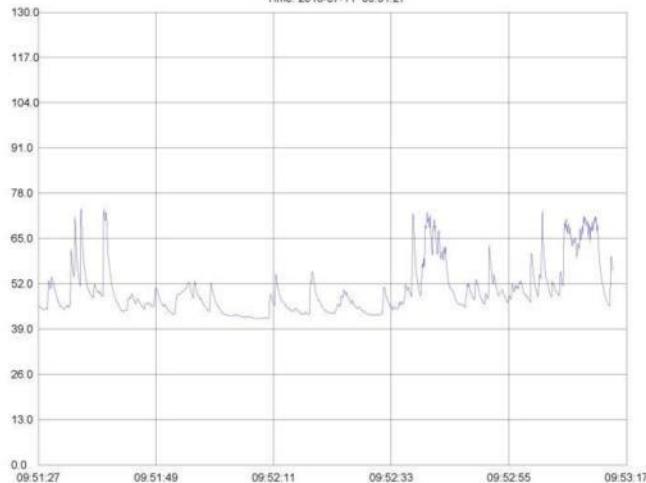
Standard Sound Level Meter RealTime Graph  
Time: 2018-07-11 09:51:27

Start Time: 11-07-2018, 09:51:27  
Maximum: 73.60 11-07-2018, 09:51:34  
Minimum: 42.10 11-07-2018, 09:52:01  
Sample Rate: 0.10  
Average: 50.14

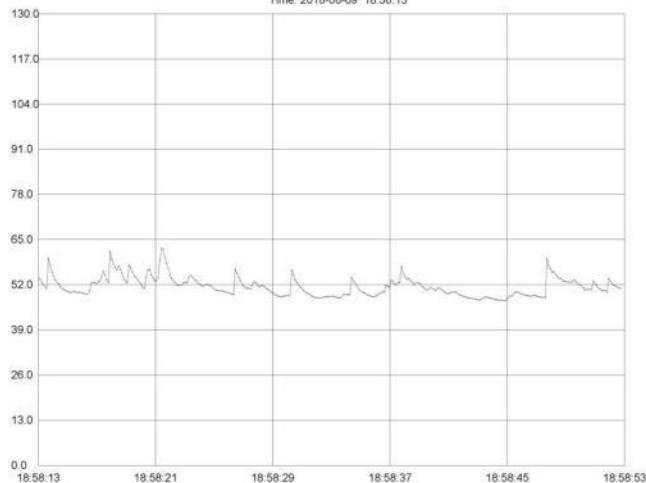
Standard Sound Level Meter RealTime Graph  
Time: 2018-08-09 18:58:13

Start Time: 09-08-2018,18:58:13  
Maximum: 62.40 09-08-2018,18:58:22  
Minimum: 47.40 09-08-2018,18:58:45  
Sample Rate: 0.10  
Average: 51.41

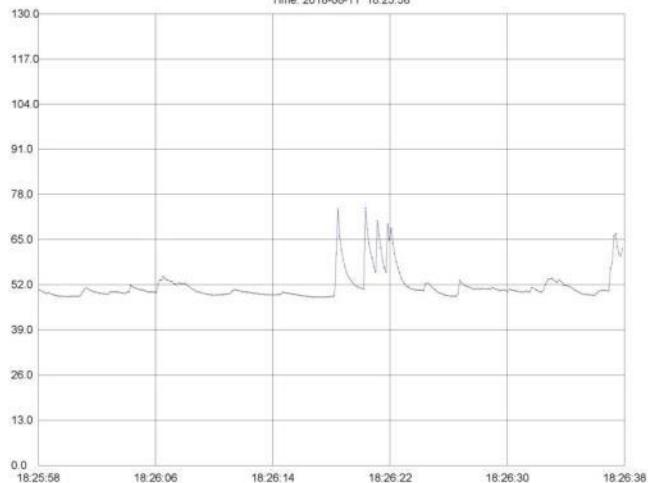
Standard Sound Level Meter RealTime Graph  
Time: 2018-08-11 18:25:58

Start Time: 11-08-2018,18:25:58  
Maximum: 74.10 11-08-2018,18:25:19  
Minimum: 48.40 11-08-2018,18:25:18  
Sample Rate: 0.10  
Average: 51.51

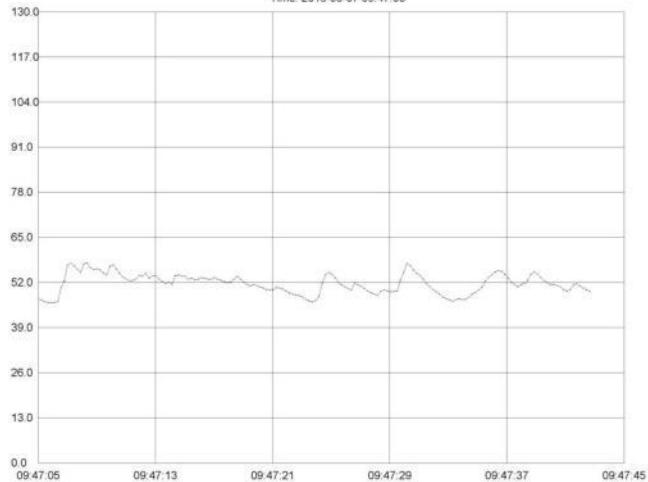
Standard Sound Level Meter RealTime Graph  
Time: 2018-08-07 09:47:05

Start Time: 07-08-2018,09:47:05  
Maximum: 57.60 07-08-2018,09:47:07  
Minimum: 46.10 07-08-2018,09:47:06  
Sample Rate: 0.10  
Average: 51.68

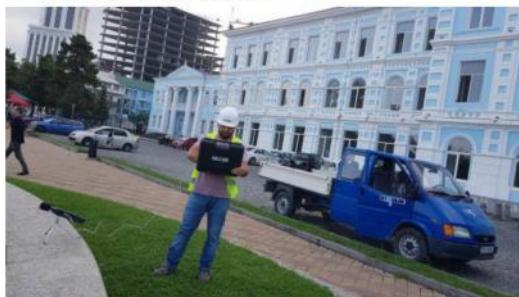
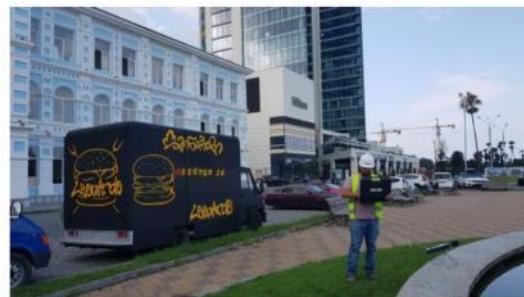
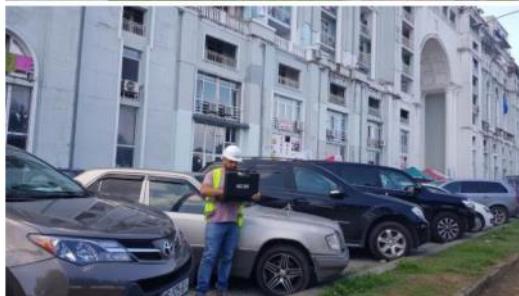
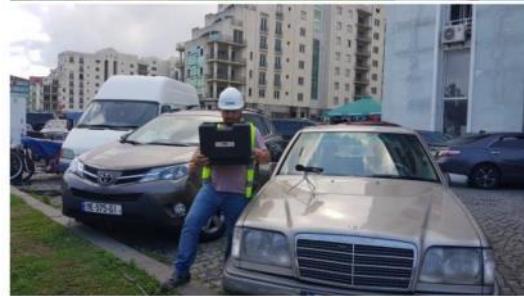
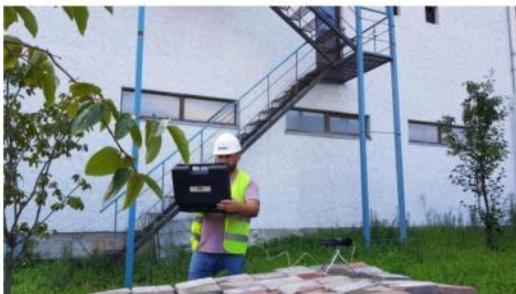
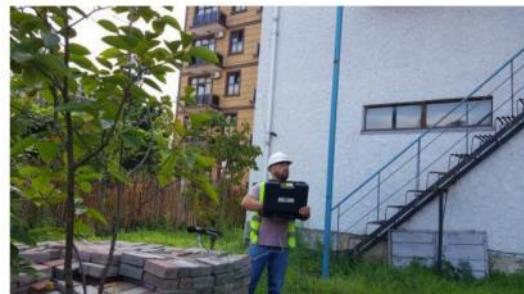
**Photo-Documentation:**

"Based on the results of the tests conducted in three locations (School Lyceum "Taoba", Shota Rustaveli University, The Magnolia Hotel), Monitoring noise levels are under the norm of Resolution No 398 of the Government of Georgia, August 15, 2017; Technical Regulations – „On the norms of acoustic noise in the premises of buildings and areas of the residential houses and social/public establishments".

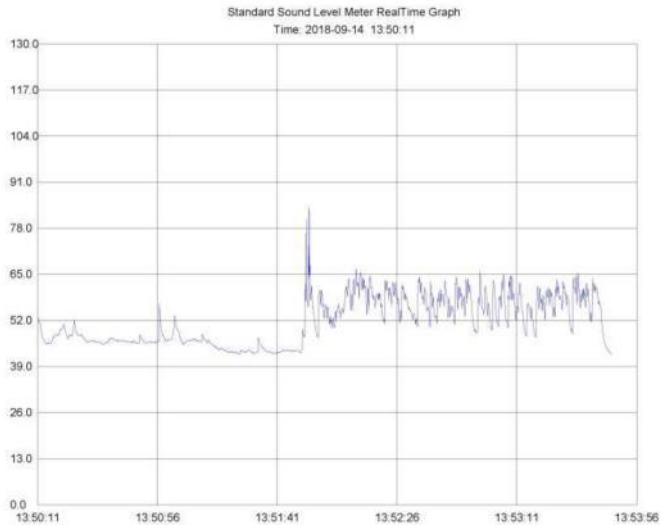
Start Time: 14-09-2018,13:50:11  
Maximum: 84.10 14-09-2018,13:51:58  
Minimum: 42.60 14-09-2018,13:50:11  
Sample Rate: 0.10  
Average: 51.71

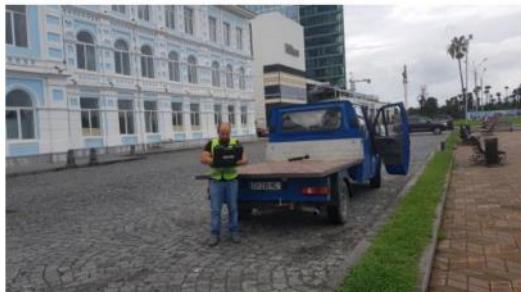
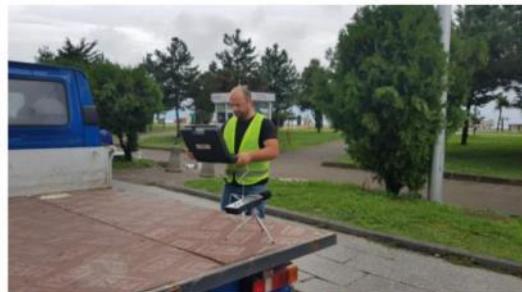
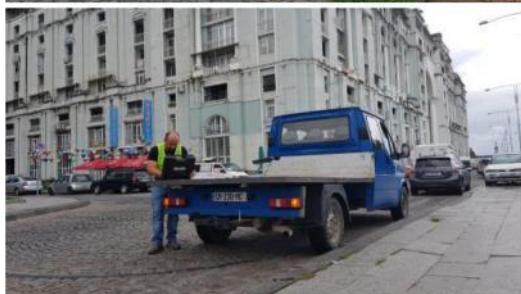
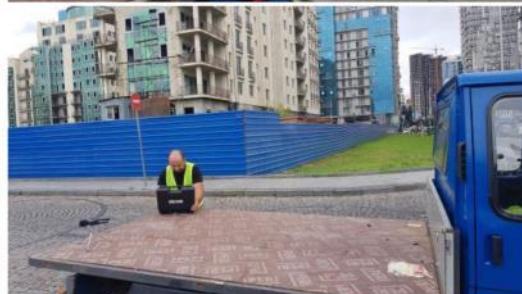
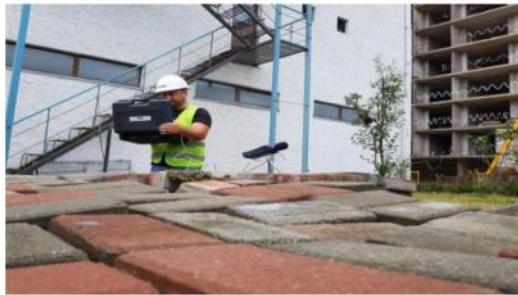
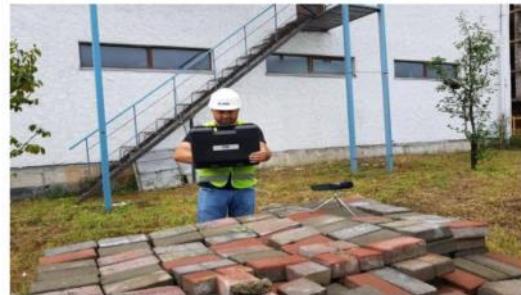
**Photo-Documentation:**

"Based on the results of the tests conducted in three locations (School Lyceum "Taoba", Shota Rustaveli University, The Magnolia Hotel), Monitoring noise levels are under the norm of Resolution No 398 of the Government of Georgia, August 15, 2017; Technical Regulations – „On the norms of acoustic noise in the premises of buildings and areas of the residential houses and social/public establishments".

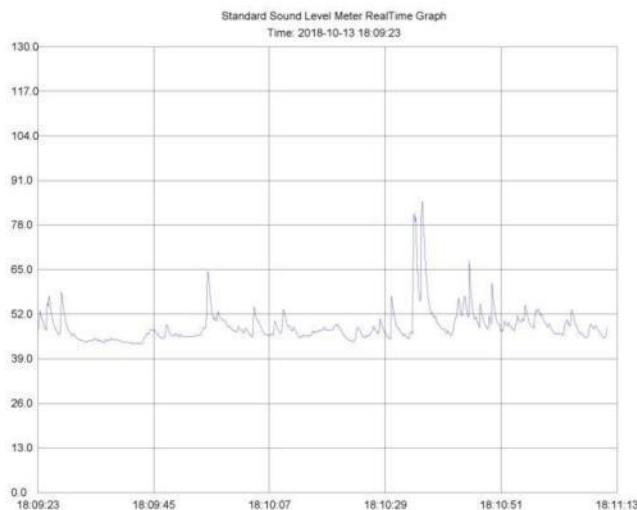
Start Time: 13-10-2018,18:09:23  
Maximum: 84.80 13-10-2018,18:10:35  
Minimum: 43.30 13-10-2018,18:09:41  
Sample Rate: 0.10  
Average: 48.47

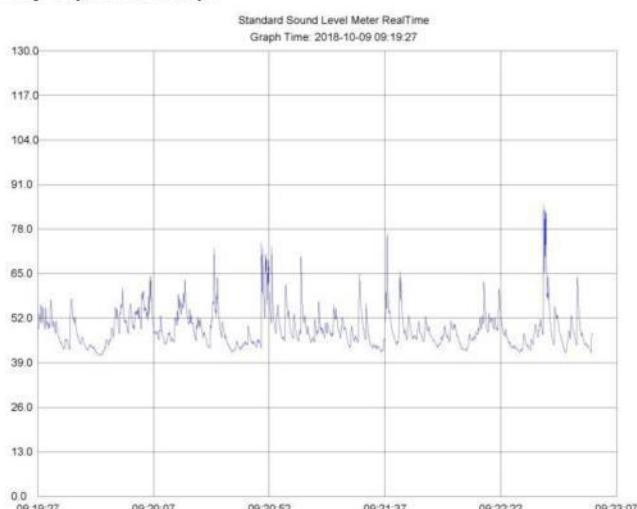
**Day I (09.10.2018):**

Start Time: 11-09-2018,09:19:27  
Maximum: 85.10 11-09-2018,09:22:48  
Minimum: 41.20 11-09-2018,09:19:49  
Sample Rate: 0.10  
Average: 48.79

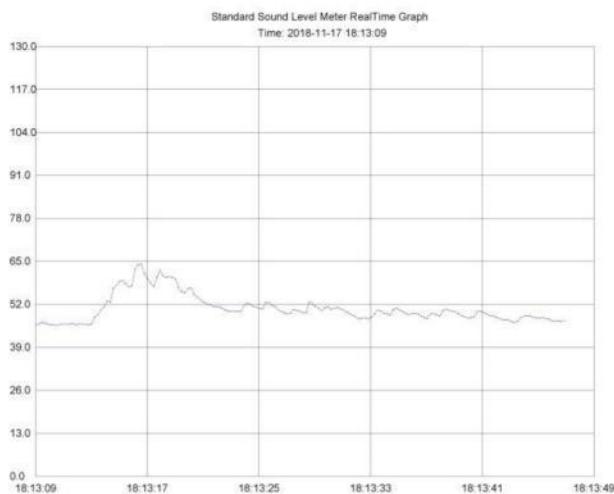
Start Time: 17-11-2018,18:13:09  
Maximum: 64.20 17-11-2018,18:13:16  
Minimum: 45.60 17-11-2018,18:13:11  
Sample Rate: 0.10  
Average: 50.85

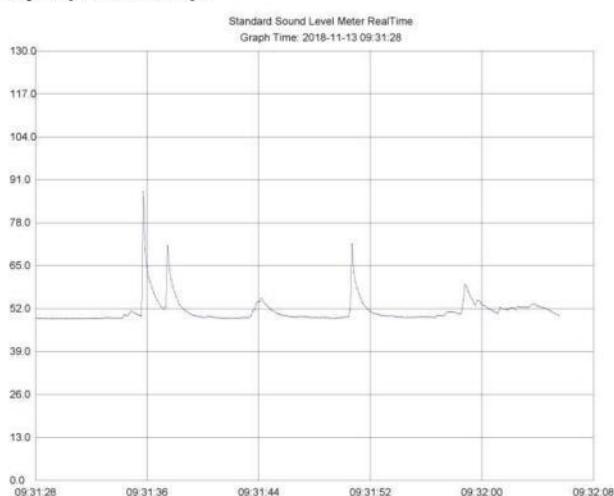
**Test results for Shota Rustaveli University:  
Day I (13.11.2018):**

Start Time: 13-11-2018,09:31:28  
Maximum: 87.40 13-11-2018,09:31:35  
Minimum: 48.90 13-11-2018,09:31:41  
Sample Rate: 0.10  
Average: 51.25

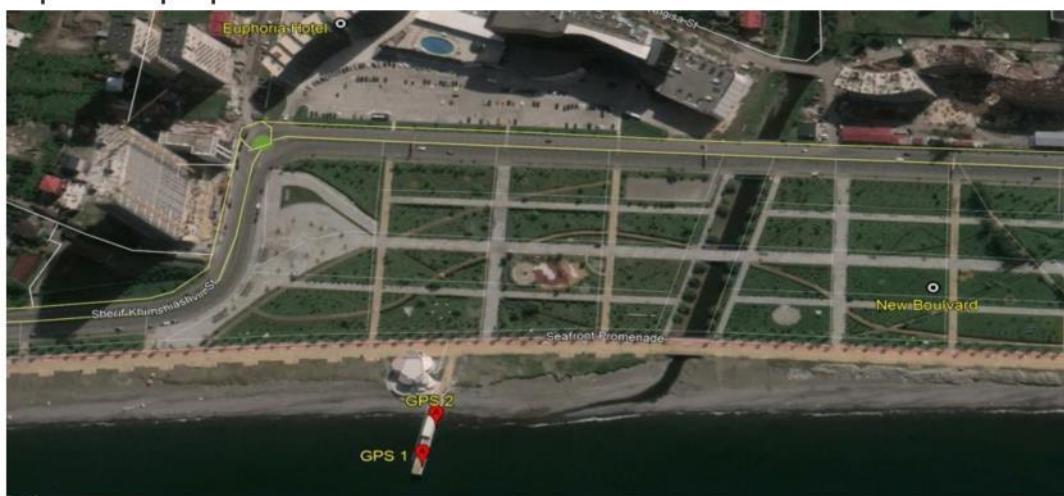
#### Map with samples points:

Based on the results of the tests conducted in two places GPS 1: (X= 716483; Y= 4611964) & GPS 2: (X= 716503; Y= 4611938), Monitoring water turbidity level are under the norm of UKTAG standard.

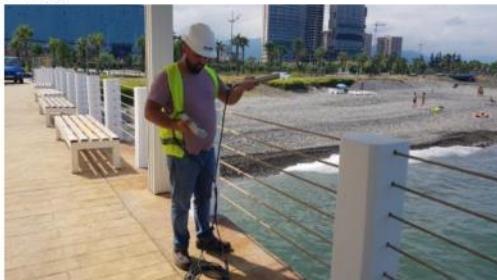
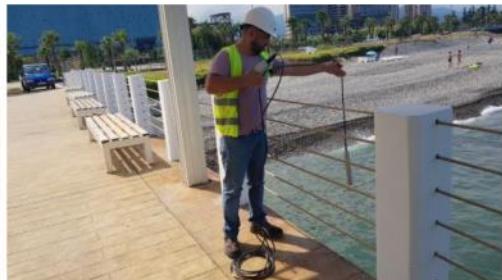
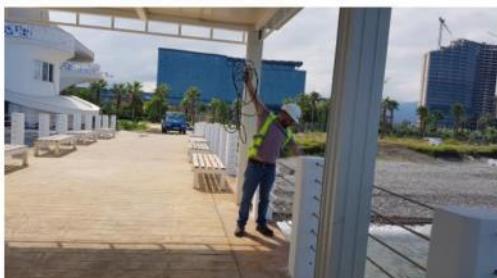
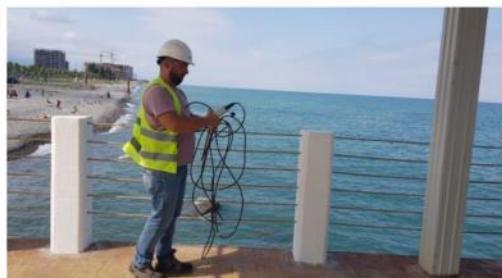
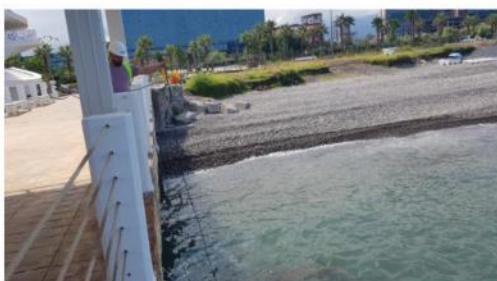
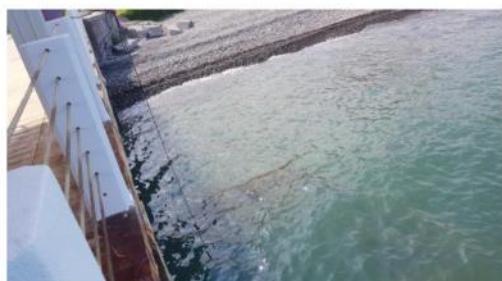
Photos:

Based on the results of the tests conducted in two places GPS 1: (X= 716510; Y= 4611927) & GPS 2: (X= 716477; Y= 4611965), Monitoring water turbidity level are under the norm of UKTAG standard.

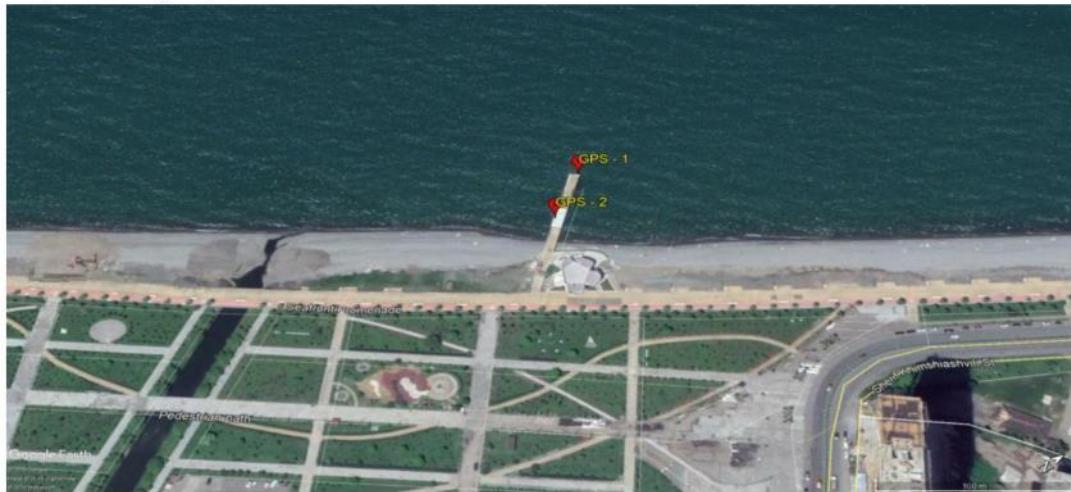
#### Map with samples points:

N1	Location	Measured Parameters	Unit	Results	Method
1	GPS 1: (X= 716480; Y= 4611971)	Suspended Solids	mg/L	37.49	Photometric

N1	Location	Measured Parameters	Unit	Results	Method
2	GPS 2: (X= 716502; Y= 4611938)	Suspended Solids	mg/L	36.17	Photometric

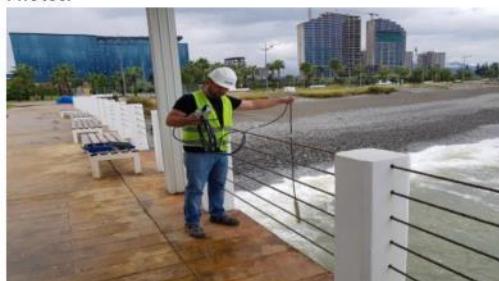
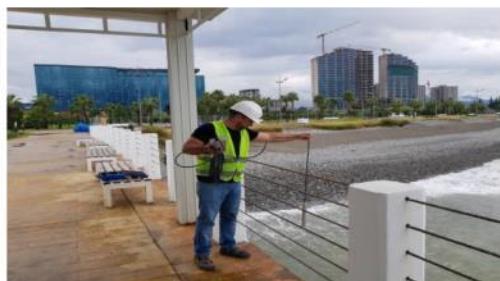
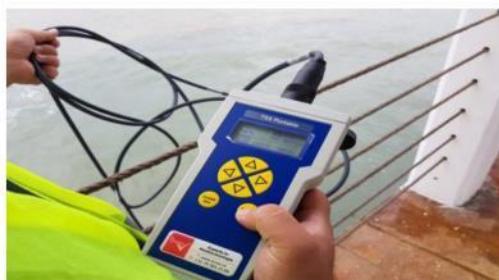
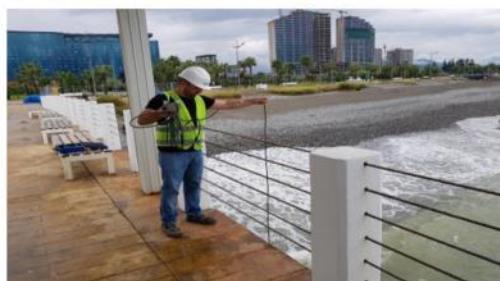
Photos:

Based on the results of the tests conducted in two places GPS 1: (X= 716480; Y= 4611971) & GPS 2: (X= 716502; Y= 4611938), Monitoring water turbidity level are under the norm of UKTAG standard.

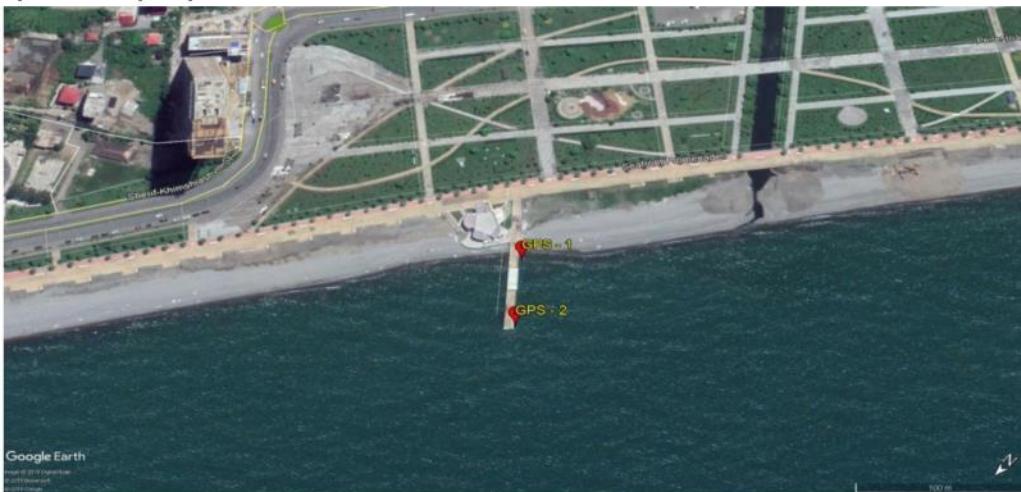
### Map with samples points:

N1	Location	Measured Parameters	Unit	Results	Method
1	GPS 1: (X= 716509; Y= 4611926)	Suspended Solids	mg/L	34.12	Photometric

N1	Location	Measured Parameters	Unit	Results	Method
2	GPS 2: (X=716477; Y= 4611965)	Suspended Solids	mg/L	38.43	Photometric

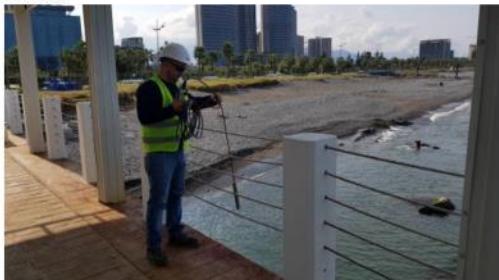
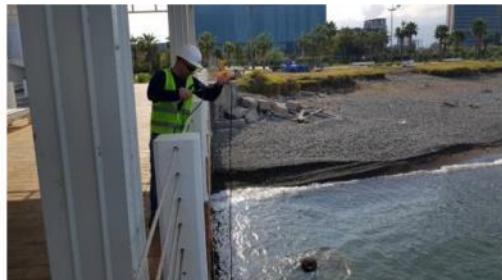
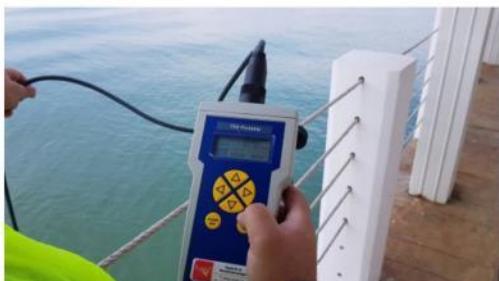
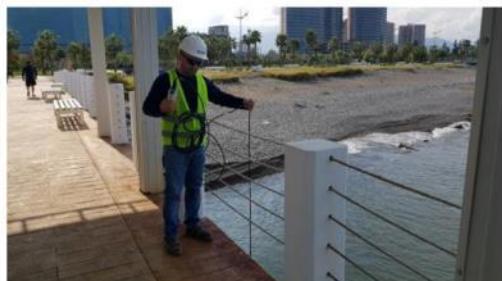
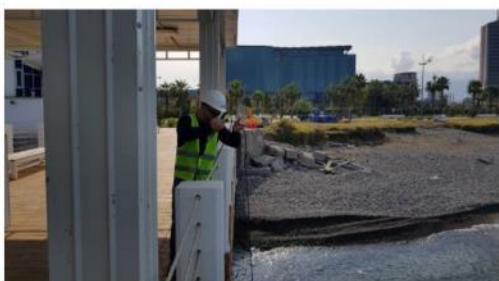
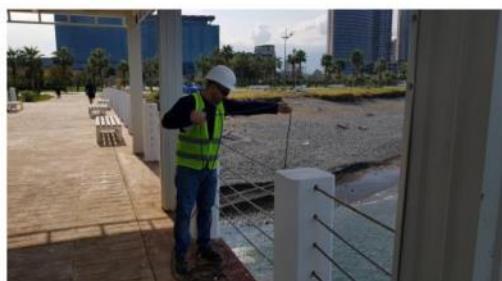
Photos:

Based on the results of the tests conducted in two places GPS 1: (X= 716509; Y= 4611926) & GPS 2: (X=716477; Y= 4611965), Monitoring water turbidity level are under the norm of UKTAG standard.

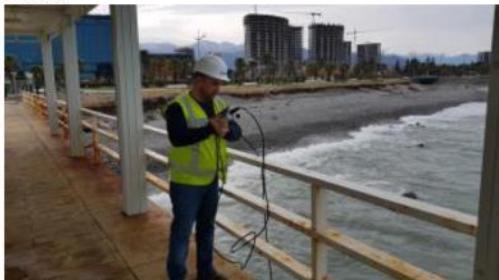
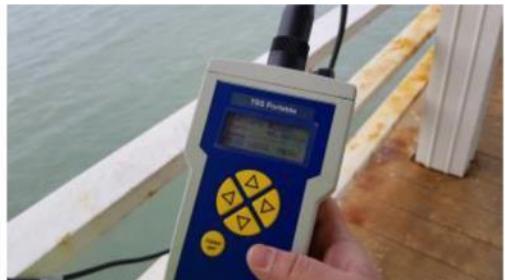
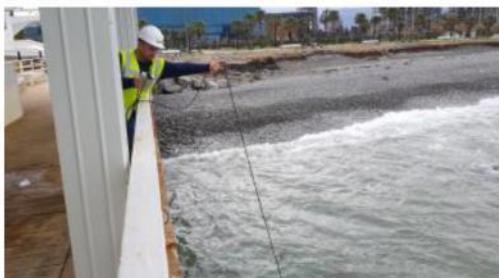
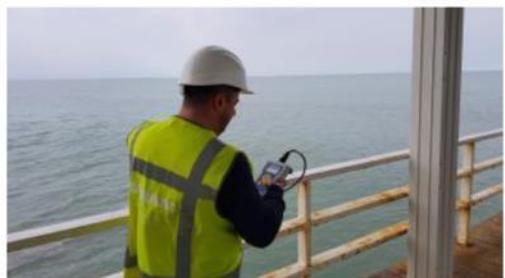
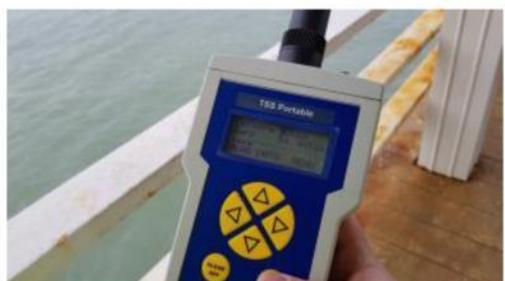
Photos:

Based on the results of the tests conducted in two places GPS 1: (X= 716502; Y= 4611932) & GPS 2: (X=716495; Y= 4611959), Monitoring water turbidity level are under the norm of UKTAG standard.

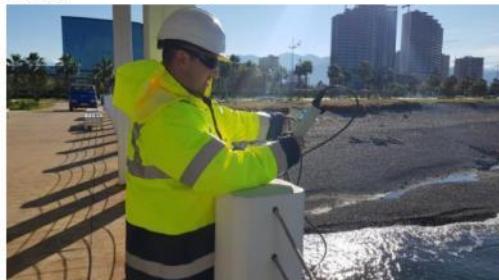
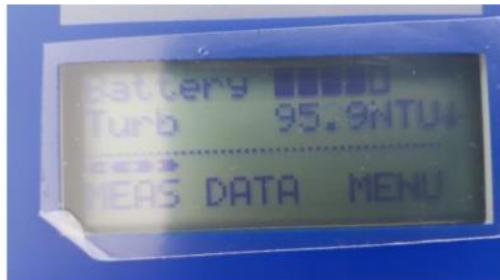
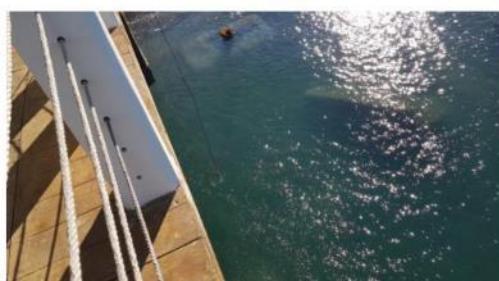
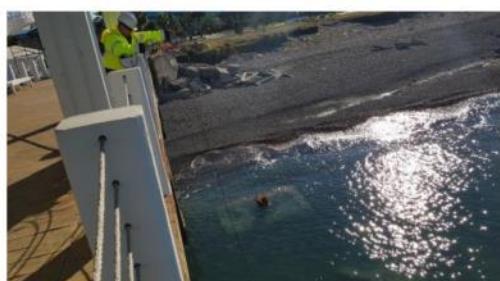
Photos:

Based on the results of the tests conducted in two places GPS 1: (X= 716498; Y= 4611937) & GPS 2: (X=716475; Y= 4611964), Monitoring water turbidity level are under the norm of UKTAG standard.

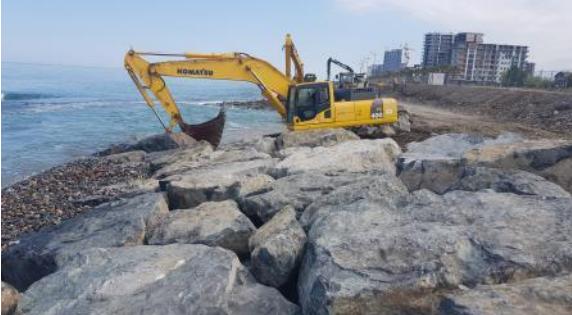
1 – Formation of rocks on site (3-7 tones)

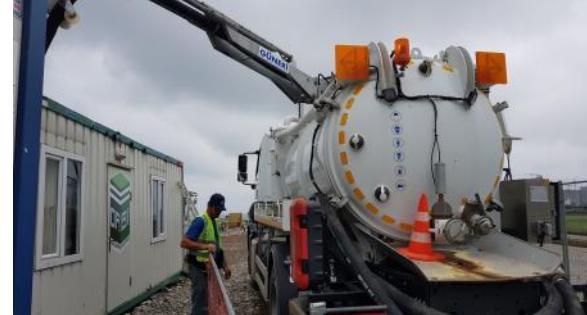
2 – Pumping of WC with special municipal car

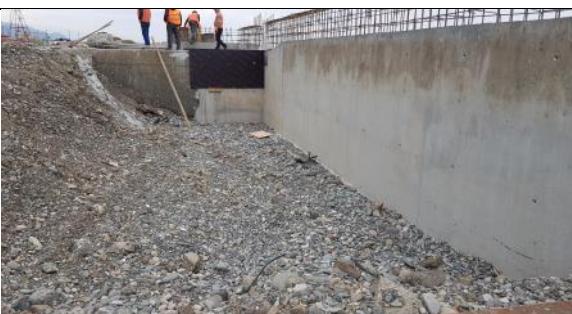
3 – Housekeeping are conducted on daily bases

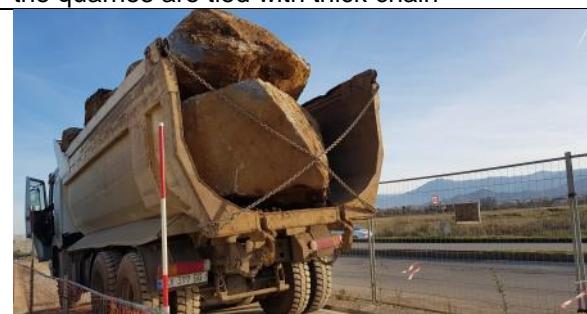
4 – All trucks during transportation of rocks from the quarries are tied with thick chain

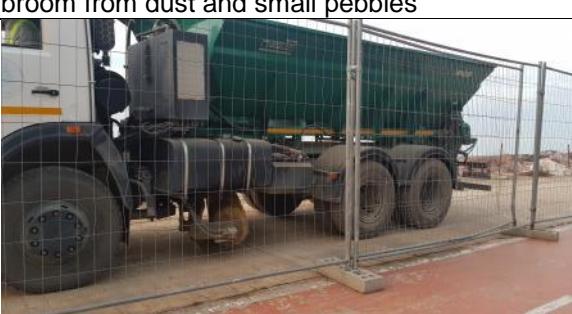
5 – Cleaning process with special municipal broom from dust and small pebbles

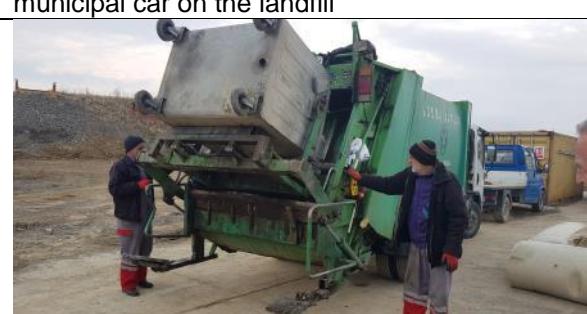
6 – Household waste taken process with municipal car on the landfill

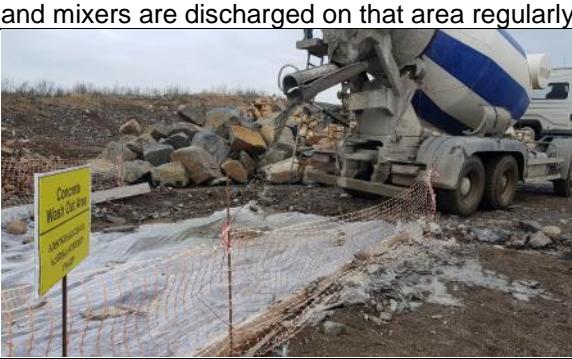
7 – Concrete washout pit was arranged on site and mixers are discharged on that area regularly

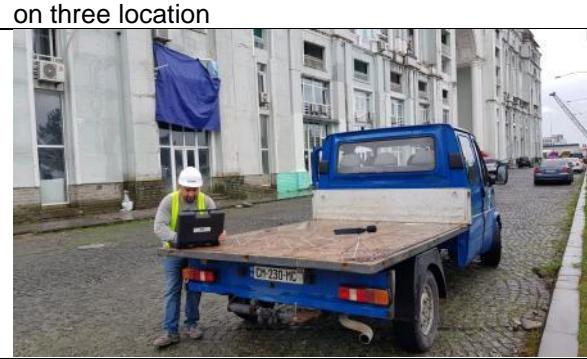
8 – Regular testing process for noise monitoring on three location
