Semi-annual Environmental Monitoring Report

Reporting period: July-December 2018

GEORGIA: SUSTAINABLE URBAN TRANSPORT INVESTMENT PROGRAM, Tranche 3

1. This report represents the Semi - Annual Environmental Monitoring Review (SAEMR) for **Modernization of Tbilisi-Rustavi Section of the Tbilisi-Red Bridge (Azerbaijani Border) Road** (Section 2) project.
2. This report is the 4th EMR for the project.

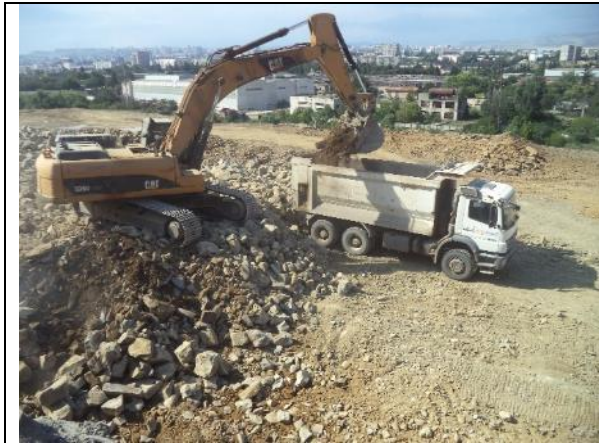
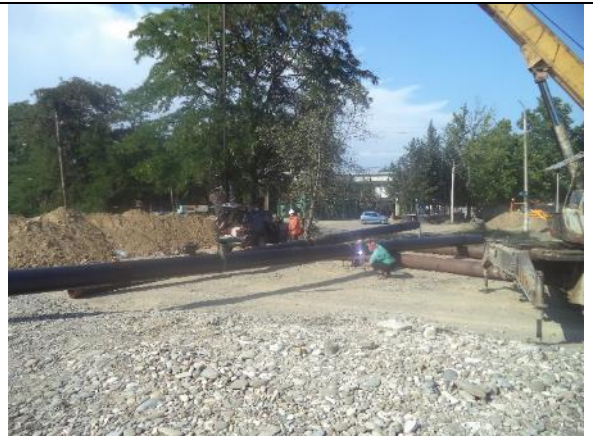
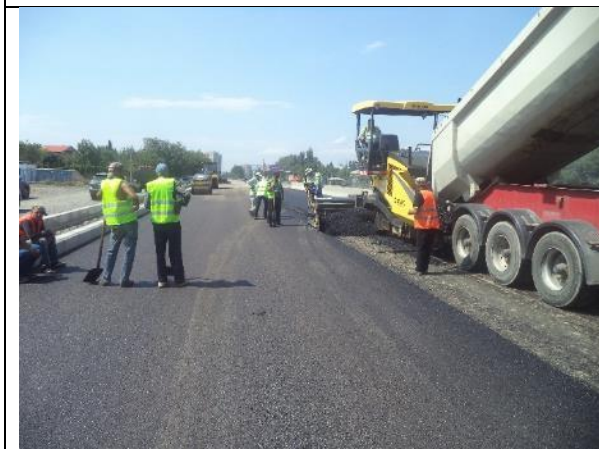
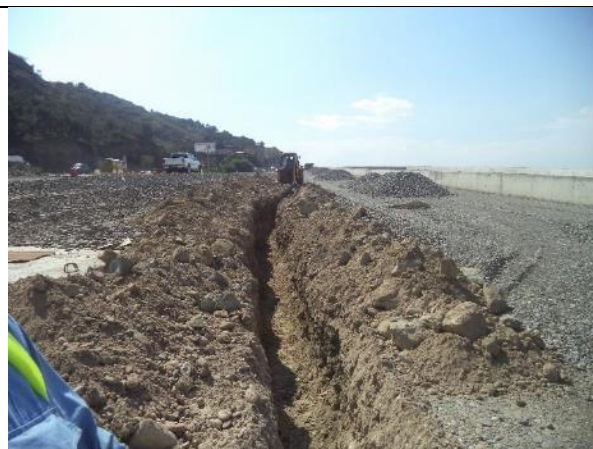
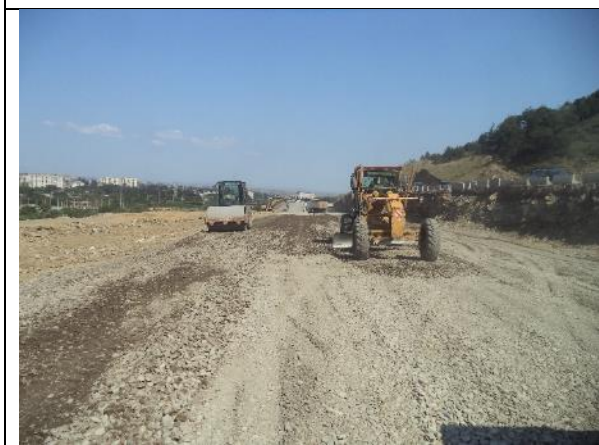
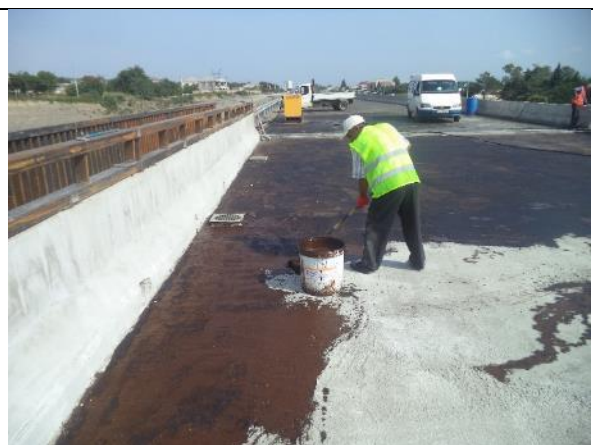
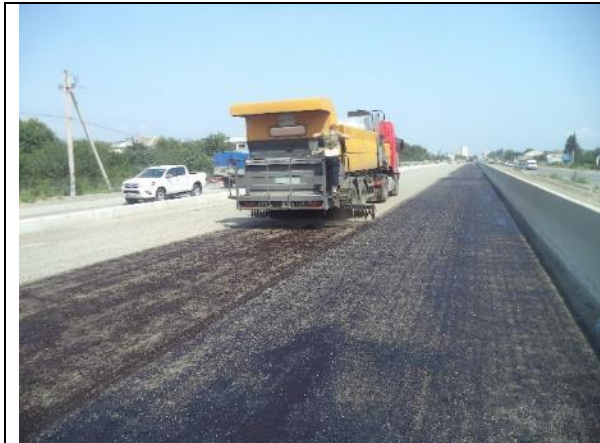
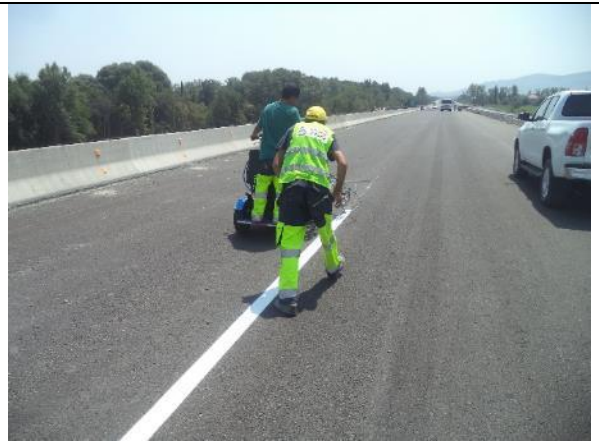
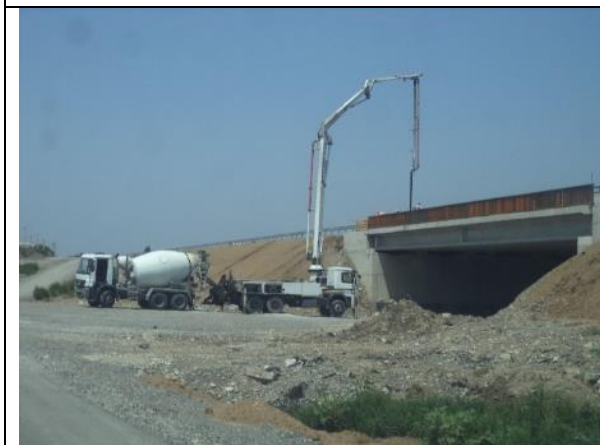
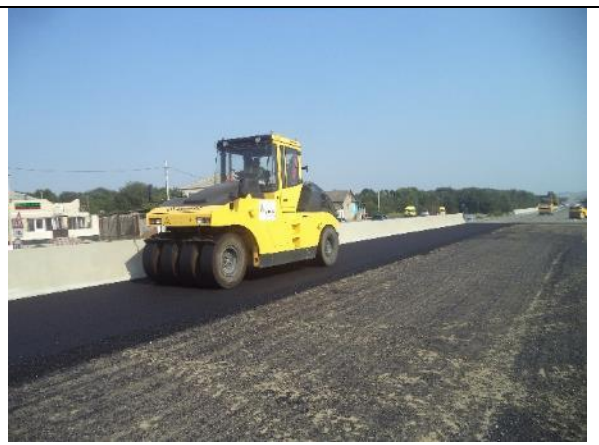
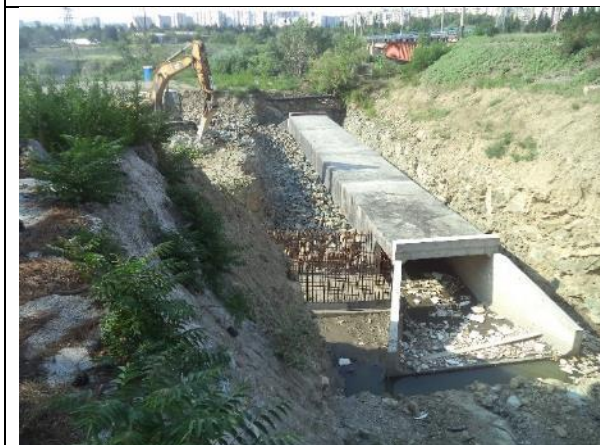
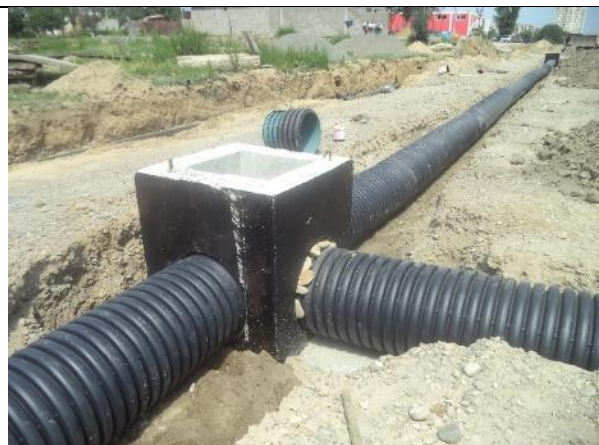
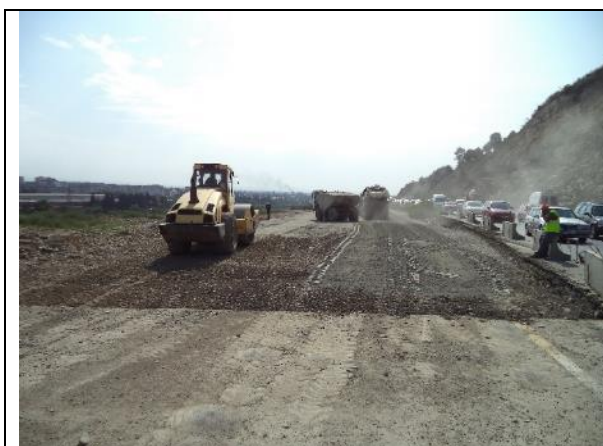
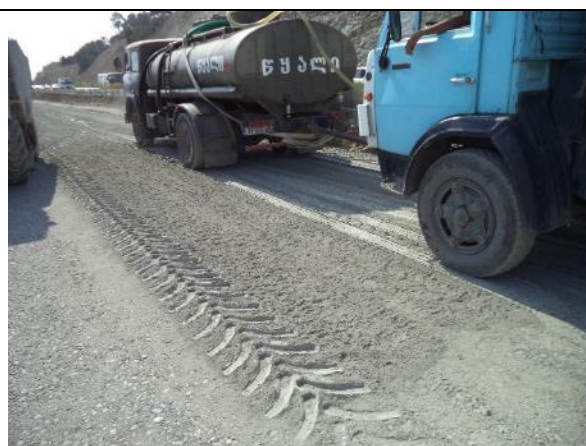
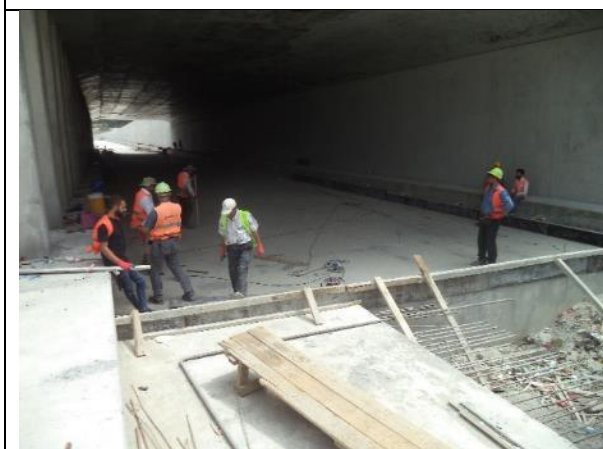
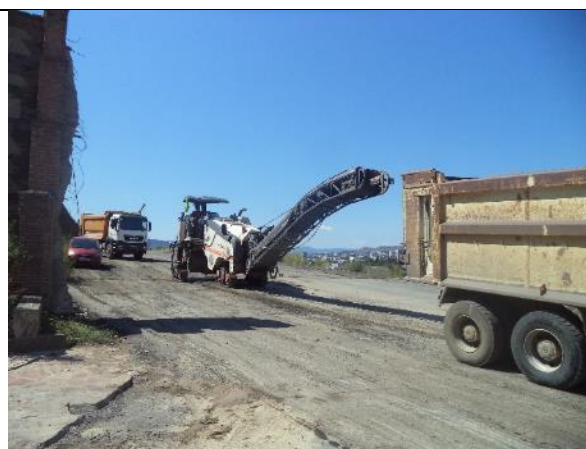
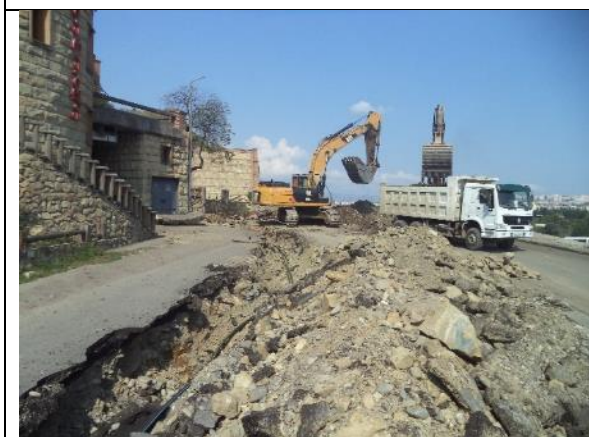
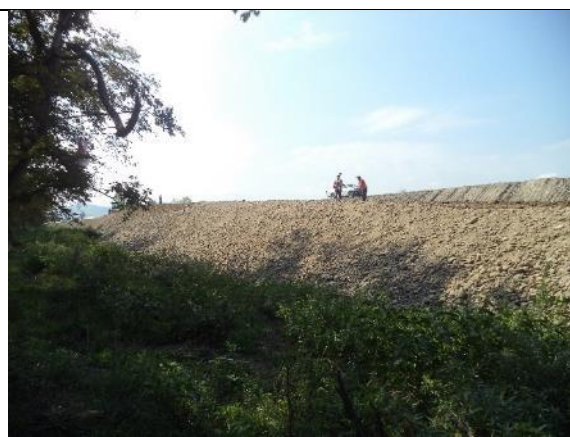
Table 3. Photographs of construction activities

- 25.** From PK 4+000 to 4+850 the Contractor completed excavation of rocky soil for the upper section of the U-type section of the tunnel. Now the contractor resumed construction activities for remaining part of U-type section of tunnel – assembling of steel cages and installation of forms is ongoing. Fully completed placement of wearing coarse for Bridge at PK 9+824, binder coarse is completely paved at the entire Interchange 2-2 (PK 98+24) adjacent roads, ramps and circles, installation of steel guard rails is completed as well.

27. From PK 8+300 (over the constructed section of box culvert at PK 8+395) the Contractor continued placement of sub base and base layers for the Main Road. But from PK 8+400 to 9+840 – placement of asphalt binder coarse is completed. Construction of the retaining wall is still suspended at the section from PK 5+840 to PK 6+440. The Contractor arranged a temporary cofferdam to shift Mtkvari River aside from the construction area on approximately 30 m. For 3 Sections of retaining wall lean concrete was already placed and started assembling of steel reinforcement, but due to complain of local habitants all works are stopped and the Contractor left jobsite (The Engineer's letter to the Employer #DOHWA-RRMSD-II-M-177-18). Continued construction of "Ney Jersey" barrier from PK 8+798 to 9+810 – left section of the Main Road. The relocation of the existing internet cable at PK 8+395 is ongoing. Completed placement of concrete for "Ney Jersey" barrier construction from PK 8+400 to 9+810 – left section of the Main Road. The Contractor continued installation of the concrete curb stones at PK 80+00.

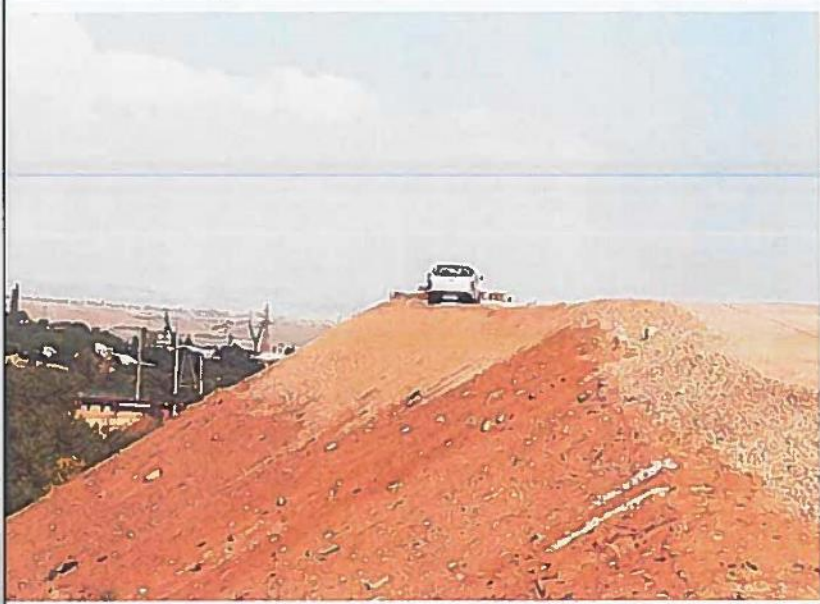
Roads Rehabilitation and Modernization Supervision Direction Ltd.	
NCR CODE / აქტის კოდი: NCR-044					
Attached Documents:/ მიბმული დოკუმენტაცია

N of NCR	Date of submission	Description of Non-Compliance	Area	Corrective action required	Performance Date of Corrective actions
1/44	09.08.18	Slopes of the embankment were covered by top soil layer. The Contractor has covered top soil by gravel.	PK4.500	Protect top soil from mixture with sub soil and gravel according EIA requirements	15.08.18
2/45	04.09.18	Oil was leaking from heavy equipment	PK6.300	Bring all equipment, working on site in condition, considered by LSEMP requirements	10.09.18

STEP 2: REMEDY/ ეტაპი 2 : გამოსწორების საშუალება	REMEDIAL WORKS PROPOSAL / CORRECTION: აღდგენითი/გამოსასწორებელი სამუშაოები:		Remove gravel from the slope		REPAIR/შეკეთება <input type="checkbox"/> DEMOLISH / REJECT/დემონტაჟი /უარყოფა <input type="checkbox"/> USE "AS IS"/ არსებულის დატოვება
	CLOSURE DATE:/დახურვის თარიღი				
	CORRECTIVE ACTION (to avoid recurrence):/ გამოსასწორებელი ქმედებები(განმეორების თავიდან ასაცილებლად):		Protect top soil from mixture with sub soil and gravel according EIA requirements		
	REVIEW by DESIGNER (if requires):დამპროექტებლის კომენტარი (საჭიროების შემთხვევაში):				
Name:/ სახელი	Paata Chankotadze	Position:/ პოზიცია	HSE specialist	Date:/ თარიღი	09.08.2018

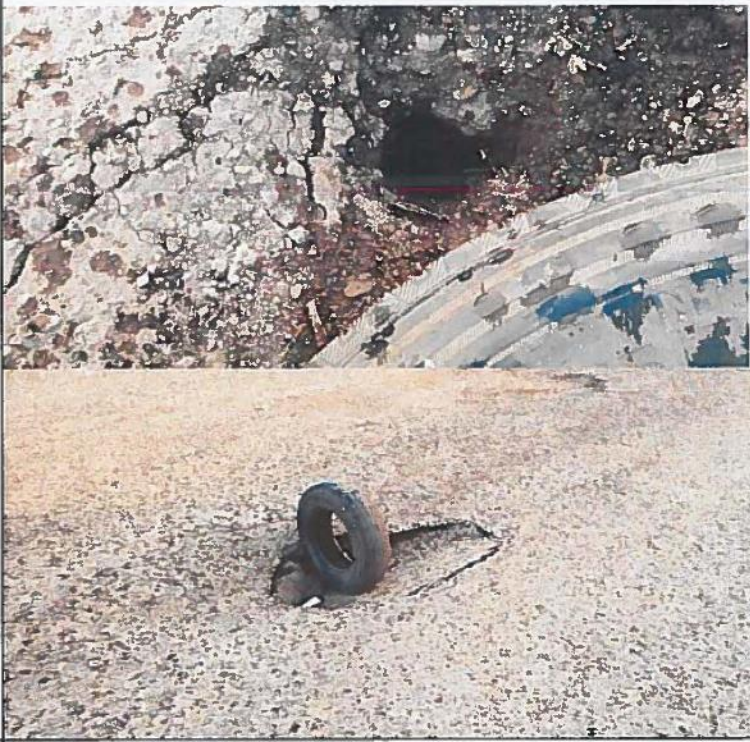
Roads Rehabilitation and Modernization Supervision Direction Ltd.	
NCR CODE / აქტის კოდი: NCR-047					
Attached Documents:/ მიბმული დოკუმენტაცია

Roads Rehabilitation and Modernization Supervision Direction Ltd.	
NCR CODE / აქტის კოდი: NCR-047					
STEP 1 : IDENTIFICATION/ეტაპი 1: იდენტიფიკაცია	REQUESTING PARTY / მომთხოვნი მხარე				
	Company: / კომპანია Dohwa		Department: / დეპარტამენტი HSE specialist		
	Name: / სახელი Paata Chankotadze		Date: / თარიღი 05.09.2018		
	NON-CONFORMANCE / შეუსაბამობა				
	Works Concerned / Location / Section: / შეუსაბამო სამუშაოს მდებარეობა/შონაკვეთი PK6.3				
	REQUIREMENT(S) / References: / მოთხოვნები/ მითითებები LSEMP: Item 5- ·Maximum rehabilitation of road sections damaged in the construction process; ·In case of complaints, it shall be recorded and adequately responded.				
DESCRIPTION OF NON-CONFORMANCE: / შეუსაბამობის აღწერილობა Access road to PK6.3 was damaged during movement of heavy trucks; underground water pipe was damaged and water is washing soil under asphalt layer and leaking in to the underground workshop pit; There is potential hazard of damaging of underground power cable

STEP 2: REMEDY/ ეტაპი 2 : გამოსწორების საშუალება	REMEDIAL WORKS PROPOSAL / CORRECTION: აღდგენითი/გამოსასწორებელი სამუშაოები:	Immediately repair damaged water pipe and bring access road to preconstruction condition		REPAIR/შეკეთება <input checked="" type="checkbox"/> DEMOLISH / REJECT/დემონტაჟი /უარყოფა	
	CLOSURE DATE: /დახურვის თარიღი			<input type="checkbox"/> USE "AS IS" / არსებულის დატოვება	
	CORRECTIVE ACTION (to avoid recurrence): / გამოსასწორებელი ქმედებები(განმეორების თავიდან ასაცილებლად):

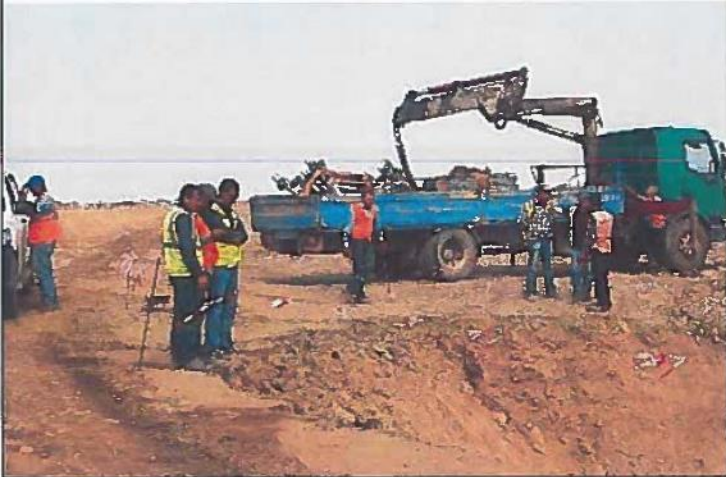
Roads Rehabilitation and Modernization Supervision Direction Ltd.		
NCR CODE / აქტის კოდი: NCR-048						
STEP 2: REMEDY / ეტაპი 2 : გამოსწორების საშუალება	Attached Documents: / მიბმული დოკუმენტაცია

Roads Rehabilitation and Modernization Supervision Direction Ltd.	
NCR CODE / აქტის კოდი: NCR-048					
STEP 1 : IDENTIFICATION/ეტაპი 1: იდენტიფიკაცია	REQUESTING PARTY / მომთხოვნის მხარე				
	Company: / კომპანია Dohwa		Department: / დეპარტამენტი HSE specialist		
	Name: / სახელი Paata Chankotadze		Date: / თარიღი 04.09.2018		
	NON-CONFORMANCE / შეუსაბამობა				
	Works Concerned / Location / Section: / შეუსაბამო სამუშაოს მდებარეობა/შონაკვეთი PK4.5				
	REQUIREMENT(S) / References: / მოთხოვნები/ მითითებები HS plan All workers and visitors should wear PPE on construction sites				
DESCRIPTION OF NON-CONFORMANCE: / შეუსაბამობის აღწერილობა Not one of the workers and foremen was not wearing a helmets on site					
POSSIBLE ROOT CAUSE: / შეუსაბამოის წარმოშობის შესაძლო მიზეზები.		<input type="checkbox"/> Material / მასალა <input type="checkbox"/> Manpower / მუშახელი <input type="checkbox"/> Design / პროექტი <input checked="" type="checkbox"/> Method / მეთოდი <input type="checkbox"/> Process / პროცესი <input type="checkbox"/> Other / სხვა

REMEDIAL WORKS PROPOSAL / CORRECTION: აღდგენითი/გამოსასწორებელი სამუშაოები:		Provide relevant PPE for all workers and foremen		REPAIR/შეკეთება <input type="checkbox"/> DEMOLISH / REJECT/დემონტაჟი /უარყოფა	
	CLOSURE DATE: /დახურვის თარიღი				<input type="checkbox"/> USE "AS IS"/ არსებულის დატოვება	
	CORRECTIVE ACTION (to avoid recurrence): / გამოსასწორებელი ღონისძიებები (განმეორების თავიდან ასაცილებლად):		Conduct additional HS training for personnel			
	REVIEW by DESIGNER (if requires): დამპროექტებლის კომენტარი (საჭიროების შემთხვევაში):					
Name: / სახელი Paata Chankotadze		Position: / პოზიცია HSE specialist		Date: / თარიღი 04.09.2018	Signature: / ხელმოწერა

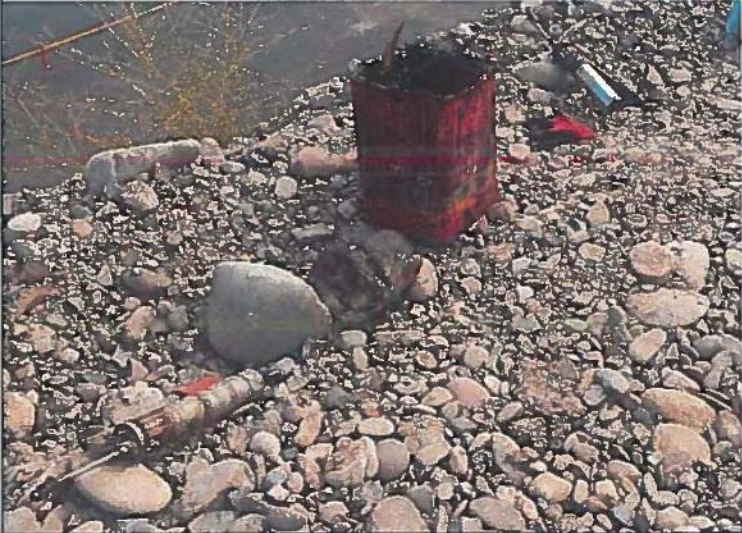
Roads Rehabilitation and Modernization Supervision Direction Ltd.	
NCR CODE / აქტის კოდი: NCR-049					
Attached Documents: / მიხმული დოკუმენტაცია

STEP 1 : IDENTIFICATION/ეტაპი 1: იდენტიფიკაცია	REQUESTING PARTY / მომთხოვნის მხარე		
	Company: / კომპანია Dohwa	Department: / დეპარტამენტი HSE specialist	
	Name: / სახელი Paata Chankotadze	Date: / თარიღი 05 09 2018	
	NON-CONFORMANCE / შეუსაბამობა		
	Works Concerned / Location / Section: / შეუსაბამო სამუშაოს მდებარეობა/მონაკვეთი PK4.5		
	REQUIREMENT(S) / References: / მოთხოვნები/ მითითებები	SEMP, Pollution prevention management plan Polluted tools and hazardous materials should be disposed in drip trays	
	DESCRIPTION OF NON-CONFORMANCE: / შეუსაბამობის აღწერილობა	Lubricants and polluted tools are disposed directly on ground	
	POSSIBLE ROOT CAUSE: / შეუსაბამობის წარმოშობის შესაძლო მიზეზები.	<div style="display: flex; justify-content: space-between;"> <div> <input type="checkbox"/> Material / მასალა <input type="checkbox"/> Manpower / მუშახელი <input type="checkbox"/> Design / პროექტი <input checked="" type="checkbox"/> Method / მეთოდი <input type="checkbox"/> Process / პროცესი <input type="checkbox"/> Other / სხვა </div> </div>

REMEDIAL WORKS PROPOSAL / CORRECTION: აღდგენითი/გამოსასწორებელი სამუშაოები:		Dispose all polluted tools and hazardous materials in drip trays		REPAIR/შეკეთება <input type="checkbox"/> DEMOLISH / REJECT/დემონტაჟი /უარყოფა <input type="checkbox"/> USE "AS IS"/ არსებულის დატოვება	
CLOSURE DATE: /დახურვის თარიღი					
CORRECTIVE ACTION (to avoid recurrence): გამოსასწორებელი ქმედებები(განმეორების თავიდან ასაცილებლად):		Conduct additional pollution prevention training for personnel			
REVIEW by DESIGNER (if requires): დამპროექტებლის კომენტარი (საჭიროების შემთხვევაში):					
Name: / სახელი Paata Chankotadze Position: / პოზიცია HSE specialist Date: / თარიღი 05.09.2018 Signature: / ხელმოწერა

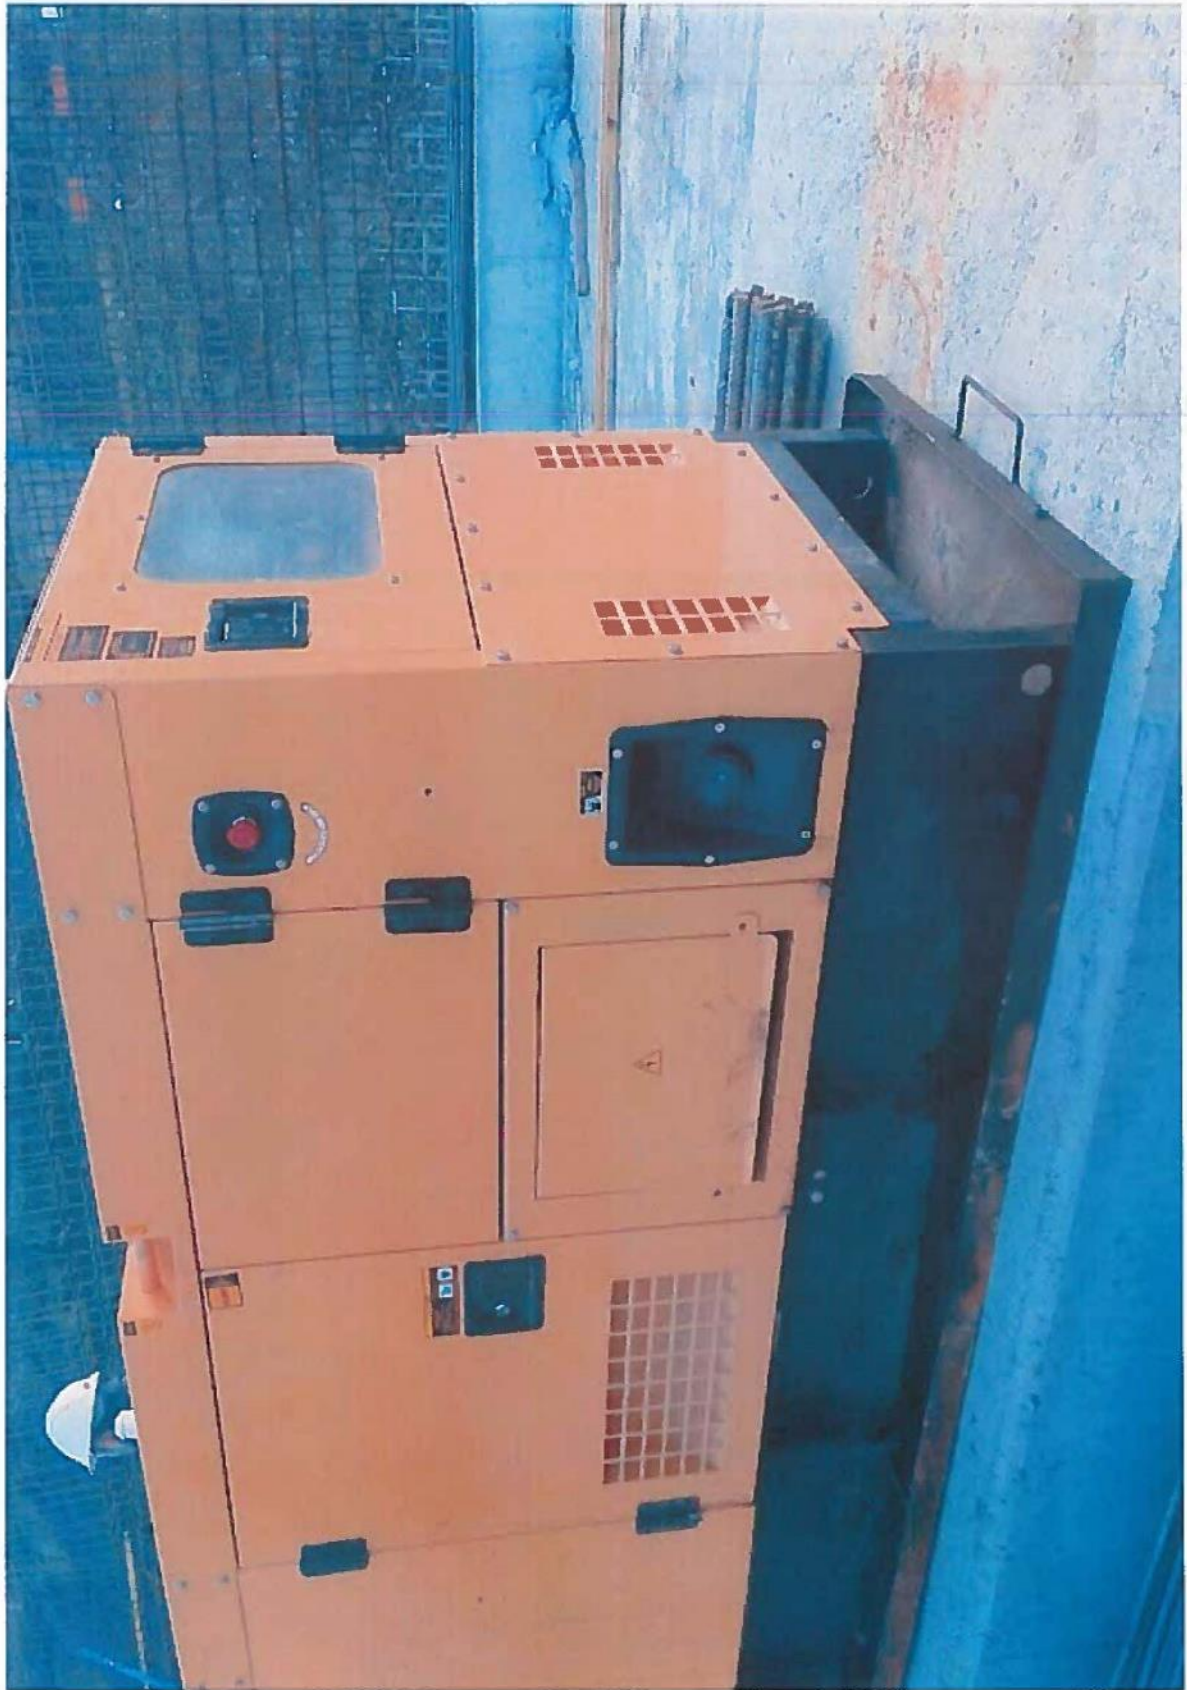
DOHWA Engineering Co., Ltd.	NON-CONFORMANCE REPORT / შეუსაბამობის აქტი	  Roads Rehabilitation and Modernization Supervision Direction Ltd.
NCR CODE / აქტის კოდი: NCR-052

STEP 1 : IDENTIFICATION/ეტაპი 1: იდენტიფიკაცია	REQUESTING PARTY / მომთხოვნის მხარე			
	Company: / კომპანია	Dohwa	Department: / დეპარტამენტი	HSE specialist
	Name: / სახელი	Paata Chankotadze	Date: / თარიღი	24.09.2018
	NON-CONFORMANCE / შეუსაბამობა			
	Works Concerned / Location / Section: / შეუსაბამო სამუშაოს მდებარეობა/მონაკვეთი	PK63		
	REQUIREMENT(S) / References: / მოთხოვნები/ მითითებები	SEMP, Pollution prevention management plan Diesel generators should be disposed in drip trays		
	DESCRIPTION OF NON-CONFORMANCE: / შეუსაბამობის აღწერილობა	Leaking diesel generator is disposed directly on ground, without drip trays, in the vicinity of riv. Mtkvari		
	POSSIBLE ROOT CAUSE: / შეუსაბამობის წარმოშობის შესაძლო მიზეზები.	<input type="checkbox"/> Material / მასალა <input type="checkbox"/> Manpower / მუშახელი <input type="checkbox"/> Design / პროექტი <input checked="" type="checkbox"/> Method / მეთოდი <input type="checkbox"/> Process / პროცესი <input type="checkbox"/> Other / სხვა

Site Inspector/ ზედამხედველი	The Contractor/ მშენებელი	The Engineer / ინჟინერი
Comments: კომენტარი	P. Chankobadze	necessary actions have been taken	closed
Name: /სახელი	Approved	A Akbulut	S. H. Miron
Date: /თარიღი	30.09.2018	28.09.2018	2018.10.28
Signature: /ხელმოწერა

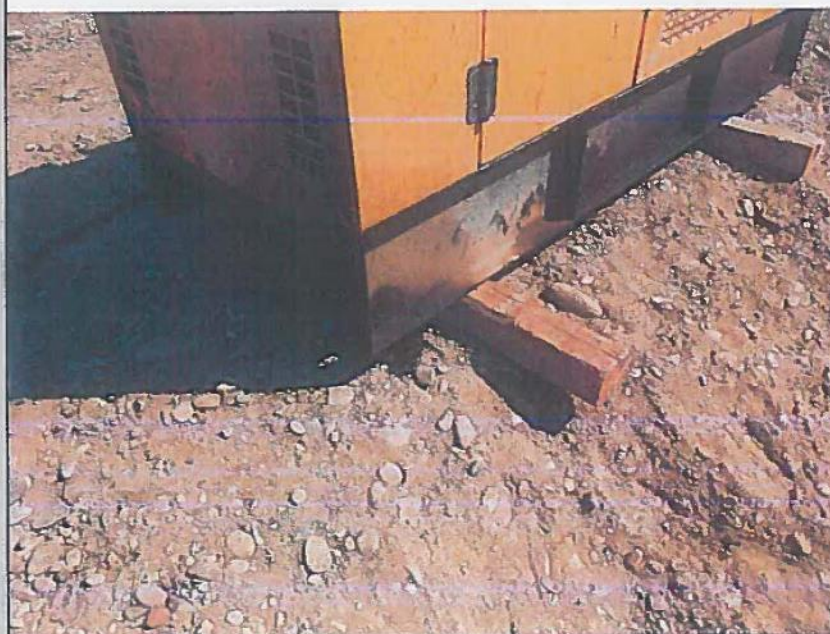
NCR CODE / აქტის კოდი: NCR-052

8/52	24.09.18	Leaking diesel generator was disposed directly on ground, without drip trays, in the vicinity of riv. Mtkvari	PK6.300	Dispose all diesel generators in drip trays	28.09.18
9/53	24.09.18	Containers with hazardous materials and polluted tools were disposed on ground, without drip trays, in the vicinity of riv. Mtkvari	PK6.300	Dispose all polluted tools and hazardous materials in drip trays	28.09.18
10/57	31.10.18	No one from workers and visitors did not equipped with relevant PPE on site	PK4.500	Provide relevant PPE for all workers and visitors	12.11.18

STEP 2: REMEDY / ეტაპი 2: გამოსწორების საშუალება	REMEDIAL WORKS PROPOSAL / CORRECTION: აღდგენითი/გამოსასწორებელი სამუშაოები:	Dispose all diesel generators in drip trays	REPAIR/შეკეთება <input type="checkbox"/> DEMOLISH / REJECT/დემონტაჟი/უარყოფა <input type="checkbox"/> USE "AS IS"/არსებულის დატოვება								
	CLOSURE DATE:/დახურვის თარიღი										
	CORRECTIVE ACTION (to avoid recurrence):/გამოსასწორებელი ქმედებები(განმეორების თავიდან ასაცილებლად):	Conduct additional pollution prevention training for personnel									
REVIEW by DESIGNER (if requires): დამპროექტებლის კომენტარი (საჭიროების შემთხვევაში):											
<table border="1" style="width: 100%; border-collapse: collapse;"> <tr> <td style="width: 15%;">Name:/სახელი</td> <td style="width: 20%;">Paata Chankotadze</td> <td style="width: 15%;">Position:/პოზიცია</td> <td style="width: 15%;">HSE specialist</td> <td style="width: 15%;">Date:/თარიღი</td> <td style="width: 15%;">24.09.2018</td> <td style="width: 20%;">Signature:/ხელმოწერა</td> <td style="width: 10%;"></td> </tr> </table>				Name:/სახელი	Paata Chankotadze	Position:/პოზიცია	HSE specialist	Date:/თარიღი	24.09.2018	Signature:/ხელმოწერა

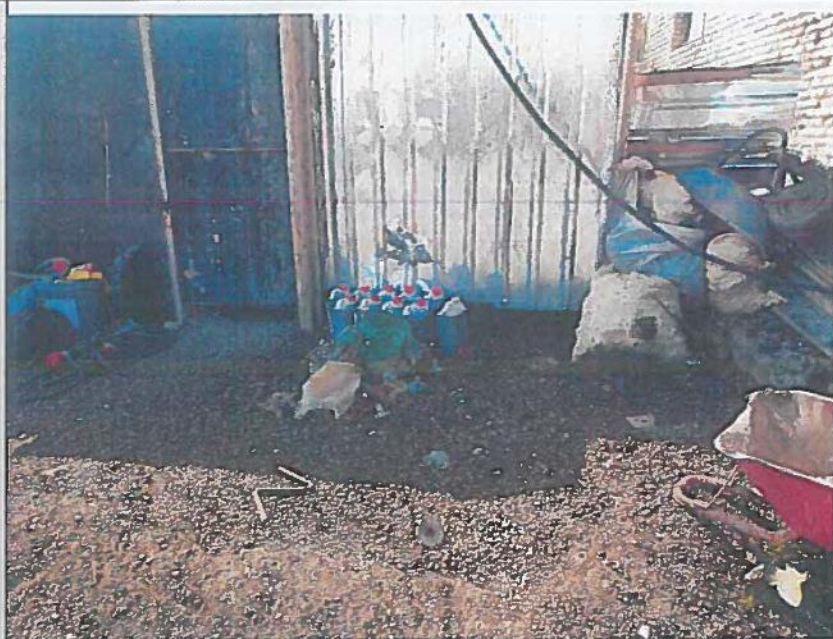
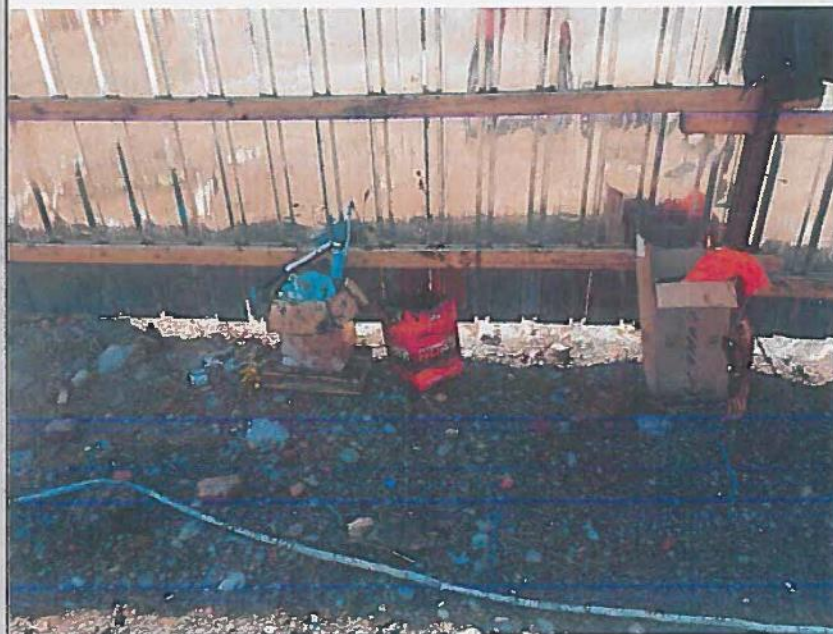
Roads Rehabilitation and Modernization Supervision Direction Ltd.	
NCR CODE / აქტის კოდი: NCR-053					
STEP 1 : IDENTIFICATION/ეტაპი 1: იდენტიფიკაცია	REQUESTING PARTY / მომთხოვნი მხარე				
	Company: / კომპანია Dohwa		Department: / დეპარტამენტი HSE specialist		
	Name: / სახელი Paata Chankotadze		Date: / თარიღი 24.09.2018		
	NON-CONFORMANCE / შეუსაბამობა				
	Works Concerned / Location / Section: / შეუსაბამო სამუშაოს მდებარეობა/მოწაკვეთი PK63				
	REQUIREMENT(S) / References: / მოთხოვნები/ მითითებები		SEMP, Pollution prevention management plan Containers with hazardous materials should be disposed in drip trays		
DESCRIPTION OF NON-CONFORMANCE: / შეუსაბამობის აღწერილობა		Containers with hazardous materials and polluted tools are disposed on ground, without drip trays, in the vicinity of riv. Mtkvari			
POSSIBLE ROOT CAUSE: / შეუსაბამობის წარმოშობის შესაძლო მიზეზები.		<div style="display: flex; justify-content: space-between;"> <div> <input type="checkbox"/> Material / მასალა <input type="checkbox"/> Manpower / მუშახელი <input type="checkbox"/> Design / პროექტი <input checked="" type="checkbox"/> Method / მეთოდი <input type="checkbox"/> Process / პროცესი <input type="checkbox"/> Other / სხვა </div> </div>

STEP 2: REMEDY / ეტაპი 2 : გამოსწორების საშუალება	REMEDIAL WORKS PROPOSAL / CORRECTION: აღდგენითი/გამოსასწორებელი სამუშაოები:	Dispose all polluted tools and containers with hazardous materials in drip trays	<input checked="" type="checkbox"/> REPAIR/შეკეთება <input type="checkbox"/> DEMOLISH / REJECT/დემონტაჟი /გარყვანა <input type="checkbox"/> USE "AS IS" / არსებულის დატოვება								
	CLOSURE DATE:/დახურვის თარიღი										
	CORRECTIVE ACTION (to avoid recurrence):/ გამოსასწორებელი ქმედებები(განმეორების თავიდან ასაცილებლად):	Conduct additional pollution prevention training for personnel									
REVIEW by DESIGNER (if requires): დამპროექტებლის კომენტარი (საჭიროების შემთხვევაში):											
<table border="1" style="width: 100%; border-collapse: collapse;"> <tr> <td style="width: 15%;">Name:/სახელი</td> <td style="width: 20%;">Paata Chankotadze</td> <td style="width: 15%;">Position:/პოზიცია</td> <td style="width: 15%;">HSE specialist</td> <td style="width: 15%;">Date:/თარიღი</td> <td style="width: 15%;">24.09.2018</td> <td style="width: 20%;">Signature:/ხელმოწერა</td> <td style="width: 10%;"></td> </tr> </table>				Name:/სახელი	Paata Chankotadze	Position:/პოზიცია	HSE specialist	Date:/თარიღი	24.09.2018	Signature:/ხელმოწერა

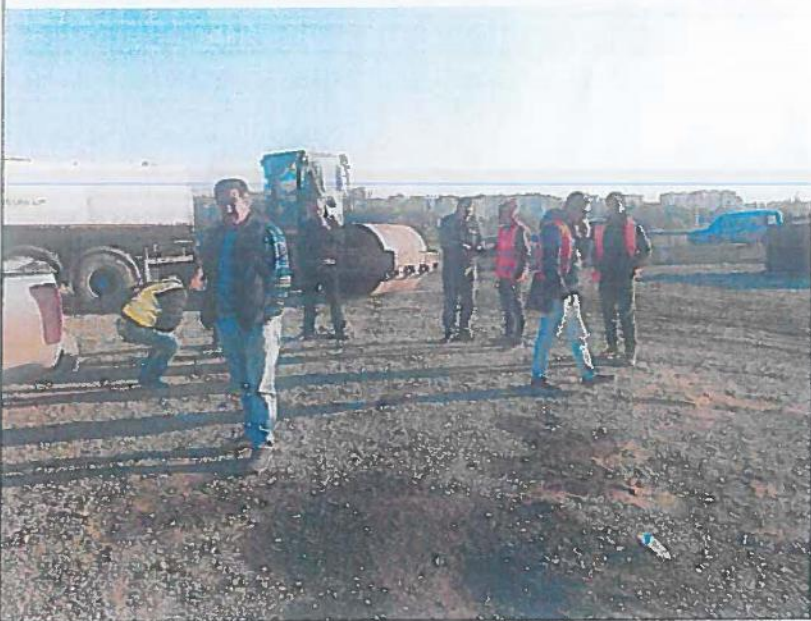
Roads Rehabilitation and Modernization Supervision Direction Ltd.	
NCR CODE / აქტის კოდი: NCR-057					
Attached Documents / მიბმული დოკუმენტაცია

Roads Rehabilitation and Modernization Supervision Direction Ltd	
NCR CODE / აქტის კოდი: NCR-057					
STEP 1 : IDENTIFICATION/გაბი 1: იდენტიფიკაცია	REQUESTING PARTY / მოთხოვნი მხარე				
	Company: / კომპანია Dohwa		Department: / დეპარტამენტი HSE specialist		
	Name: / სახელი Paata Chankotadze		Date: / თარიღი 31.10.2018		
	NON-CONFORMANCE / შეუსაბამობა				
	Works Concerned / Location / Section: / შეუსაბამო სამუშაოს მდებარეობა/მონაკვეთი PK45				
	REQUIREMENT(S) / References: / მოთხოვნები/ მითითებები HS plan All personnel and visitors should wear PPE on site ✓				
DESCRIPTION OF NON-CONFORMANCE / შეუსაბამობის აღწერილობა No one from workers and visitors did not equipped with relevant PPE on site					
POSSIBLE ROOT CAUSE: / შეუსაბამობის წარმოშობის შესაძლო მიზეზები.		<div style="display: flex; flex-direction: column; align-items: flex-end;"> <div style="display: flex; align-items: center; margin-bottom: 5px;"> <input type="checkbox"/> Material / მასალა </div> <div style="display: flex; align-items: center; margin-bottom: 5px;"> <input type="checkbox"/> Manpower / მუშახელი </div> <div style="display: flex; align-items: center; margin-bottom: 5px;"> <input type="checkbox"/> Design / პროექტი </div> <div style="display: flex; align-items: center; margin-bottom: 5px;"> <input checked="" type="checkbox"/> Method / მეთოდი </div> <div style="display: flex; align-items: center; margin-bottom: 5px;"> <input type="checkbox"/> Process / პროცესი </div> <div style="display: flex; align-items: center;"> <input type="checkbox"/> Other / სხვა </div> </div>

REMEDIAL WORKS PROPOSAL / CORRECTION: აღდგენითი/გამოსასწორებელი სამუშაოები:		Provide relevant PPE for all workers and visitors		REPAIR/შეკეთება <input type="checkbox"/> DEMOLISH / REJECT/დემონტაჟი /უარყოფა <input type="checkbox"/> USE "AS IS"/ არსებულის დატოვება	
CLOSURE DATE:/დახურვის თარიღი					
CORRECTIVE ACTION (to avoid recurrence):/ გამოსასწორებელი ემედეგები(განმეორების თავიდან ასაცილებლად):		Conduct additional HS training for personnel
