Project Number: P53118-001 LCIP

Reporting period: April - June 2022 N1 Semestral Report

GEORGIA: Livable Cities Investment Project for Balanced Regional Development

Prepared by: Municipal Development Fund (MDF) of Georgia for the Asian Development Bank

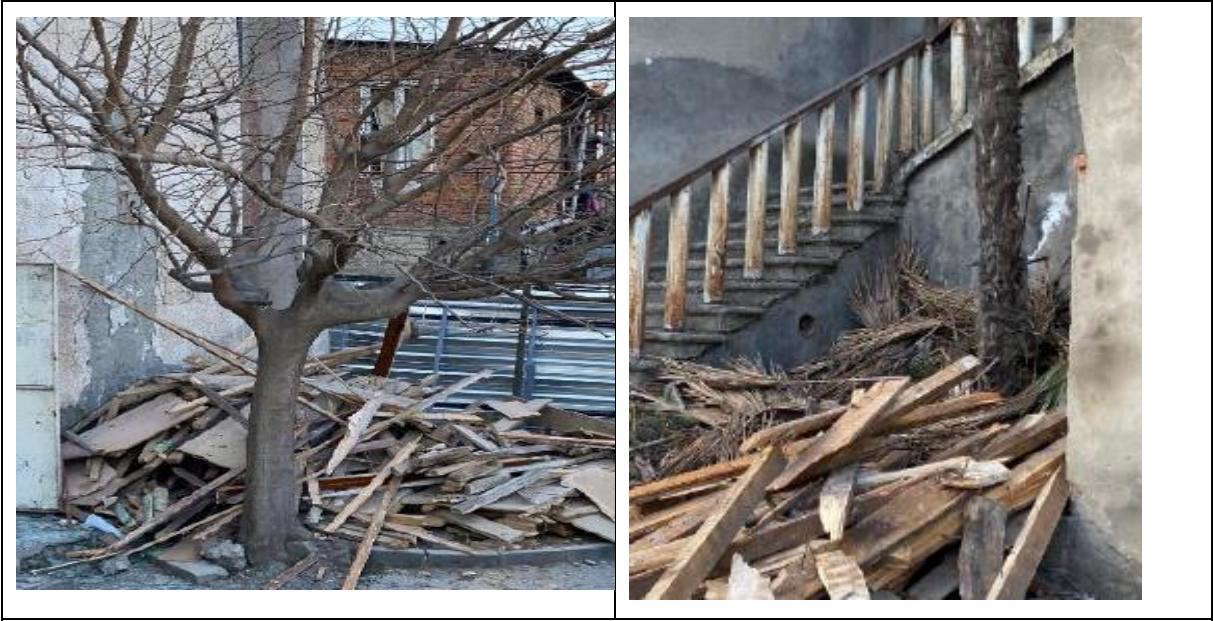
Table 5. General Non-compliances have been revealed during the reporting period

Trees at/nearby construction zone are not protected

The waste treatment facility territory was not fenced and supervisory consultant together with MDF recommended to fence the territory

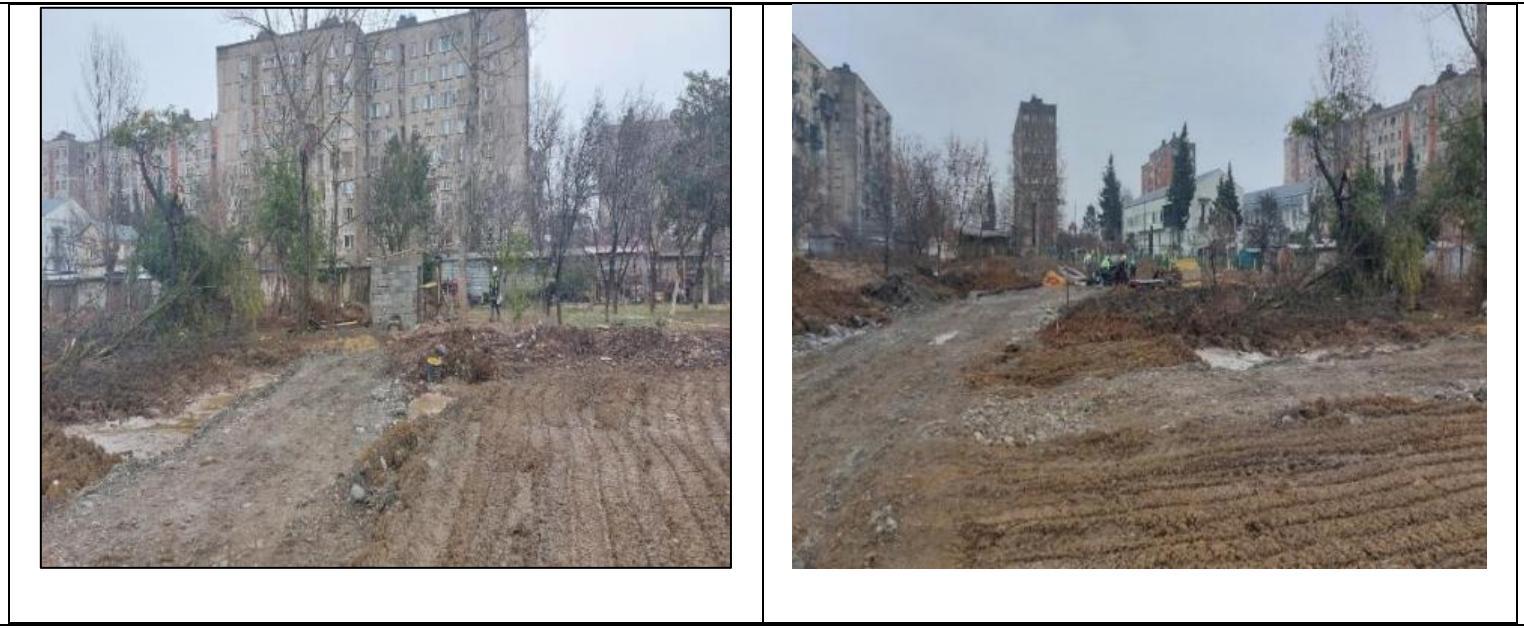
Non-compliance Notice

- Waste containers (Hazardous and Household) are not installed. Proper containers with relevant signs "HOUSEHOLD WASTE"/ "HAZARDOUS WASTE" should be installed at the construction territory. Hazardous Waste container with should be installed at the proper organized place with concrete floor and roofing

All these conditions have to be remedied within seven days (by the 20.04.22) by the prime Contractor (Satave+" LLC)

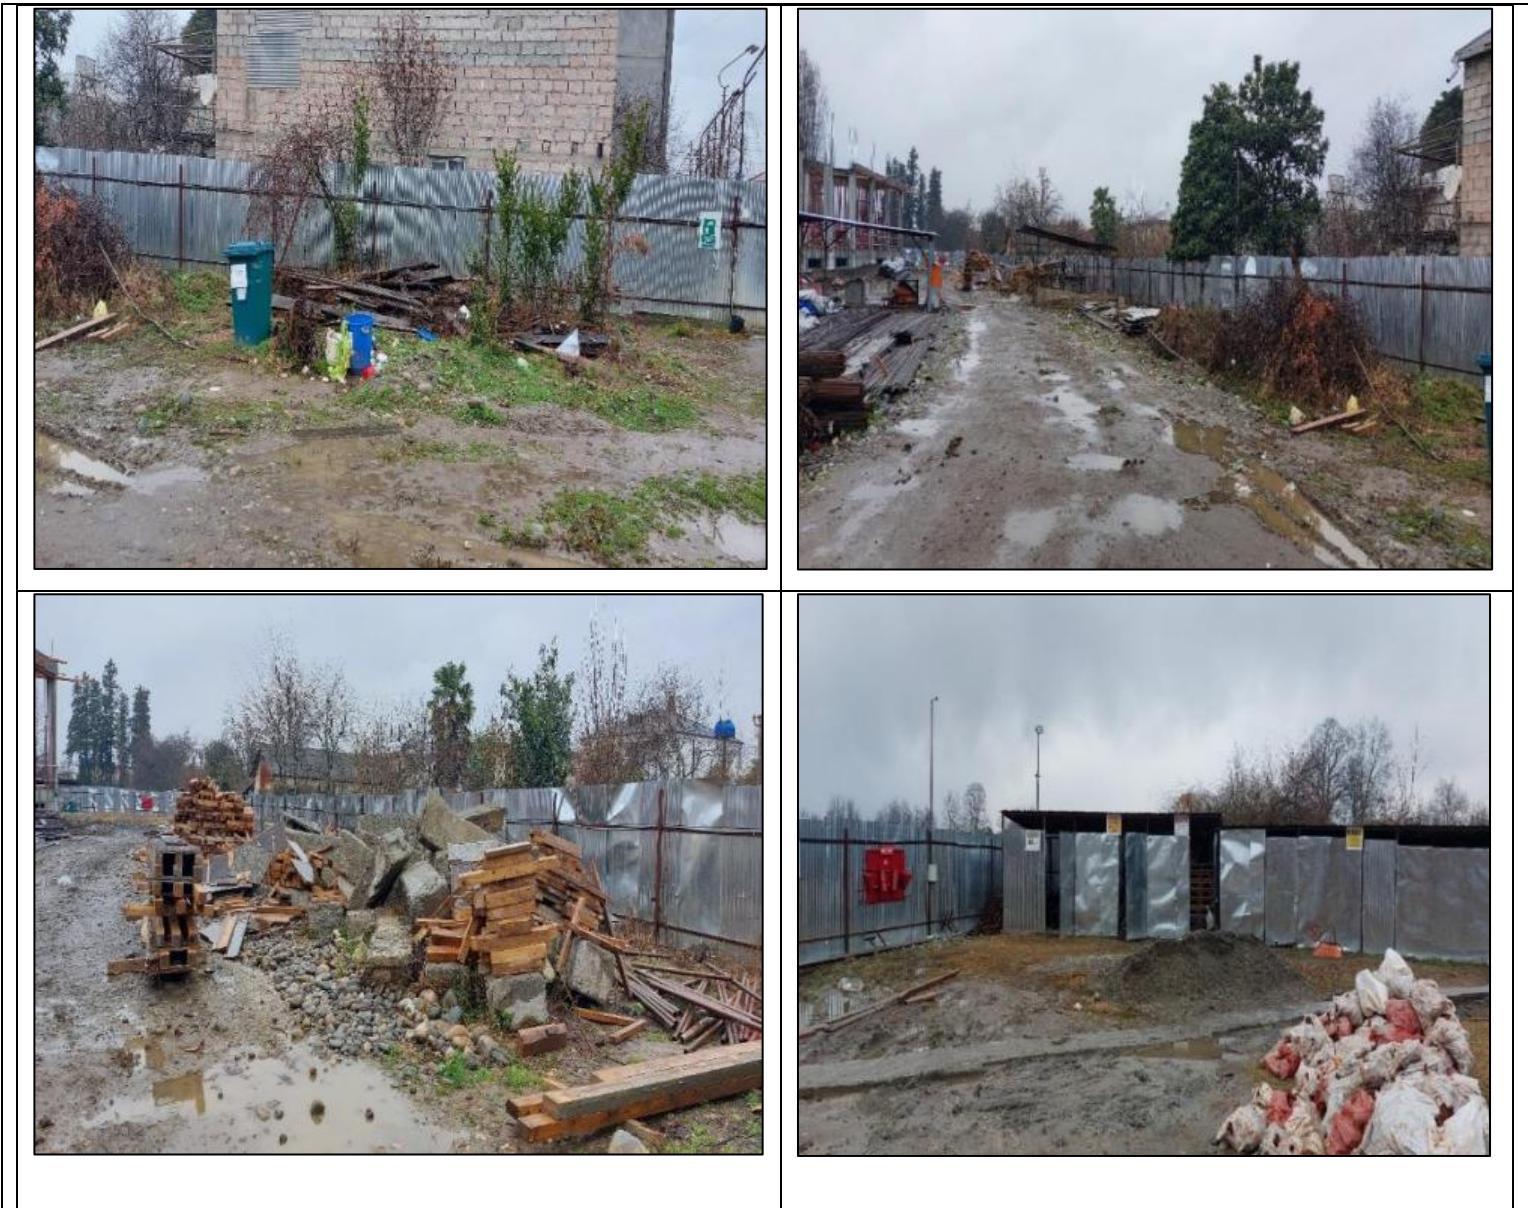
- Construction/Demolition waste is not removed. Construction/Demolition waste should be removed completely and disposed according to the agreement
- Hazardous Waste container is not installed. Proper container with relevant signs "HAZARDOUS WASTE" should be installed at the proper organized place with concrete floor and roofing

- Workers are not using complete Personal Protection Equipment (PPE). Workers always should use complete PPE (hard hats, goggles, gloves, vests, safety shoes)

All these conditions have to be remedied within seven days (by the 20.04.22) by the prime Contractor ("JIANGSU NANTONG SAATJTATV CONSIRUCTION GROUP Co. LTD (China)")

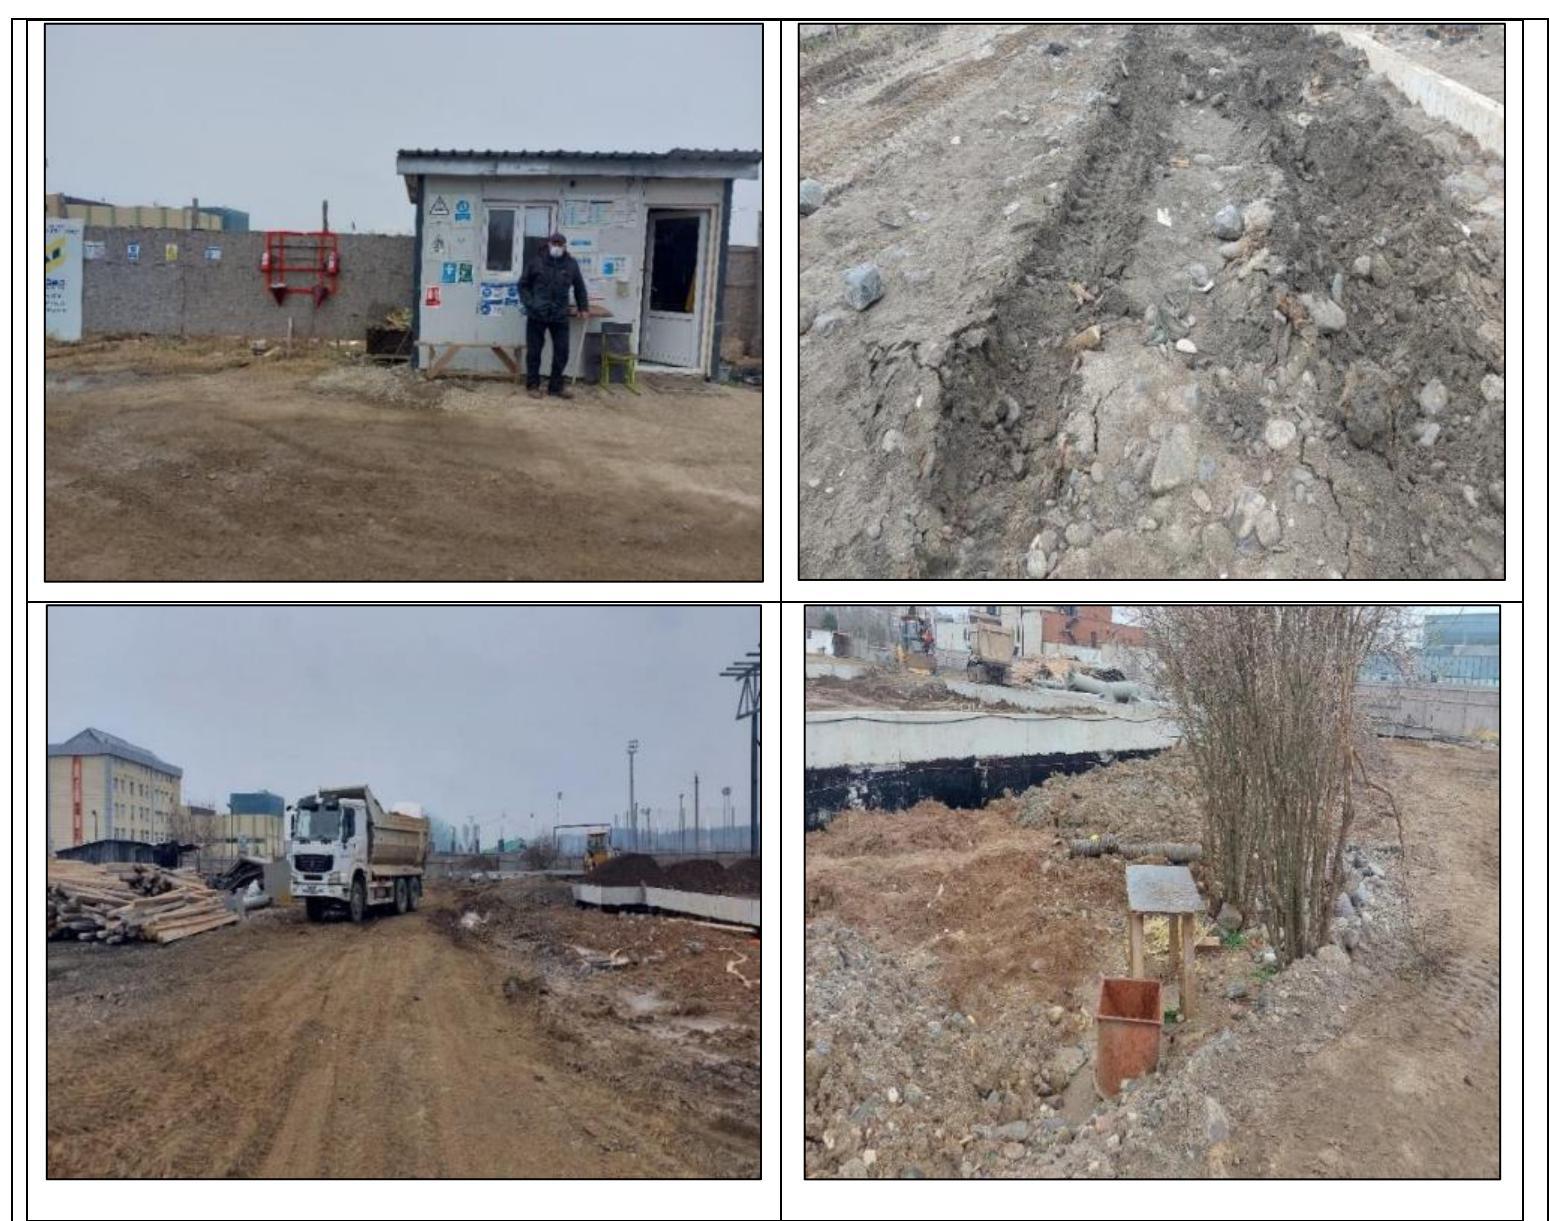
- Waste containers (Hazardous and Household) are not installed. Proper containers with relevant signs "HOUSEHOLD WASTE"/ "HAZARDOUS WASTE" should be installed at the construction territory. Hazardous Waste container with should be installed at the proper organized place with concrete floor and roofing

- Tarpaulin cover during loose materials transportation is not used. Tarpaulins to cover loose material that is transported to and from the site by truck should be used

- Workers are not using complete Personal Protection Equipment (PPE). Workers always should use complete PPE (hard hats, goggles, gloves, vests, safety shoes)

All these conditions have to be remedied within seven days (by the 20.04.2022) by the prime Contractor ("SABA Construction")

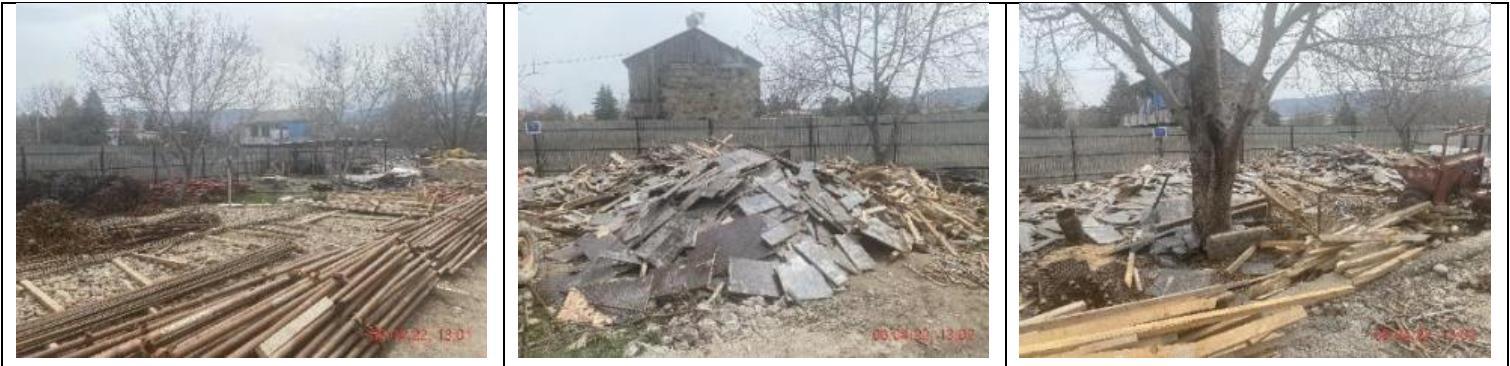
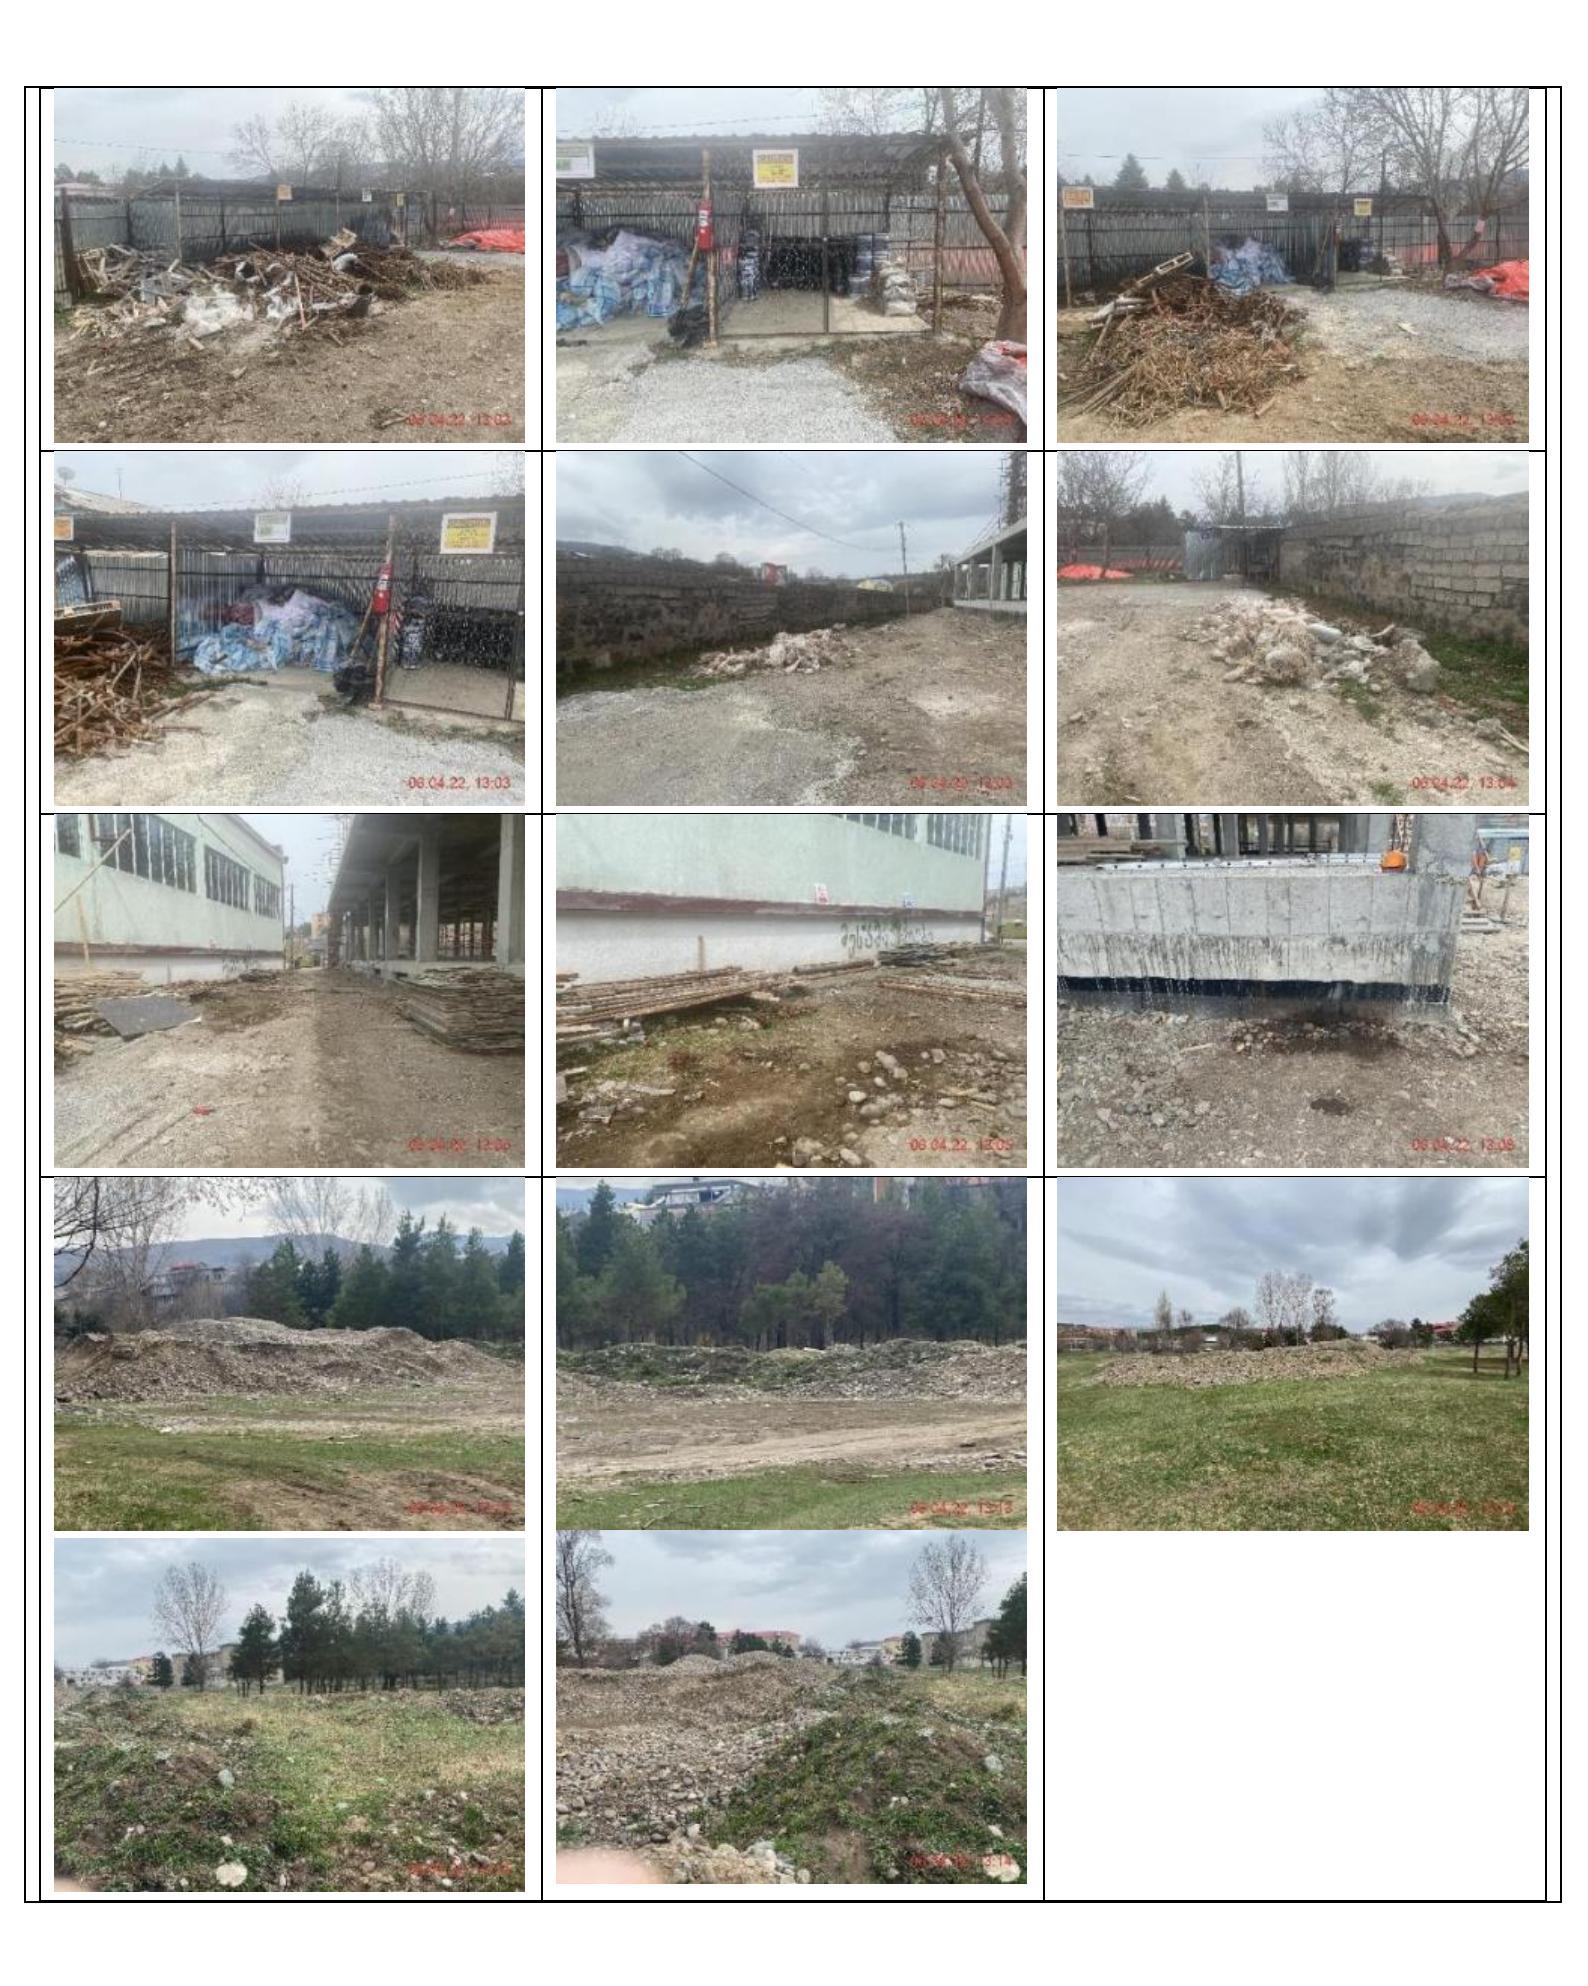
- Hazardous Waste container is not installed. Proper container with relevant signs "HAZARDOUS WASTE"/"ບໍs b ດ ອຣ om ნ s რ β ე ნ ე ຽ ດ " should be installed at the proper organized place with concrete floor and roofing

- Workers are not using complete Personal Protection Equipment (PPE). Workers always should use complete PPE (hard hats, goggles, gloves, vests, safety shoes)

All these conditions have to be remedied within seven days (by the 20 April) by the prime Contractor (Nantong Sanjian Georgia LLC)

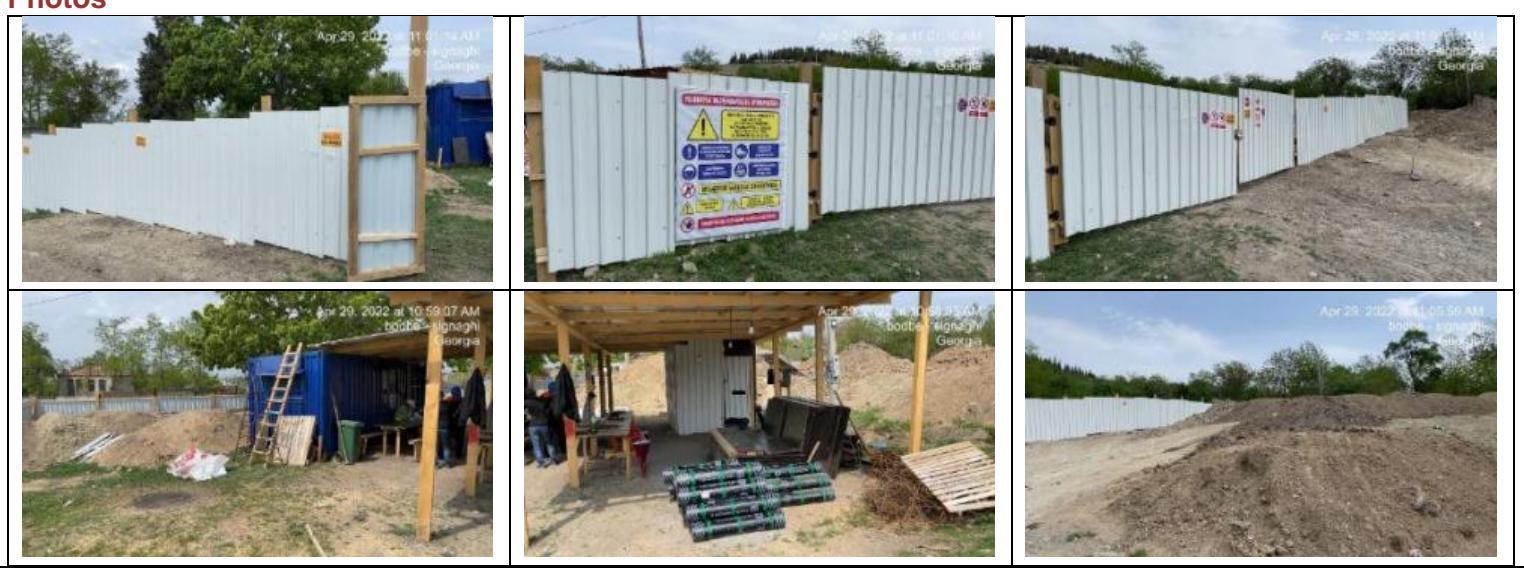
• Scrap at the construction site should be collected separately at on ("Scrap"/"ჯართი")	e location, fenced and signed
 Hazardous Waste container is not installed. Proper container with releva "სახიფათონარჩენები" should be installed at the proper organize roofing 	nt signs "HAZARDOUS WASTE"/ ed place with concrete floor and
 Household Waste container must be available on site. Container should WASTE/ს ა ყოფა ცხოვრებო ნ არჩენები". 	be signed "HOUSEHOLD
 Top soil should be stored separately in appropriate location (height of fill inclination of the fill slope must not exceed 45°), fenced by tape and sign 	must not exceed 2 m and the ed
 Construction waste is not fully removed from construction area. Construction completely and disposed according agreement 	ction waste should be removed
 Workers are not using complete Personal Protection Equipment (PPE). complete PPE (hard hats, goggles, gloves, vests, safety shoes) 	Norkers always should use

erue 47 du 1 du 19 igadh Gerus		Arr 25.202 ar tribe 100 104 Arr	
All these conditions have to be remedied within seven days (by the 09 May) by the prime Contractor ("Instali" LLC)			
Date of site visits	29.04.2022		
EPTISA – Environmental Specialist	st Nika Go

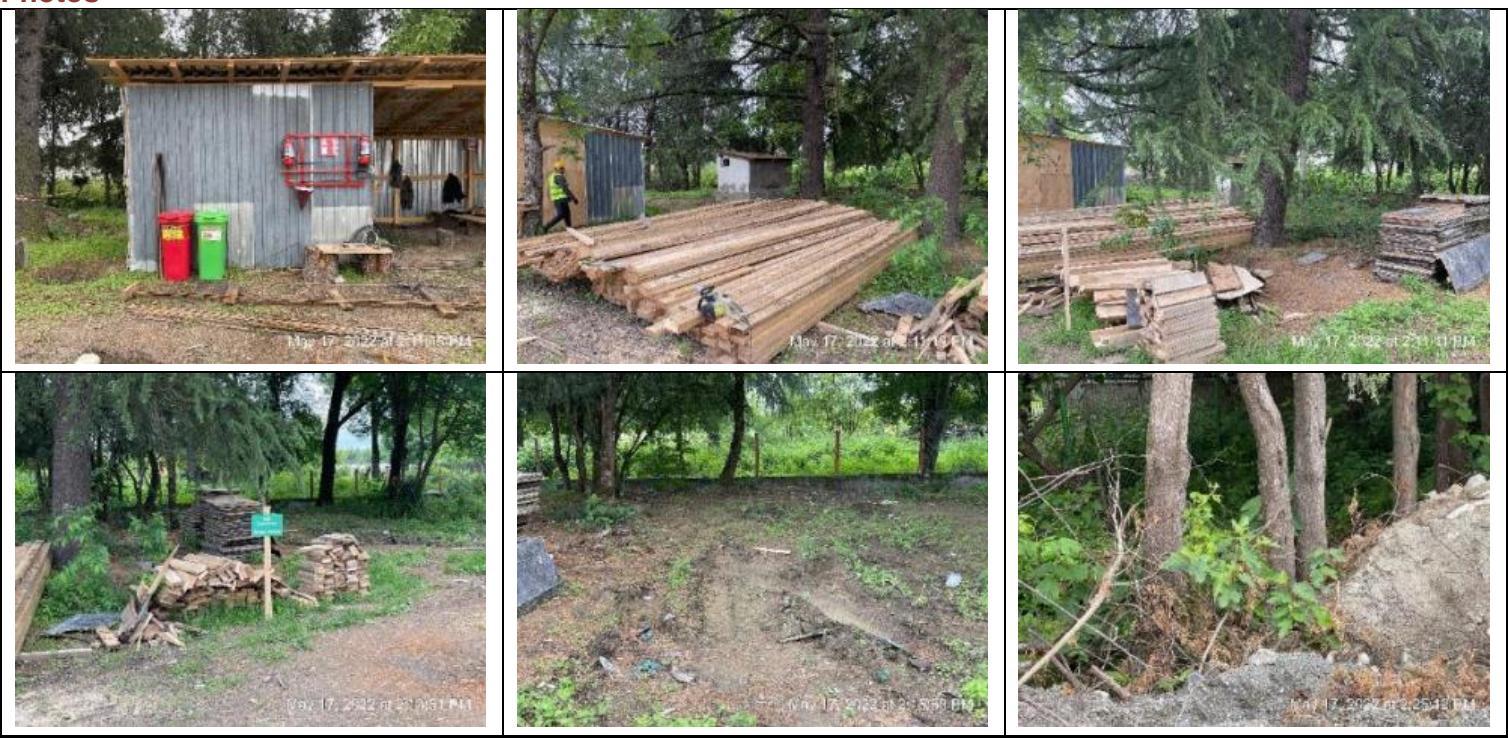
- Scrap at the construction site should be collected separately at one location, fenced and signed ("Scrap"/"ჯართი")
- Hazardous Waste container is not installed properly. Hazardous Waste container should be installed at the proper organized place with concrete floor and roofing.

- Hazardous waste should be removed/disposed according agreement with authorized organization
- Construction site is not fenced from all sides. Construction sites should be properly fenced from all sides and equipped with lockable gate

- Wooden Waste at the construction site should be fenced (e.g. by tape)
- Construction site is not arranged properly. Site internally should be better arranged, materials should be better segregated/stored and cleaned regularly from household and construction waste

NN 17 21 2 412 + 0.23 FM	
All these conditions have to be remedied within seven days (by the 27 May) by the prime Contractor ("Instali" LLC)			
Date of site visits		17.05.2022	
EPTISA – Environmental Specialist		Nika Gogitidze

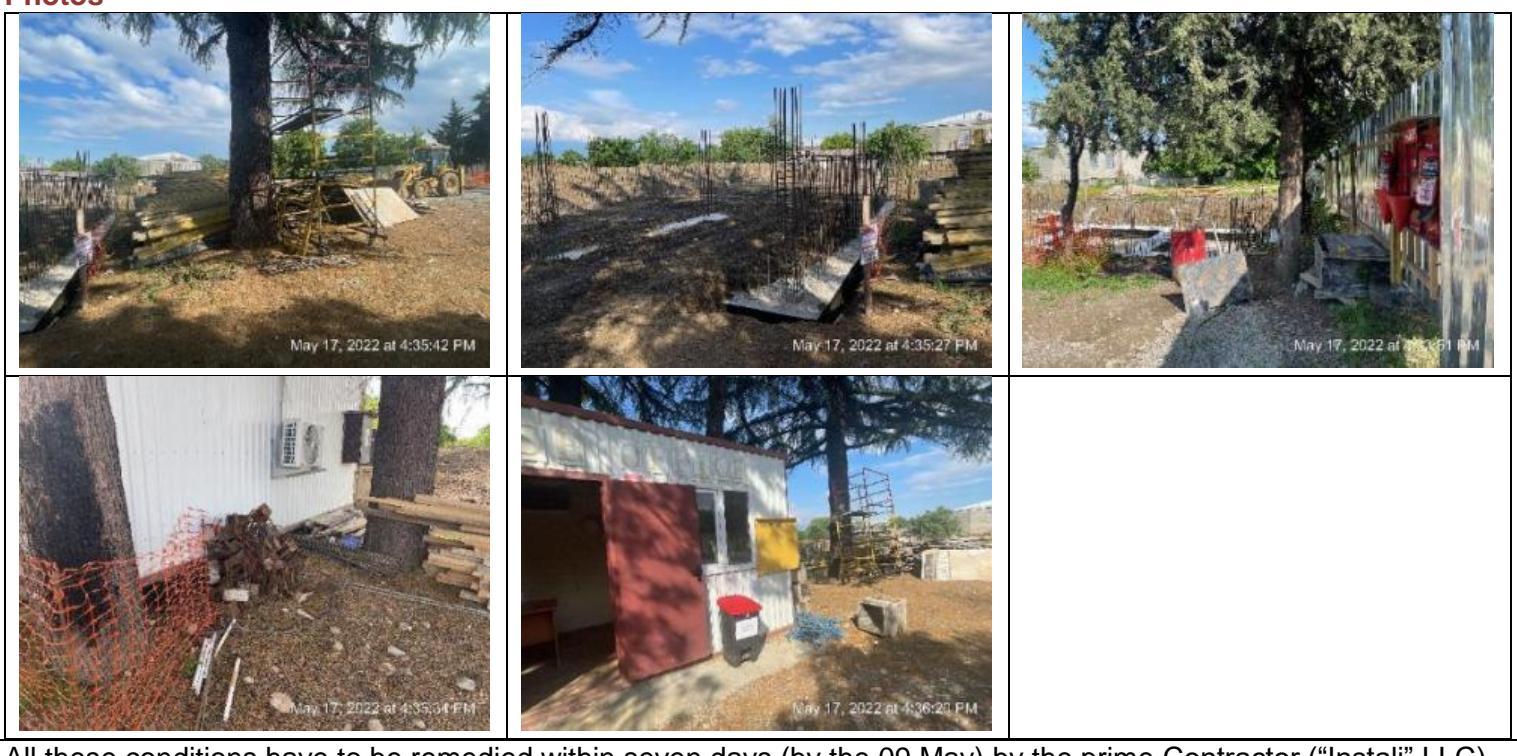
- Scrap at the construction site should be collected separately at one location, fenced and have the appropriate inscription ("Scrap" / "ჯართი").

All these conditions have to be remedied within seven days (by the 09 May) by the prime Contractor ("Instali" LLC)		
Date of site visits	17.05.2022	
EPTISA – Environmental Specialist	Nika Gogitidze

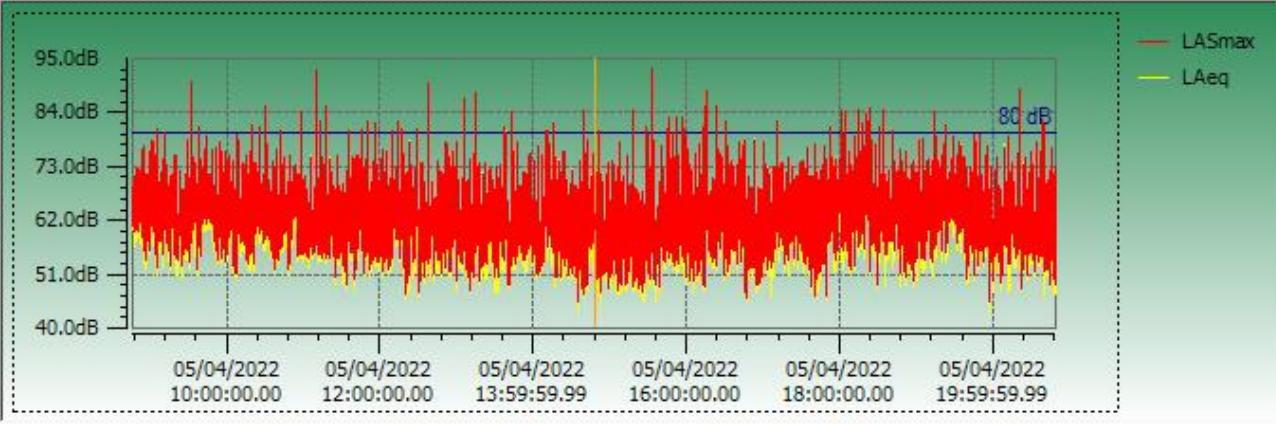
12-hour measurement diagram of noise near the theater,

Nº	Description of survey points	Coordinates	The results of 12 hours of noise level measurement, LAeq/DB
1	Near the theater	X – 562889,905 Y – 4628845,789	66
2	Near the former kindergarten area	X – 563040,167 Y – 4628557,619	58
	45-50
