**Project Number: P53118-001 LCIP**

**Reporting period: January-June 2025  
N7 Semestral Report**

## **GEORGIA: Livable Cities Investment Project for Balanced Regional Development**

Prepared by the Municipal Development Fund of Georgia of the Ministry of Infrastructure of Georgia for the Asian Development Bank.

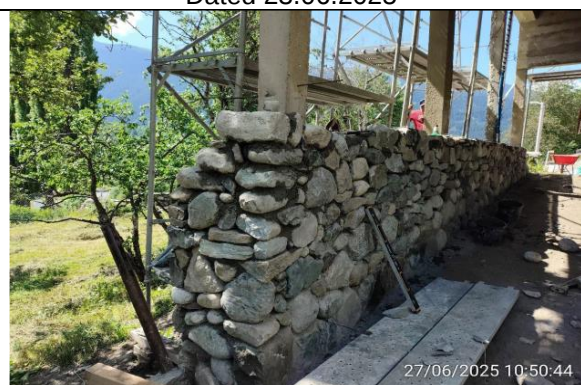
Sector #9 – Building #030 \_Arrangement of cement mortar on the Façade  
Dated 25.06.2025

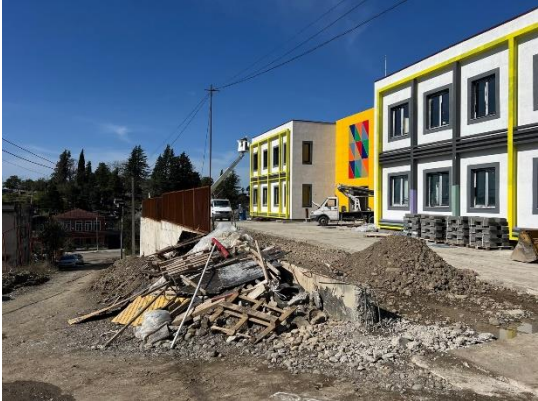
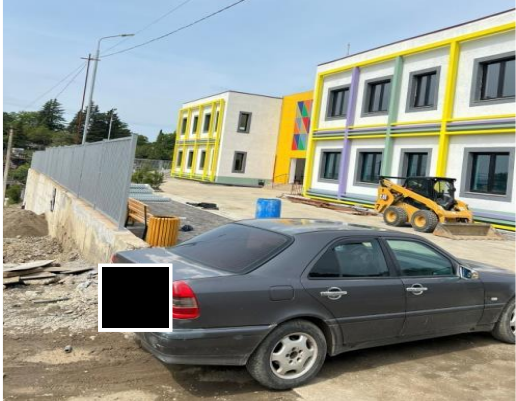
| Nonconformities | Remedial Actions |
|---|---|
| <p>Third party access - contractor installed final fencing only after construction activities were completed; During the work the non-conformity remained open;</p> | <p>Status: (open, in progress, closed) - <b>Closed</b></p> |

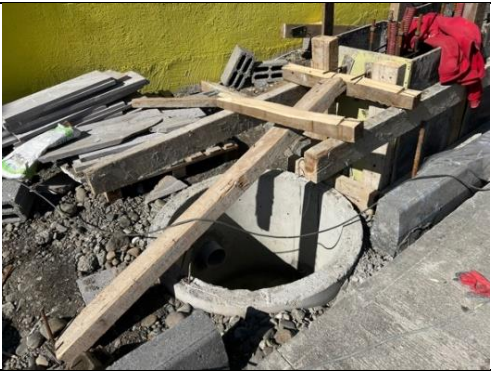
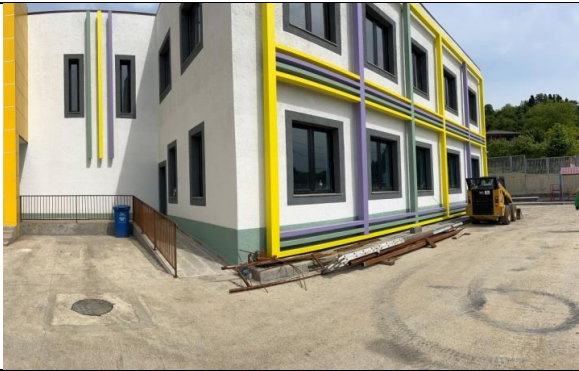
| Nonconformities | Remedial Actions |
|---|---|
| <p>Open manholes - contractor Covered manholes only after construction activities were completed;</p> | <p>During the work the non-conformity remained open; Status: (open, in progress, closed) - <b>Closed</b></p> |

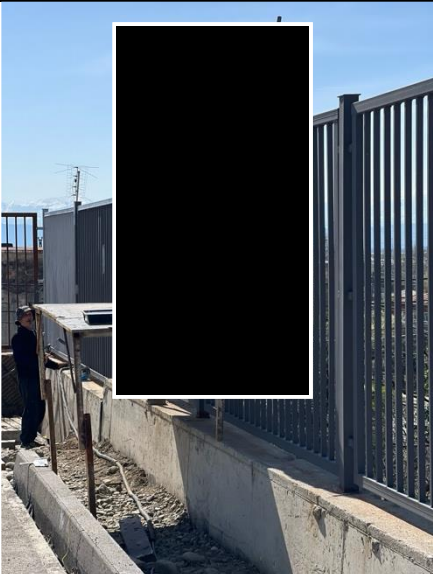
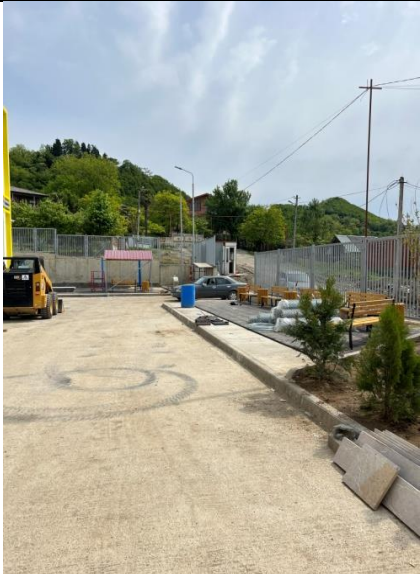
| Nonconformities | Remedial Actions |
|---|---|
| <p>Self-made platform in critical zone - contractor rectified only after construction activities were completed;</p> | <p>Status: (open, in progress, closed) - <b>Closed</b><br/>During the work the non-conformity remained open;</p> |

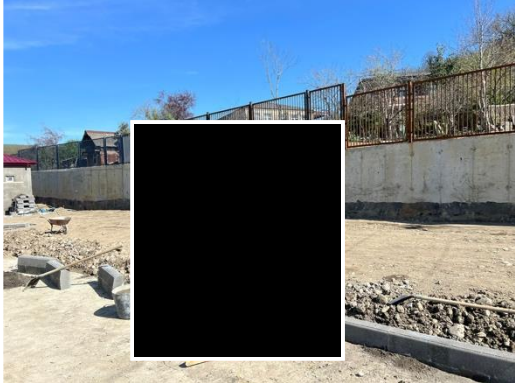
| <p>Lack of PPE - During the work stage there was lack of PPE;</p> | <p>Status: (open, in progress, closed) - Closed</p> |

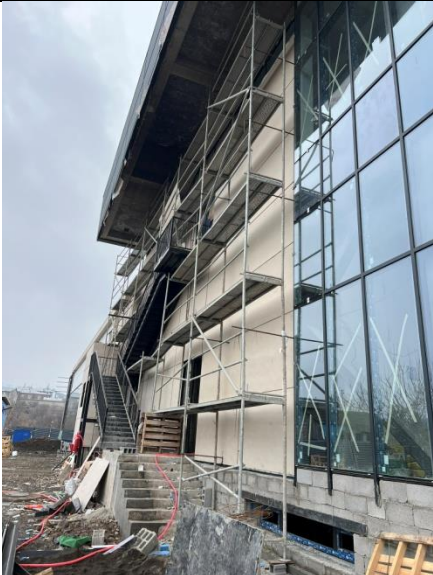
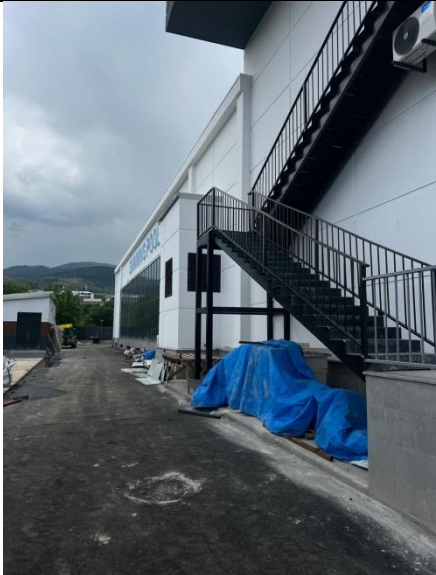
| <p>Not protected surface for scaffold, therefore scaffold is not assembled properly, high risk to fall</p> | <p>Non conformity is closed as main construction activities are completed;<br/><b>Status:</b> (open, in progress, closed) - <b>Closed</b></p> |

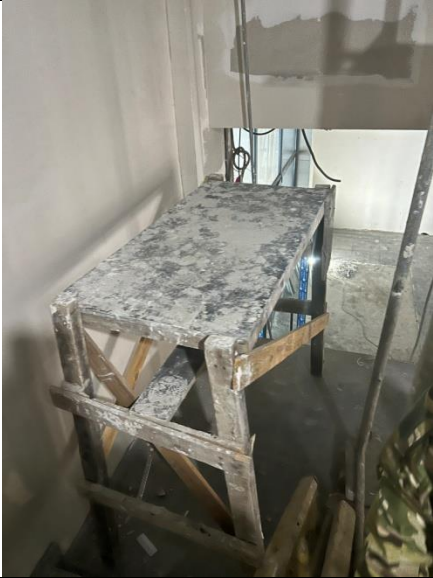
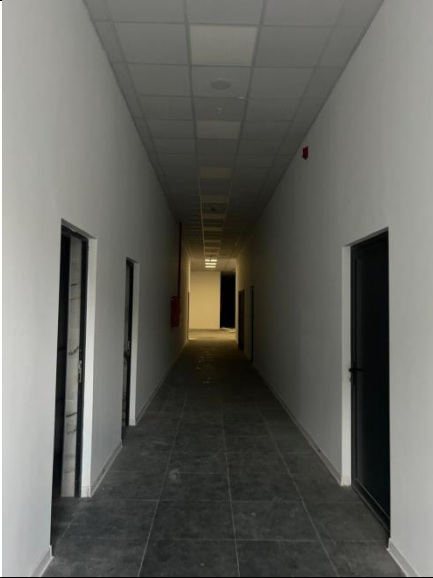
| <p>Critical practice of Using on construction self-made “scaffolds” and not full set of assembled scaffolds</p> | <p><b>Status:</b> (open, in progress, closed) - <b>Closed</b><br/>- Non conformity closed when construction activities were completed during the work stage contractor was using self-made ladders and platforms on site; activities are completed</p> |

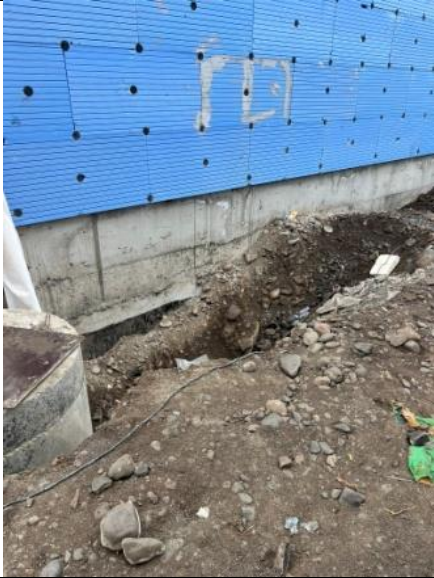
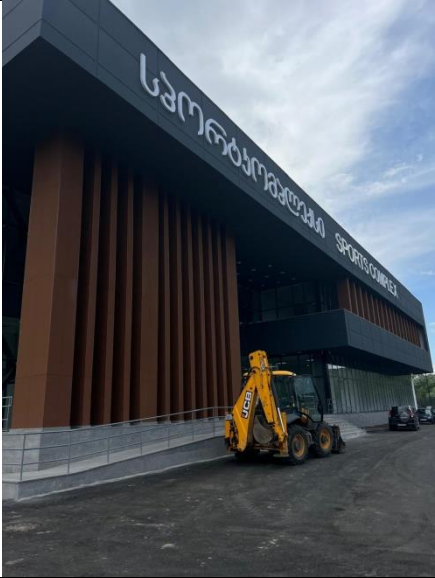
| <p>Open trenches</p> | <p><b>Status:</b> (open, in progress, closed) - <b>Closed</b><br/> - Non conformity is closed as contractor backfilled trench;</p> |

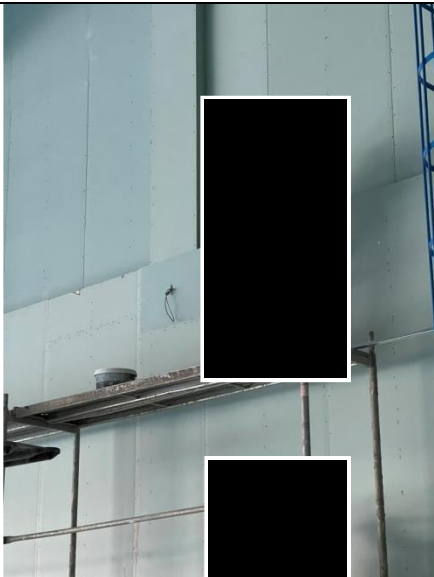
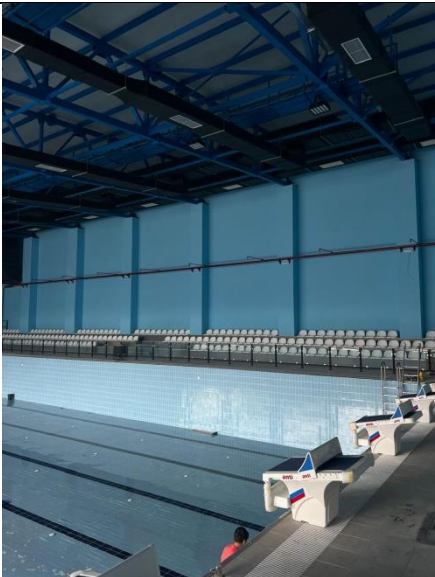
| <p>Critical practice of working on height - No action taken from safety specialist No trainings submitted; no documents submitted; Non conformity is closed</p> | <p><b>Status:</b> (open, in progress, closed) - <b>Closed</b></p> |

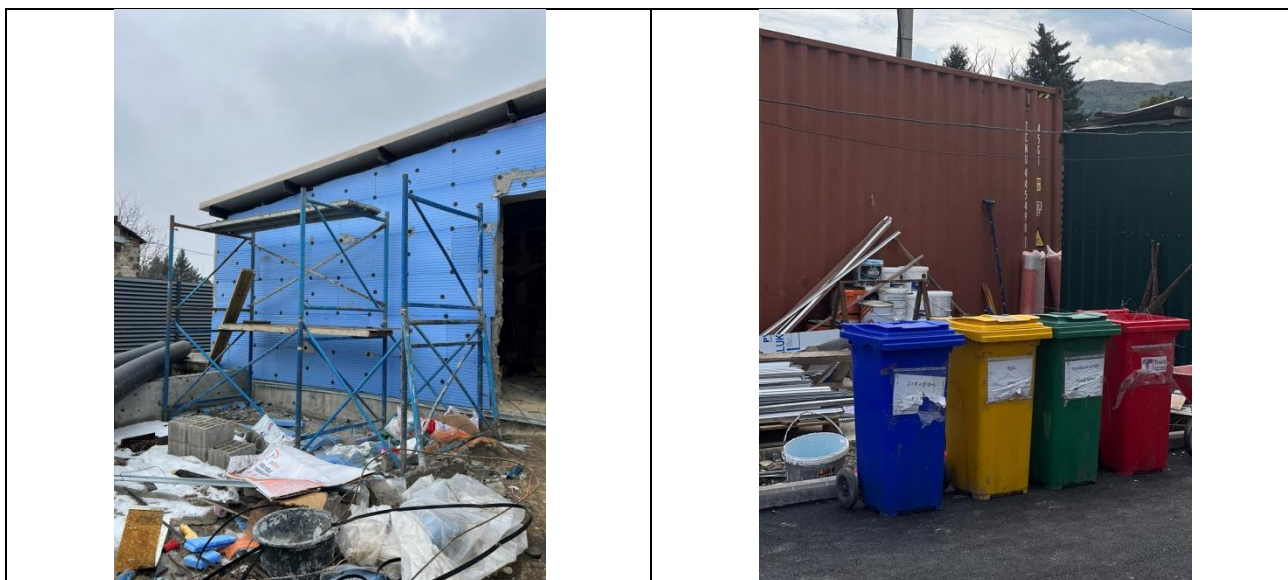
| <p>Lack of general site clearance and self-made scaffold</p> | <p><b>Status:</b> (open, in progress, closed) - <b>In progress</b></p> |

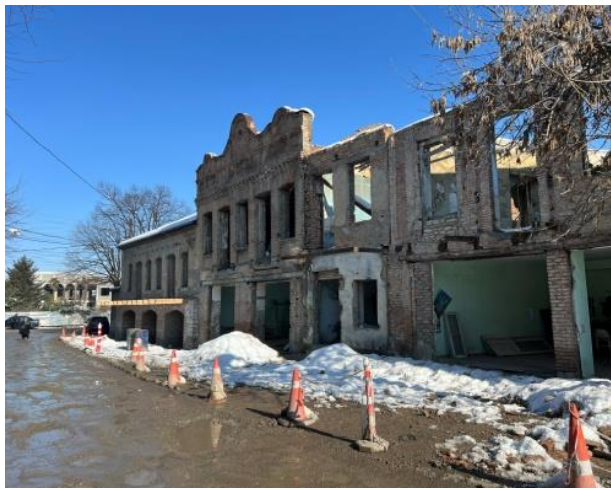
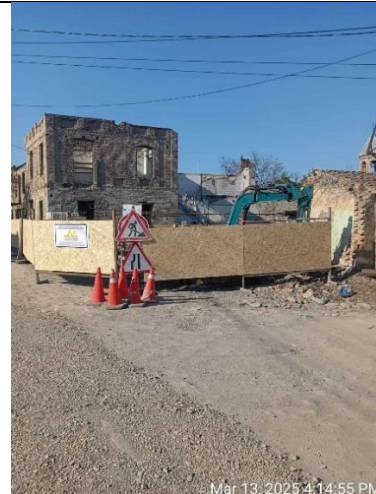
Open and not supported trenches

- Non conformity is rectified in reasonable deadline;  
**Status:** (open, in progress, closed) - **Closed**

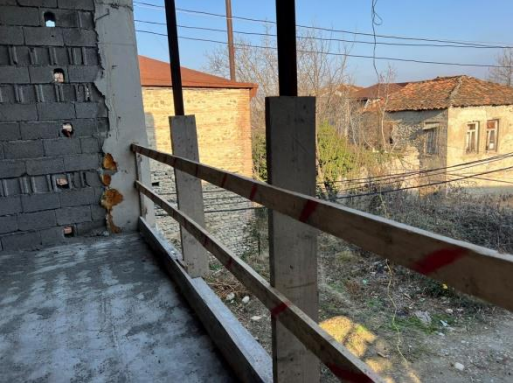
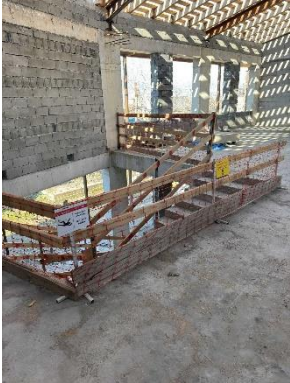
| Detected non conformities | Remedial Actions |
|---|---|
| Not supported slab, safety barriers are fixed not according 477 regulations | Non conformity Is closed within is reasonable deadline<br><b>Status:</b> (open, in progress, closed) - <b>Closed</b> |

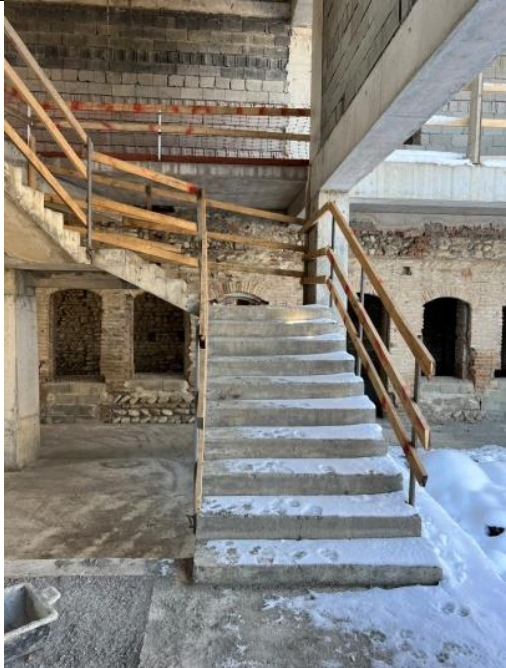
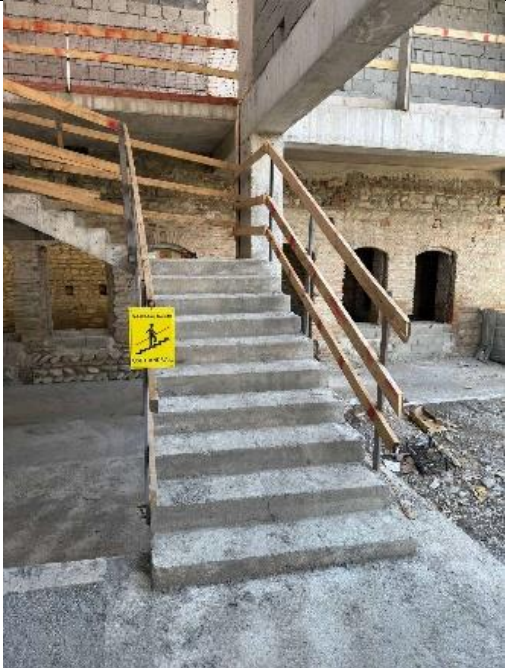
| <p>Life sell was not supported and floored</p> | <p>Non conformity is rectified within in reasonable deadline<br/> <b>Status:</b> (open, In progress, closed) - <b>Closed</b></p> |

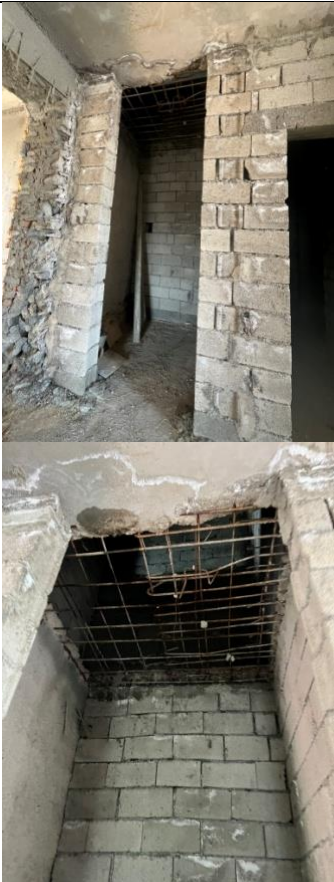
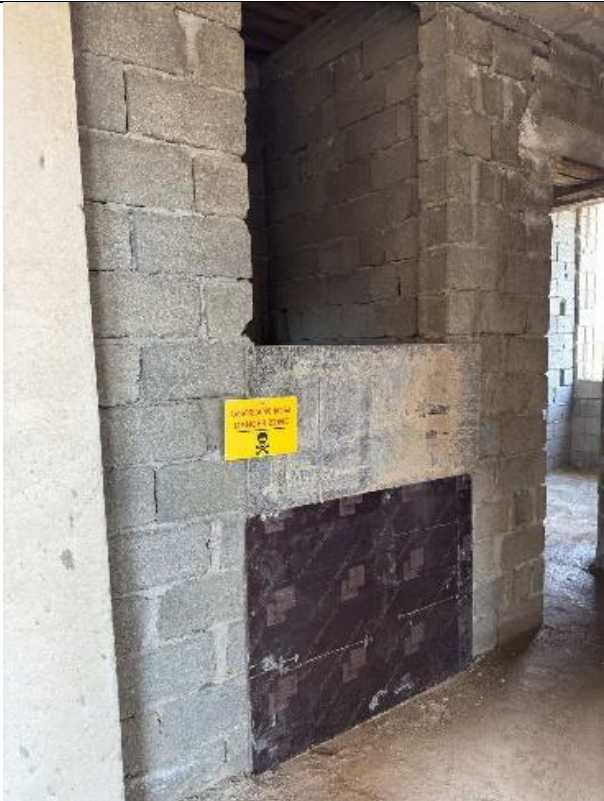
| <p>Scaffold is not assembled properly (1) submit act of competent person for scaffolding and certificate of scaffold</p> | <p>Non conformity is still open<br/> <b>Status:</b> (open, In progress, closed) - <b>Open</b></p> |

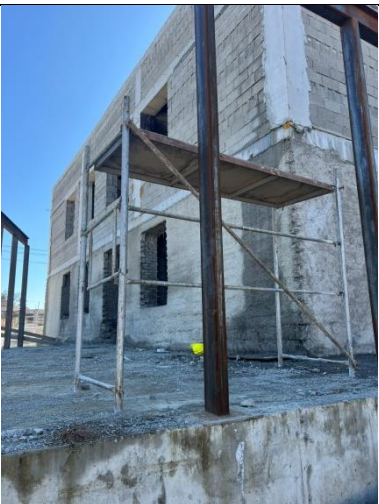
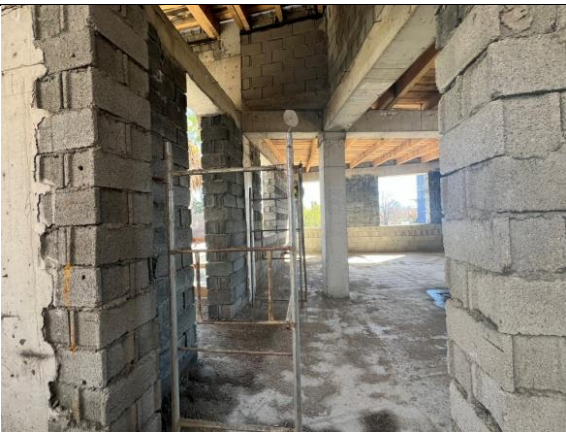
| <p>Self-made “platform” and ladder detected – non conformity Is still remains open</p> | <p><b>Status:</b> (open, In progress, closed) - <b>Open</b></p> |

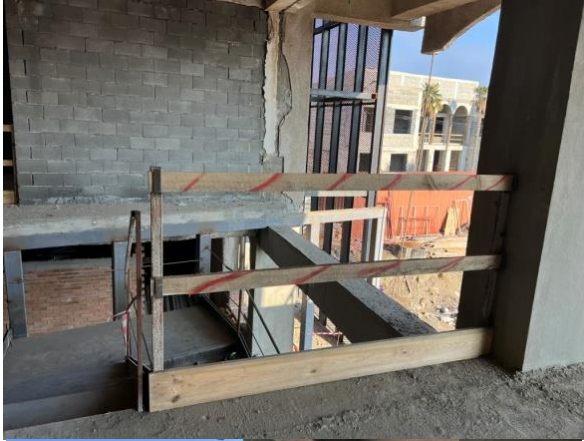
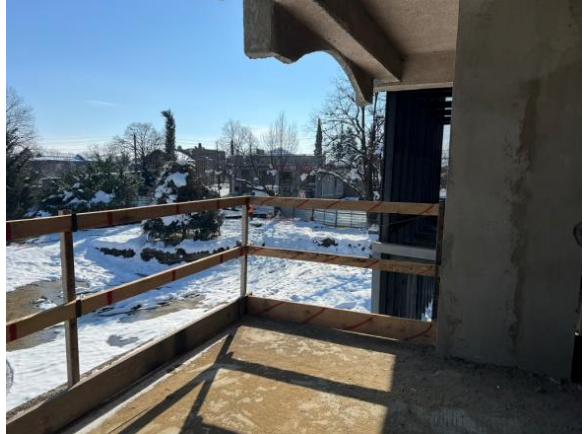
| Detected non conformities | Remedial Actions |
|---|---|
| Safety barriers are not according 477 regulations;<br>vertical poles are not according regulation; and | <b>Status:</b> (open, In progress, closed) - <b>Closed</b> |

barriers itself are not fixed properly; – non conformity Is closed

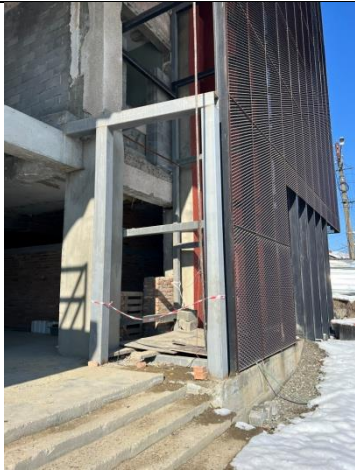
Lift sell is not fenced and marked according 477 regulation sub clause 15;

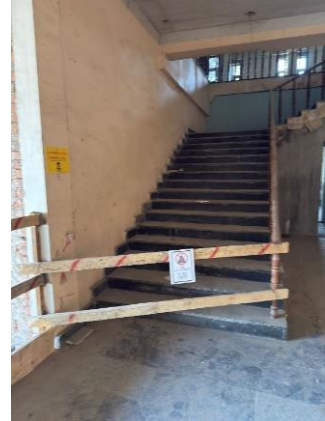
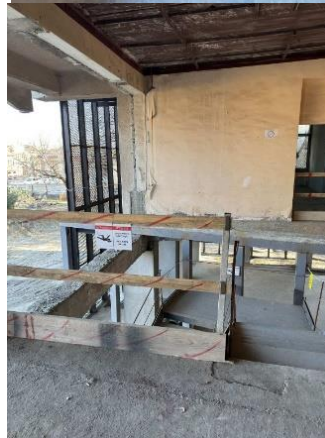
Self-made collective equipment detected

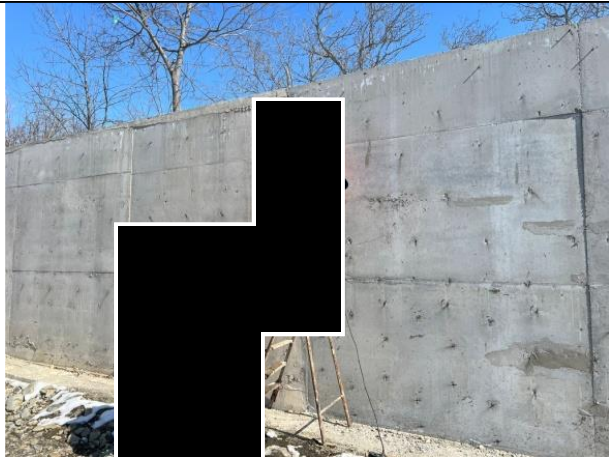
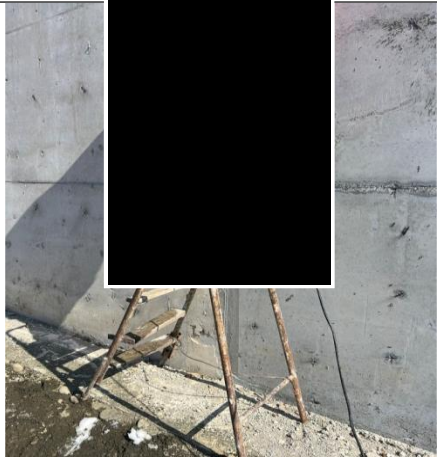
| Non-Conformity | Remedial Actions |
|---|---|
| self-made ladders (2) not supported hand tool (3)<br>No PPE | Status: (open, In progress, closed) - <b>Open</b> |

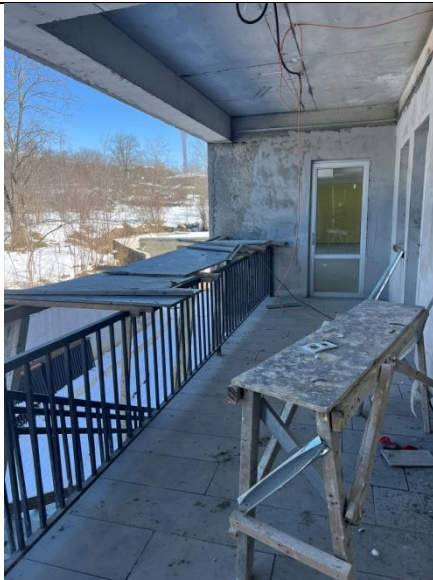
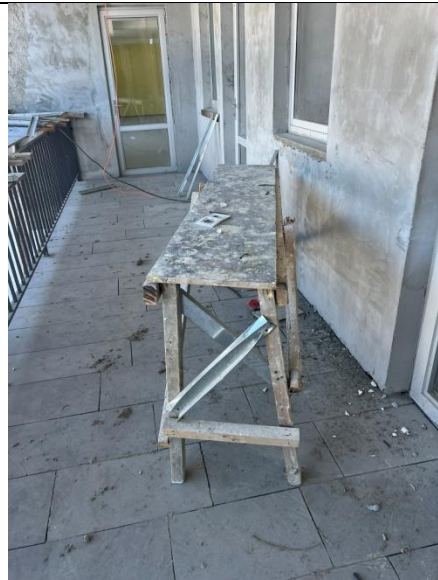
Self made "scaffolds" detected

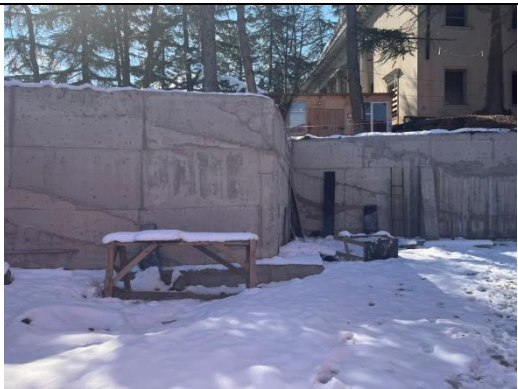
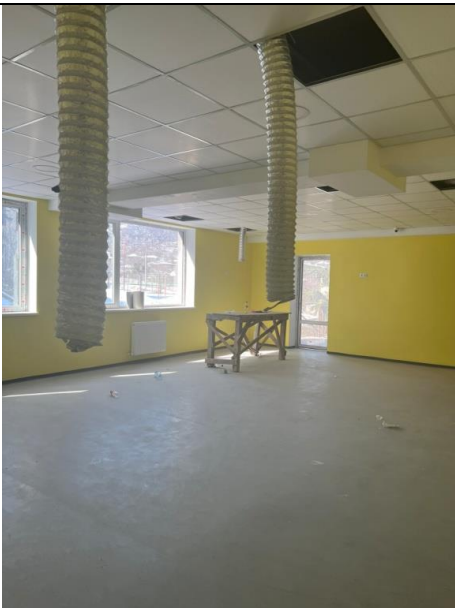
| <p>Self-made “scaffolds” and ladders detected</p> | <p><b>Status:</b> (open, In progress, closed) - <b>Open</b></p> |

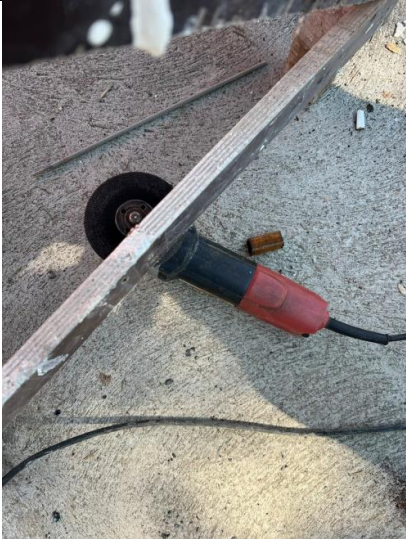
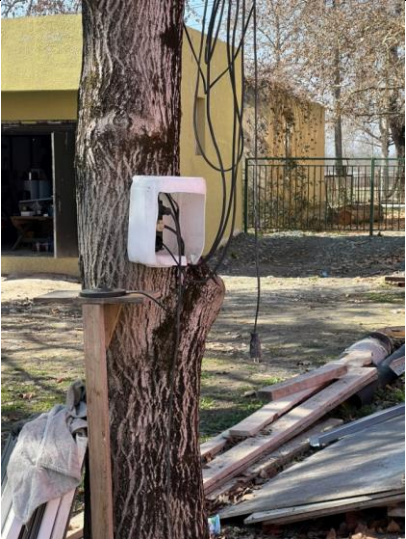
| <p>Not organized electrical cables; lack of fire</p> | <p><b>Status:</b> (open, In progress, closed) -<b>Open</b></p> |

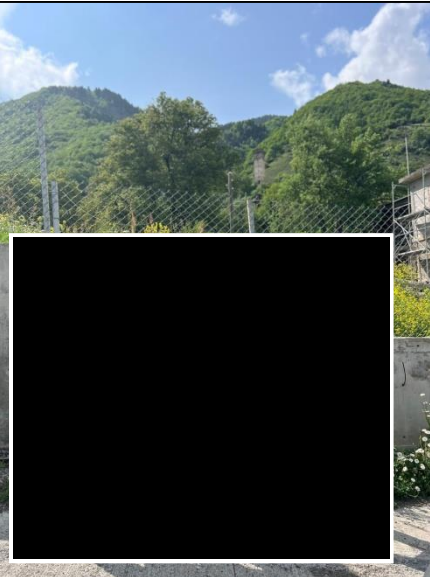
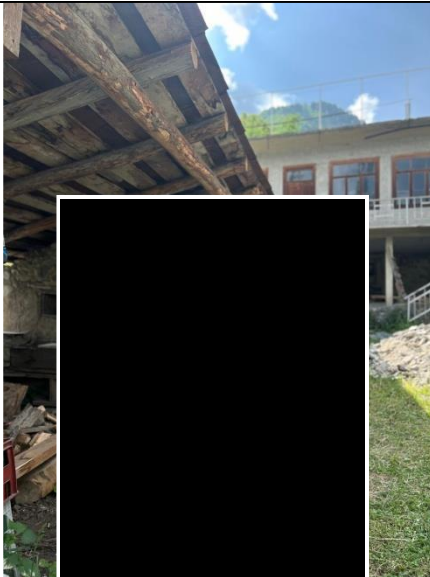
| <p>(1) lack of waste management (2) absence of safety signs, unmanaged access open pathways;<br/> <b>Status:</b> (open, In progress, closed) - <b>Closed</b></p> | |

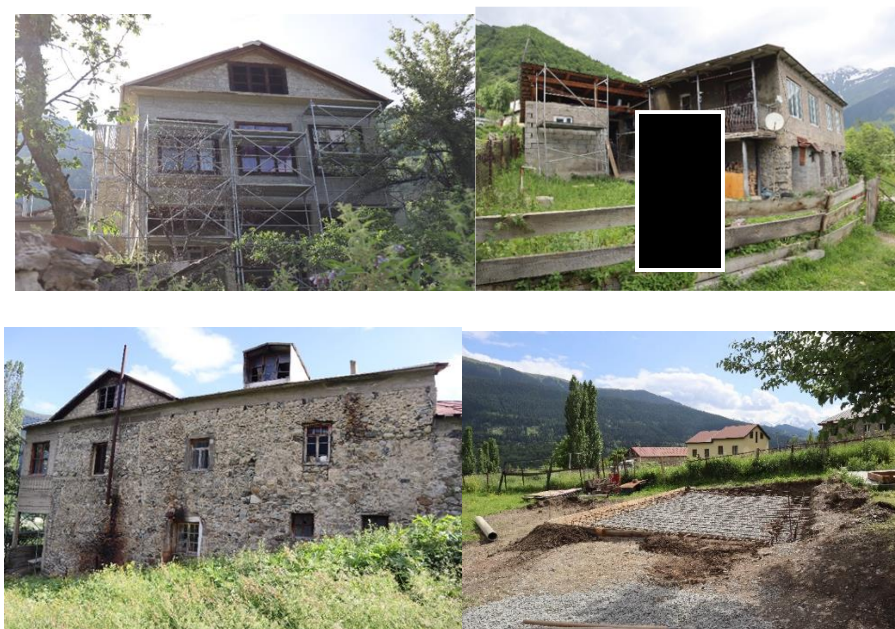
**Figure 43 Photo Material**

187. Targeted Residential houses are from the second half of the 20th century and are significantly different from traditional structures. Their walls are built with stone and concrete blocks, and the shapes and sizes of openings are atypical for a highland settlement. None of these buildings hold individual heritage status. Nevertheless, these structures form part of the urban heritage complex, and their rehabilitation must be carried out in accordance with the Georgian Law on Cultural Heritage and international conservation principles.

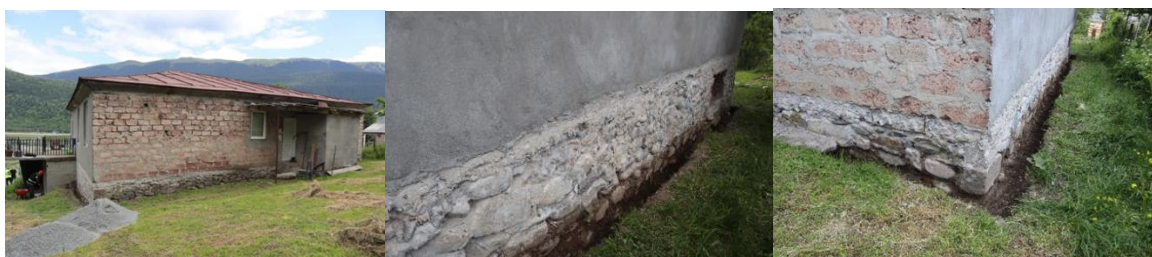
**Figure 47 Photo Material**

195. **Building N29.** This two-story residential building is constructed of concrete blocks, with a plinth and semi-basement built from rubble stone. The building is unplastered and covered with a metal roof. The project provides for cladding the façades with stone and wooden panels, plastering the sanitary unit added to the northern façade, and replacing the wooden roof structure with a new one, covered with wooden shingles. Metal and wooden windows will be installed in the basement.
196. At the time of inspection, no large-scale construction work had been initiated. A narrow trench had been dug around the perimeter of the building to lay the foundation for the stone-clad plinth.

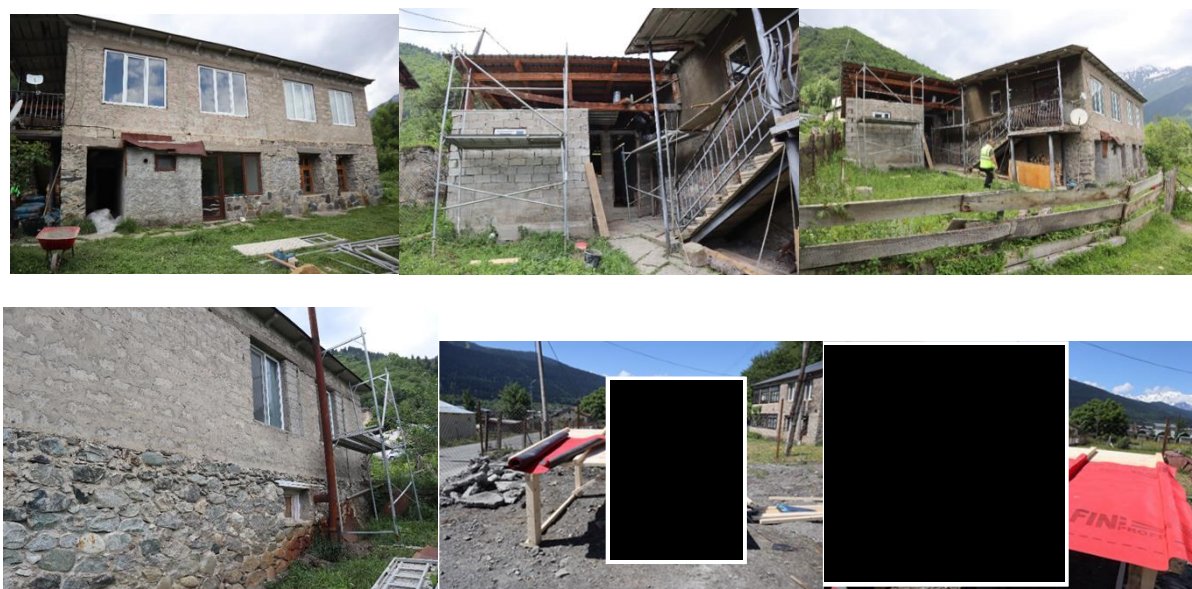
**Figure 49 Photo Material**

199. **Building N30.** This two-story residential building has its first floor constructed with natural stone of various sizes and the second floor with concrete blocks. The intermediate ceiling structure is made of wooden beams. The unplastered façades are broken up by door and window openings. On the west side, a metal staircase and utility structure have been added. Both structures have metal roofing. According to the project, partial boarding of the building and auxiliary structure is planned. The residence, its staircase, and the utility structure will be reroofed using wooden shingles. A storage space will be built beneath the staircase, and part of the façades will be clad in natural stone. At the time of monitoring, construction work was underway in the attached utility room, and plastering of the west façade of the residential building with sand-cement mortar had begun. At this stage, construction work is underway at all sites within the project, although delays from the original schedule are expected.

200. On June 20, a sample roof section using wooden shingles, insulating membranes, and wooden elements was prepared together with the project author. The completed sample was presented to residents, who signed their agreement to have their homes roofed with wooden shingles.
