Reconstruction of Vani Archaeological Museum – Phase 3

Sub-project Environmental and Social Screening and Environmental Review

**WORLD BANK FINANCED
REGIONAL DEVELOPMENT PROJECT 2**

**December, 2016
Last updated: January 2018**

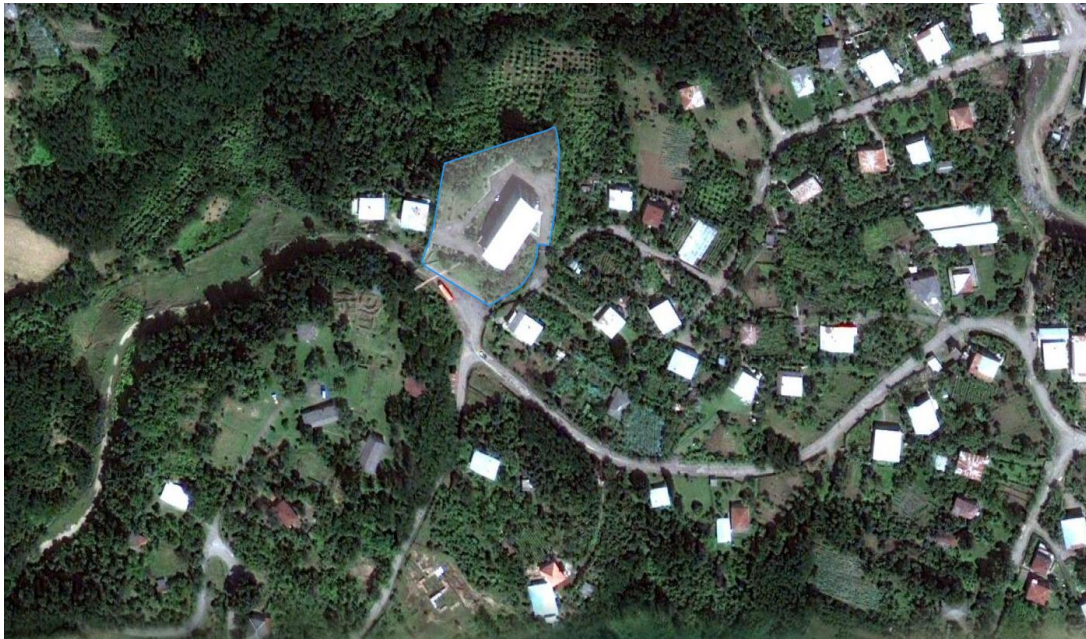
Ortho-photo of the land plot on which pump station and wastewater treatment units will be located

The land plot on which pump station and waste water treatment units (45 m²) will be placed, is registered as municipal property.

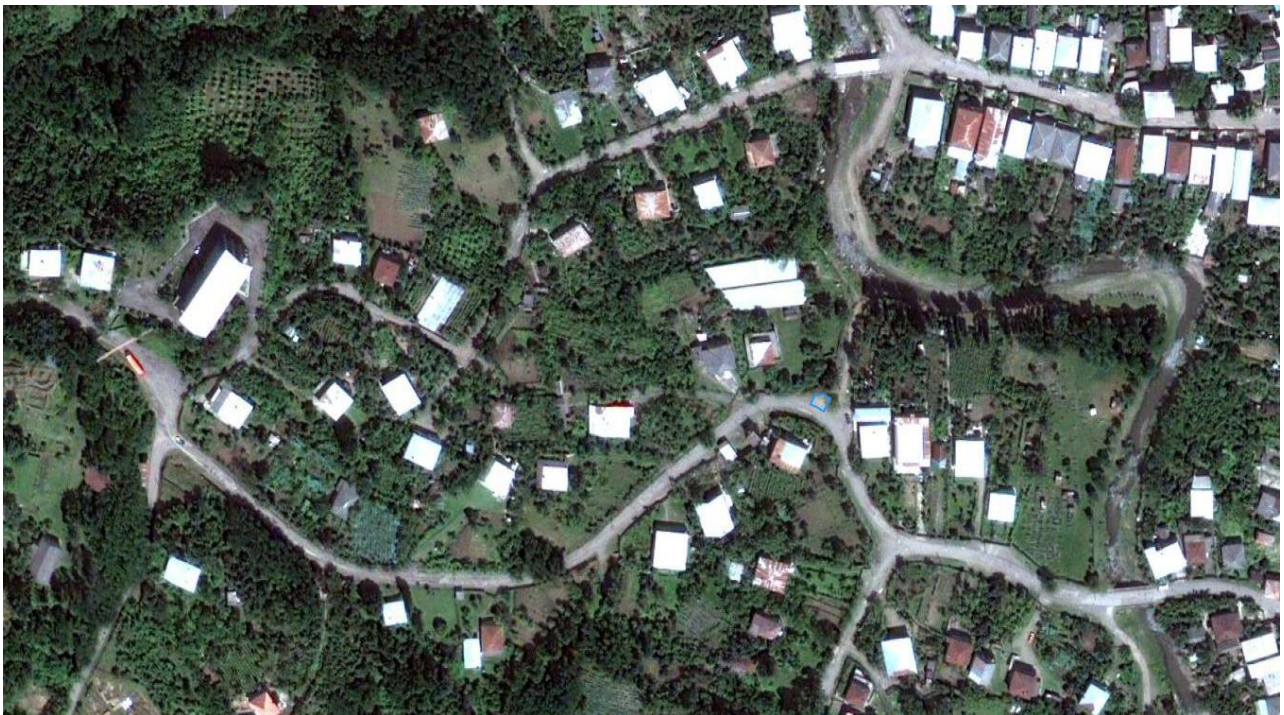
Ortho-photo of the land plot where water reservoir will be placed

Water reservoir will be placed on the plot one piece of which is part of the archeological site, while the other piece is a regular State property. Territory of the archeological site is registered also as the State property with unspecified area of 85 000 m² and has been transferred to the Georgian National Museum for use based on the usufruct agreement. Private houses with yards owned by local residents are situated on the territory of Vani Archaeological site. All civil works will be implemented outside of residential areas. Resident of one plot will also benefit from connection to the new water supply system. As no assets or livelihood of users will be impacted, no compensation is required. An official letter was provided by the Georgian National Museum stating that the involuntary resettlement of the local population has never been planned and it is not considered currently either.
