Restoration of Stepantsminda Museum (Kazbegi Municipality) Subproject

Environmental Review

Third Regional Development Project Funded by the World Bank

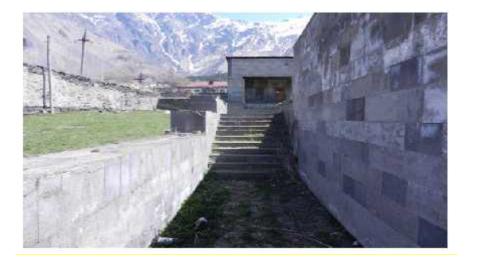
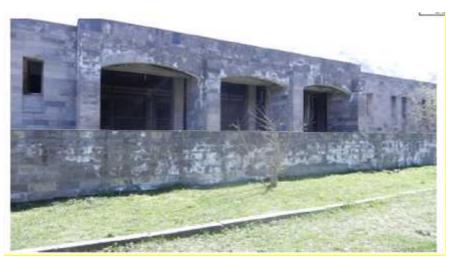
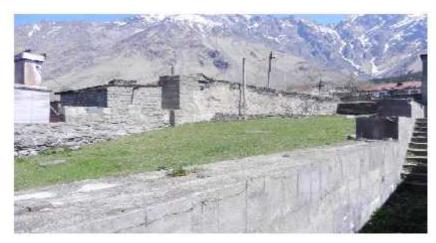
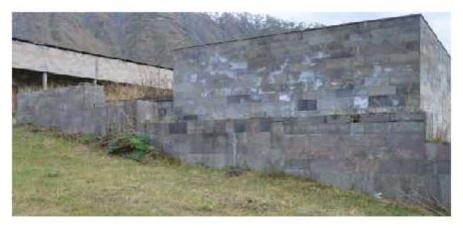
Building of Historical Museum

Historical museum building was built in 80s. Currently it is rather damaged, thus the museum administration and the exhibits are allocated in Alexander Kazbegi house-museum and Nikoloz Kazbegi house. This is single-floor building with the area - 485 m². Restoration is planned in the way in order to maintain maximally the style of the building. The following is foreseen with the SP:

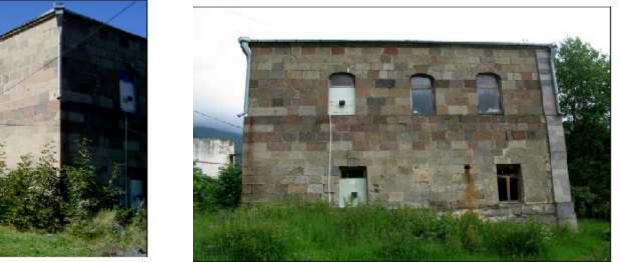
kawaamaa gakawa/ North Facade

Alexander Kazbegi memorial house is two-story building-construction of the area 410 m². House-museum restoration has been designed taking into account historical photo and graphical materials, as well as taking into account measuring drawings of previous years. In the first place, the building fundament and cracks reinforcement works shall be carried out, drainage system will be restored. Damaged ferroconcrete balcony will be removed at the west façade, and new one will be arranged, where two storerooms will be arranged, in two edges of the balcony, and wooden roofing over the columns. The balcony will be enclosed with the metal light bannister. Façade later stone cover will be removed, the wall construction and the door apertures will be restored. At the semi-curved stone staircases to the roofing, stone rectangular

staircases will be arranged with the bannister, which is verified on one of the old photos. Fine-cut stone fronton will be restored at the west façade, adorned with four columns. At the south façade, the balcony will be restored. Damaged door aperture will be rearranged at the east façade. At the perimeter of the entire building, currently dismantled parapet will be arranged with 40 cm high well-cut stone blocks. Along the parapet, chimneys with the fine-cut stone blocks restored in interior will be arranged. The roof damaged tin cover will be removed. Gable window will be arranged in the roof, covered with the high quality brown tin material. Damaged plaster will be removed in the interior of the building, it will be plastered and painted, stoves will be restored, damaged wooden staircases will be changed, and first and second story ceilings, floors and wooden windows and doors will be restored. Under the staircase to the roof, the toilet will be arranged for service personnel. On the first floor, part of the small room to the right will be arranged for cash-office and wardrobe. Water supply, sewerage, lighting and alarm systems will be arranged.
