# Daba Mestia Leo Pilpani Public and Folklore Theatre (Mestia Municipality) Rehabilitation Sub-Project

# Sub-Project Environmental and Social Screening and Environmental Management Plan

WORLD BANK FINANCED
SECOND REGIONAL AND MUNICIPAL INFRASTRUCTURE DEVELOPMENT PROJECT

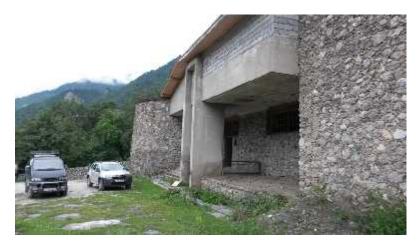
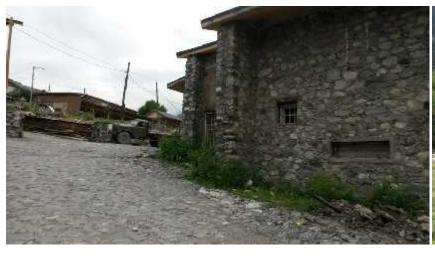
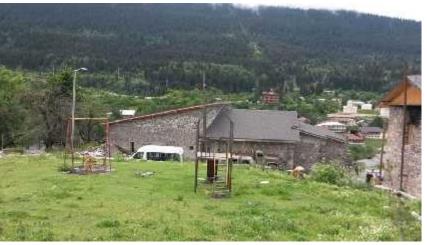
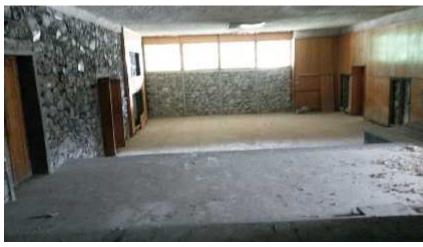
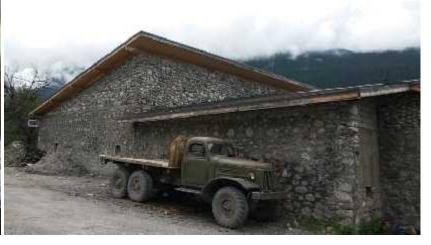
# Pictures of the existing building

The sub-project (SP) envisages rehabilitation of the Leo Pilpani Public and Folk Theater in Mestia Municipality village Mestia. The existing theater is a two-storied building (area 806.3 m<sup>2</sup>). It was constructed in 80-ies of past century. Currently it is nonfunctional.

- Complete dismantling of floors (stone, wood), windows, doors, partitions, ceiling and roofing in the existing building. Currently the building is roofed with bitumen based roof tiling;

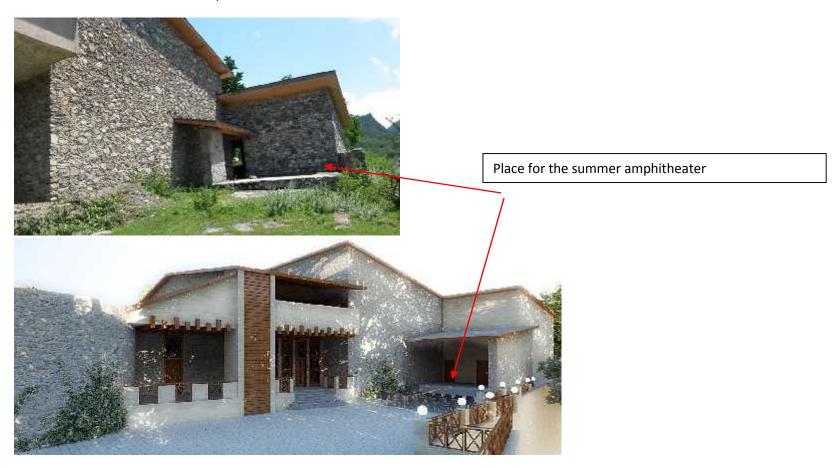
## Picture and render of summer amphitheater

Improvement of the outdoor area. The outdoor area will be paved with stone pavement, a wooden and partially concrete fence will be arranged, which will be faced with travertine. The SP also provides for arrangement of the parking lot for 10 cars, including the one place for disabled. The scene for amphitheater (37, 09 m²) will be placed in front the existing building (see attachment 1).

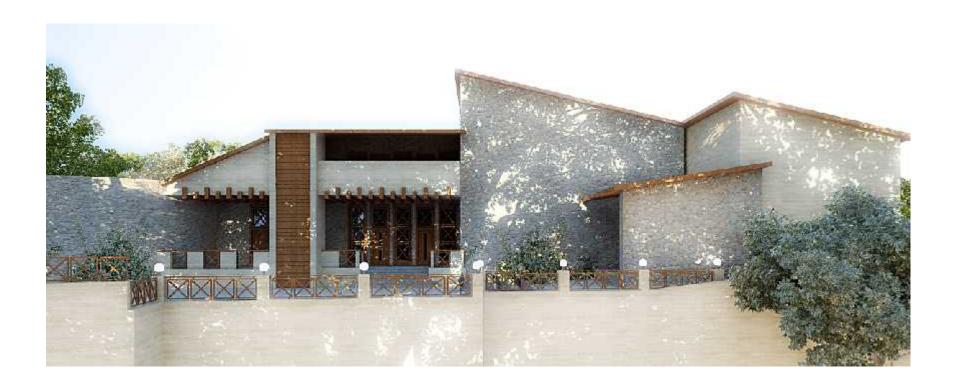
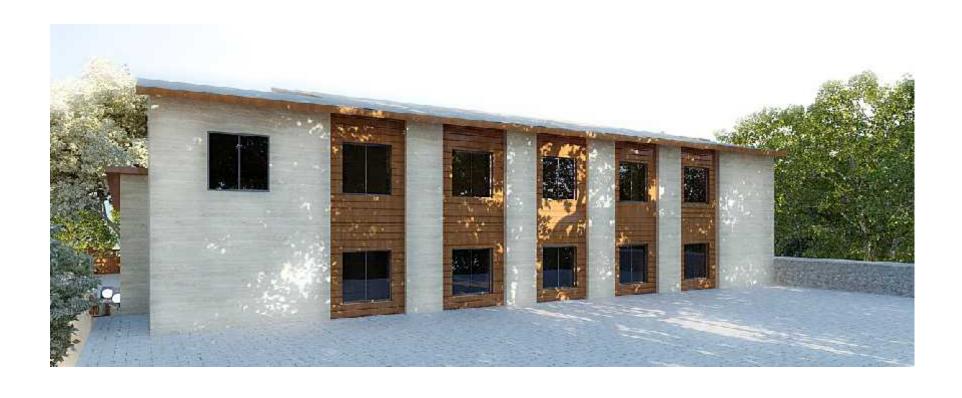
## Renders

- Rehabilitation and extension of the multifunctional hall, the lobby and bathrooms, as well as arrangement of café with kitchen, an administrative office, a property-room, a dressing room and a laundry on the first floor of the building. Arrangement of a rehearsal space and a cloakroom on the second floor. The Multi-functional hall (133, 42 m²) designed for 208 sits, and the stage (97, 54 m²) will be equipped with due ragard to all technological requirements. The multifunctional hall will be expanded for 50 m². Café will connected with terrace, where could be arranged seasonally the open-air café.

- Construction of boiler storage extension (26,5 m<sup>2</sup>) from the north side;
- Extension of the existing space on the east side of the building by 11 m<sup>2</sup> and construction of overstorey (6 room hotel volume space) (Total area of the extensions will be 211,2 m<sup>2</sup>, from this on-ground 37,5m<sup>2</sup>);

- Cleaning the existing façade stone facing, facing the existing and new walls with decorative stone, travertine and wood material;
- Arrangement of the new roofing with bitumen based roof tiling;
